**AIR EDUCATION AND TRAINING
COMMAND HANDBOOK 11-210**

04 FEBRUARY 2020

Flying Operations

ROAD TO WINGS

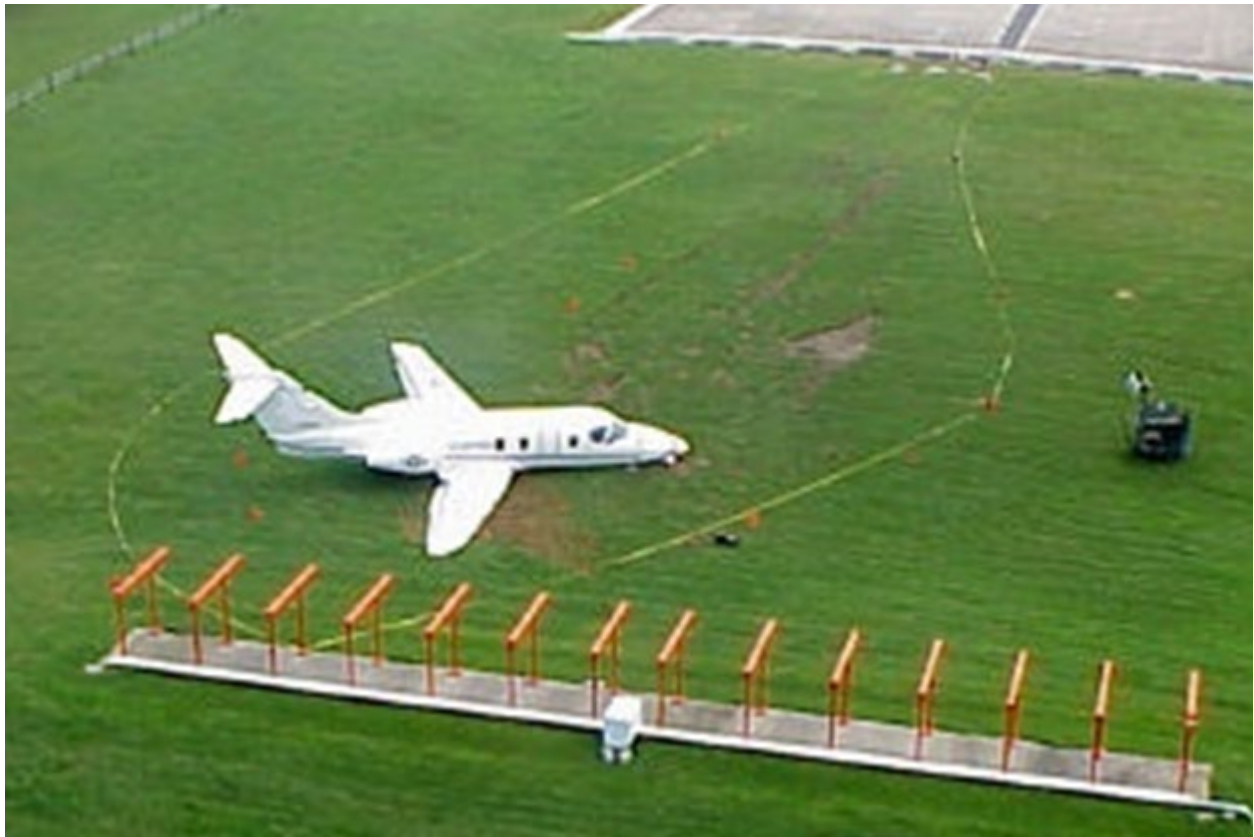
Figure 1. Runway Departure During Landing.

1.1. **Mishap.** **Figure 1.** On a student night navigation sortie, the mishap crew flew an instrument landing system (ILS) approach. The crew crossed the final approach fix 500 feet high. The instructor pilot allowed the student pilot to continue and the aircraft touched down long and fast on a wet runway. The aircraft could not be stopped and departed the end of the runway with the left wingtip striking the ground followed by the right main and nose gear collapsing. As the right wing impacted the ground, the wing spar cracked and the fuel tank ruptured. The crew egressed without injury.

1.2.1. **Operator Factor.** The IP changed the destination but did not inform squadron supervision. This was required as the change dictated a higher risk management (RM) score and changes to the planned destination had to be approved by the supervisor.

1.2.2. **Operator Factor.** The mishap crew (MC) failed the first step in instrument flying, Tune, Identify and Monitor. Failing to tune the correct tactical air navigation (TACAN) resulted in a loss of situational awareness while flying the ILS approach and led to being 500 feet high at the final approach fix. During an attempt to correct the glidepath, the Ground Proximity Warning System (GPWS) sounded, which was ignored by the MC. The steep, fast final led to a long, fast landing on a short, wet runway.

1.2.3. **Operator Factor.** Upon landing, the MC failed to ensure the throttles were at idle. This combined with landing fast delayed the weight on wheels switch and prevented the speed brakes from deploying. Confusion on which crewmember was applying the brakes caused the aircraft to not decelerate as expected and the MC misdiagnosed this situation as a loss of anti-skid braking. The IP applied the emergency brakes which resulted in the aircraft hydroplaning and skidding until it departed the runway and resulted in damage to the landing gear and the right wing.

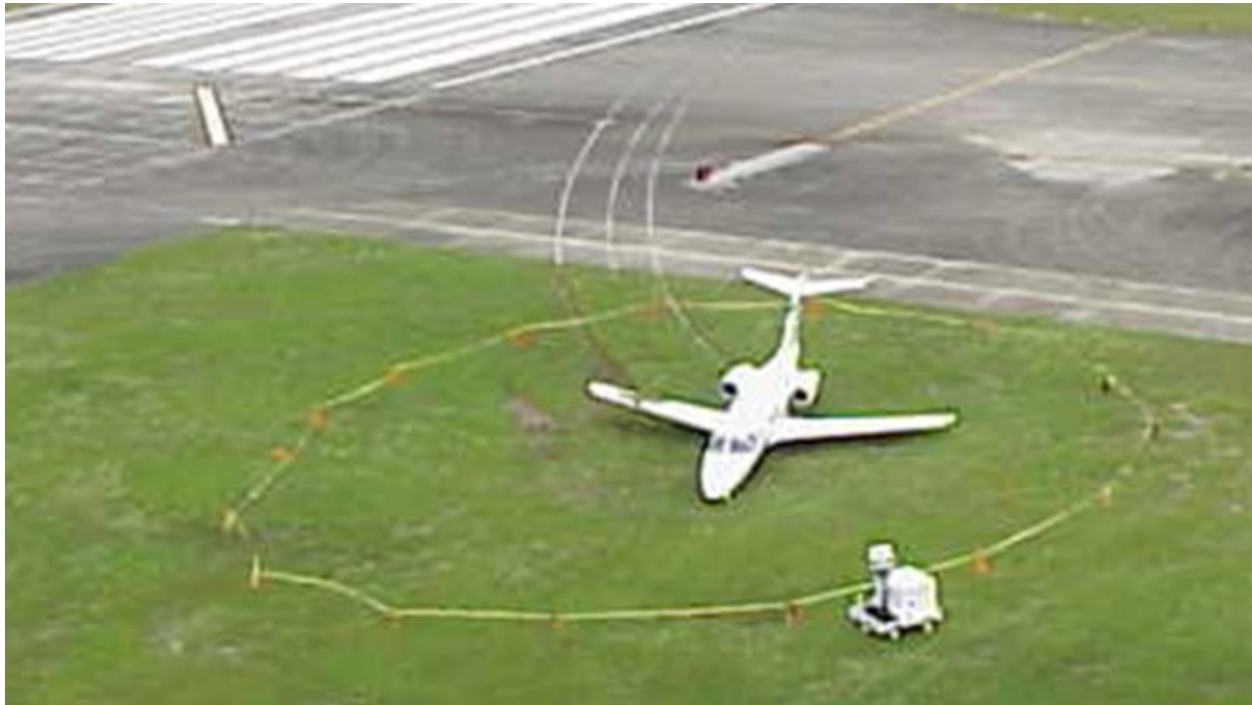
Figure 2. Taxiway Departure During Landing.

2.1. **Mishap. Figure 2.** After a normal pre-brief and takeoff, the mishap crew (MC) flew to an off station base but was unable to conduct the needed training due to thunderstorms in the area. The MC flew back to home station for briefed TACAN approach. As they began the approach, there were thunderstorms in the vicinity of the airfield and light rain showers. As the MC landed for the full stop, the tower failed to pass the wet runway and standing water conditions to the MC. After touchdown, the mishap instructor pilot (MIP) did not feel or hear the anti-skid cycling and released and reapplied the brakes several times. Halfway down the runway, the MC experienced a torrential downpour. The mishap aircraft (MA) started hydroplaning and encountered standing water with about 1,200 feet remaining. The student navigator called out to start the turn for exiting the runway but the MIP lost control of the aircraft in the turn. The MA skidded off the prepared surface and the nose gear collapsed. The MC emergency ground egressed without injuries.

2.2.1. Supervisory Factor. The contract agency for the T-1A instructor pilots failed to comply with AFI 11-418 by not providing adequate operations supervision. Supervisors of flying (SOF) act proactively to direct appropriate actions to correct and prevent unsafe situations.

2.2.2. Operations Factor. Weather issued observations and special observations to Air Traffic Control (ATC) via an electronic means but it did not provide a visual or audio alert feature nor a process to confirm ATC had received the message. Tower controllers either did not notice two special observations for changing weather conditions and thunderstorms or did not react to them due to an on-going extraneous conversation. They also did not relay information on wet/standing water runway conditions and braking action to arriving aircraft. This resulted in a failure of critical airfield information being relayed to arriving aircraft.

2.2.3. Operator Factor. T.O. 1T-1A-1 states that “Failure to maximum brake properly will result in exceeding the computed landing/stopping distance” and “To maximum brake properly, immediately depress toe brakes in one smooth, continuous application. Do not release the brakes. Initially, at high speeds or heavy gross weights the aircraft will not appear to decelerate.” The MIP repeatedly released and reapplied the brakes which invalidated the calculated landing distance. A preceding T-1 that landed 3 minutes before the MA was able to land and clear the runway 1,000 feet prior to the end of the runway.

2.2.4. Operator Factor. Approaching the end of the runway at 50 knots, the MIP elected to start a turn onto the taxiway instead of continuing into the 1,000 foot overrun because the MIP was concerned about the condition of the overrun and an incorrect belief

2.3.2. Following technical order procedures leads to safe execution under normal operating conditions and prevents aircraft damage. Had the MIP correctly applied maximum braking and stopped straight ahead, the mishap would have been prevented.

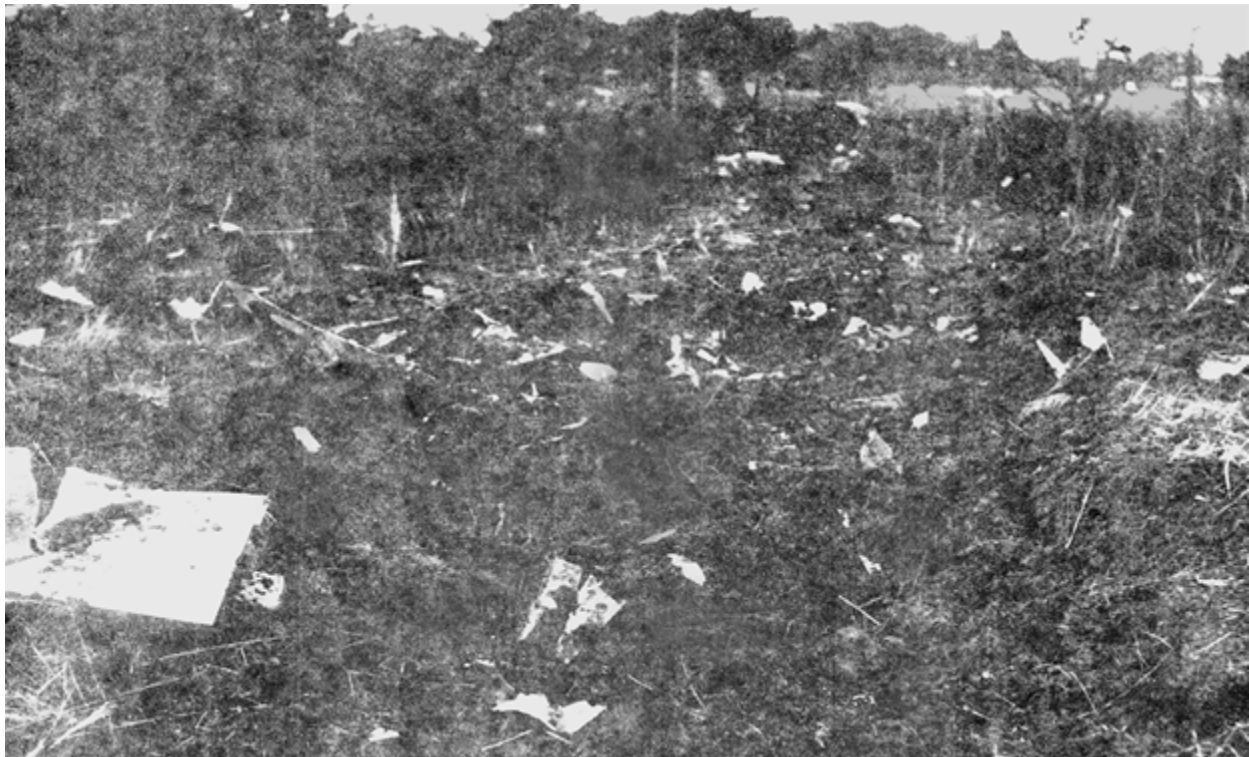
Figure 7. Engine Failure and Loss of Flight Controls.

6.2.1. **Maintenance Factor.** The right engine turbine wheel failed due to a fatigue crack. The failure resulted in damage to pitch control linkages and loss of aircraft control.

6.4.1. Reduced turbine wheel replacement time and accelerated efforts to procure a turbine wheel with a better design.

6.4.2. Changed inspection methods and requirements in an effort to improve detection of fatigue cracks.

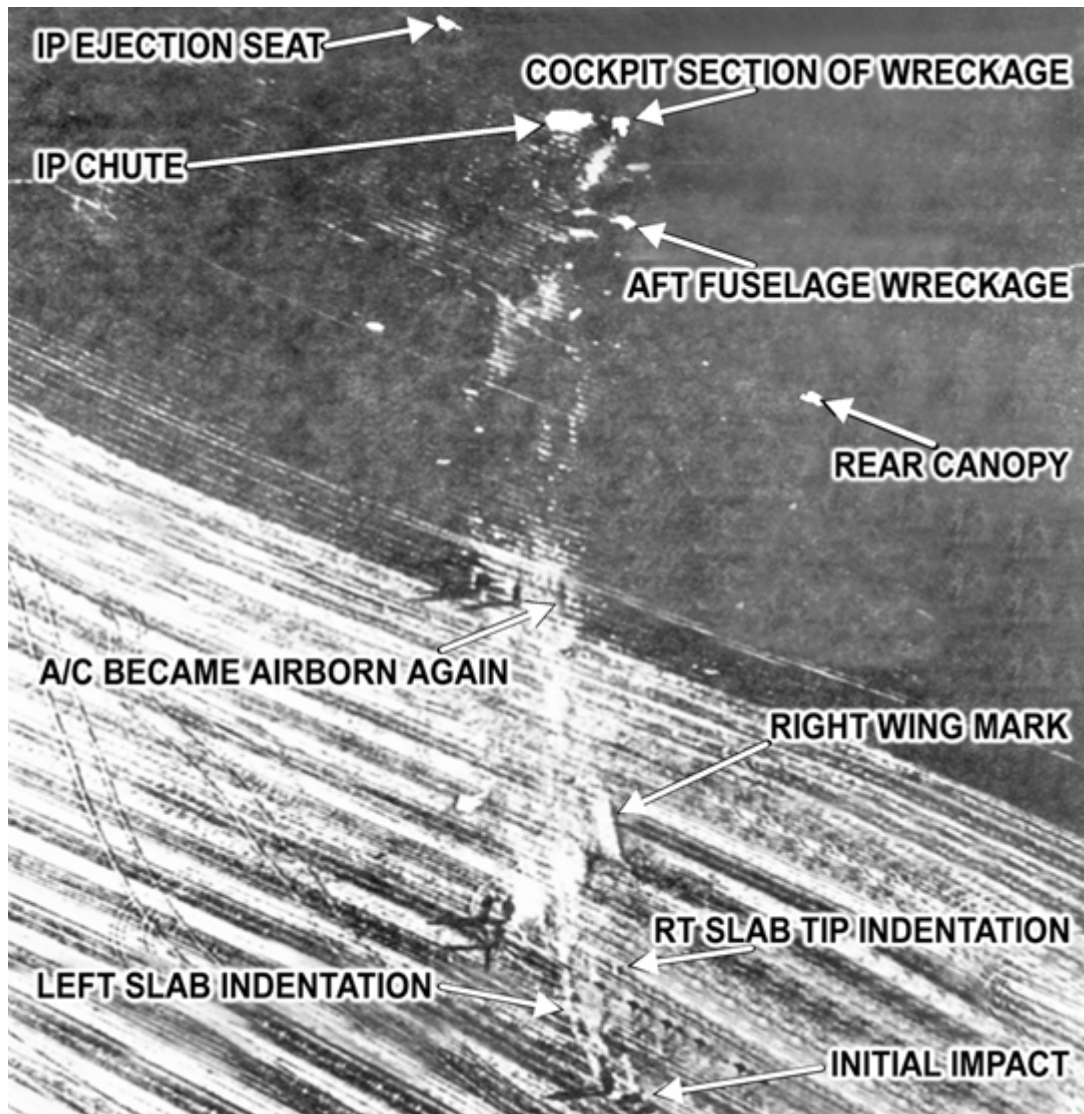
Figure 8. Bird Strike – Dual Engine Failure.

7.1. **Mishap. Figure 8.** The mission was a two-ship formation flight with SPs in the front seats. Preflight, taxi, and formation takeoff were normal. As the formation accelerated to 270 KIAS and climbed to 3,100 feet mean sea level (MSL) (600 feet AGL), several birds struck the lead aircraft front canopy. The front canopy Plexiglas was completely destroyed, and the engines ingested the debris. Neither crewmember was injured by the bird strike, but the damage caused a loss of thrust. The aircraft decelerated immediately and entered a shallow descent. The IP's forward visibility was probably obscured due to bird remains on the windscreen. As the rpm fluctuated, the SP observed what he believed to be throttle movements made by the IP. However, the engines did not respond so the IP ordered ejection. After a slight hesitation, the SP ejected successfully around 300 feet AGL. The IP's seat fired as the aircraft impacted the ground. The aircraft was destroyed, and the IP was fatally injured.

7.2.1. **Operator Factor.** A bird strike shortly after takeoff destroyed the front cockpit canopy. Both engines ingested bird remains and/or Plexiglas fragments, resulting in a loss of thrust and the inability to sustain level flight.

7.3.1. Aircrews should weigh the benefits of using dual visors if conditions permit. Additionally, aircrews must make timely ejection decisions, use proper terminology during critical and emergency phases of flight, and thoroughly brief ejection considerations with and without intercom.

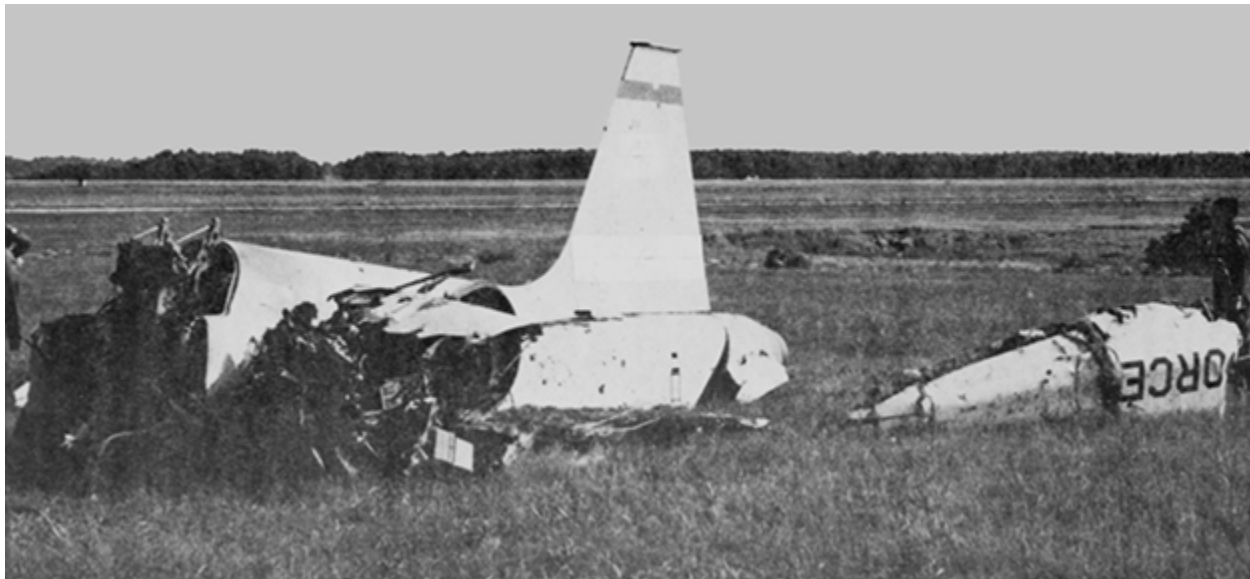
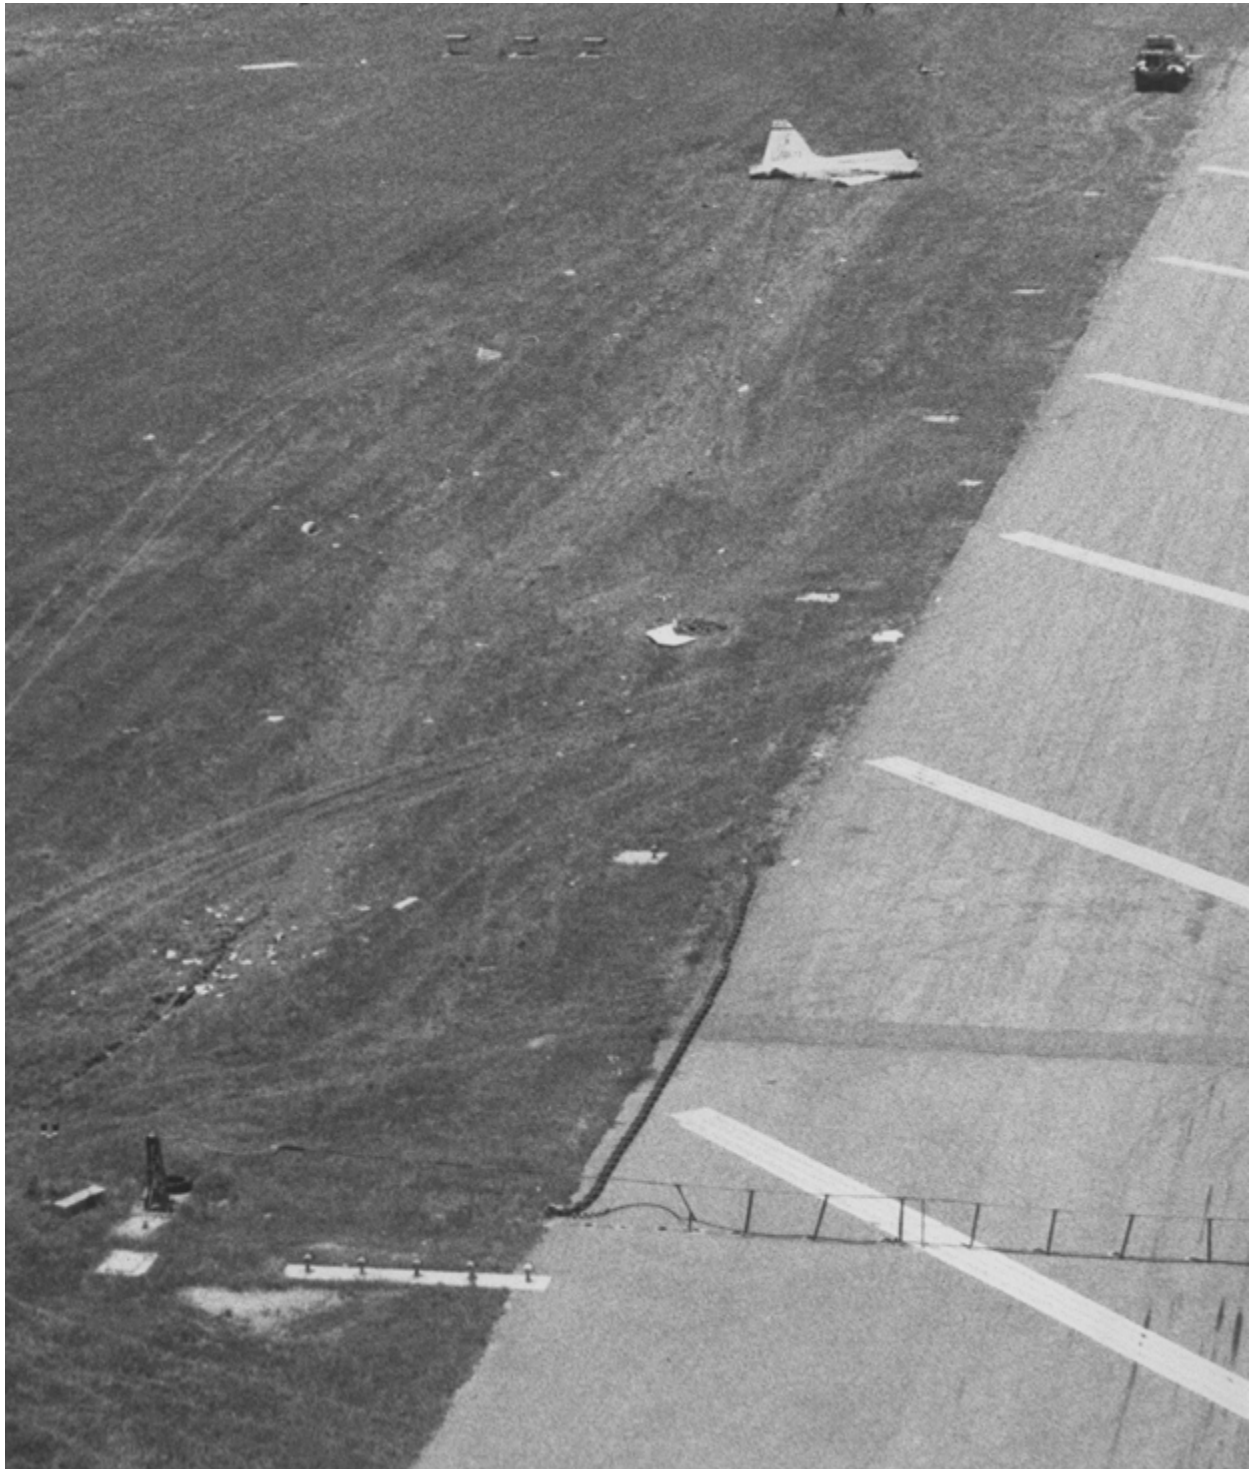
Figure 9. Engine Failure – Touch and Go.

8.2.1. **Maintenance Factor.** Shortly after takeoff the left engine rpm rolled back to 60 to 70 percent due to an undetermined malfunction. The IP did not initially recognize the rollback and initiated gear and flap retraction.

8.2.2. **Operator Factor.** The FE recognized engine rollback while assuming aircraft control, but did not notice the gear and flap retraction. He failed to take immediate action to establish the correct aircraft attitude and/or flap position.

8.2.3. **Logistics Factor.** The IP's parachute lanyard assembly was severed just below the parachute arming lanyard knob by impact with the FCP ejection seat prior to seat/man separation. This caused the automatic parachute deployment sequence to fail. The IP attempted to manually deploy his chute by pulling the D-ring, but did not get a full chute prior to ground impact.

8.4.2. Changed Technical Order (TO) IT-38A and AT-38B Aircraft, Flight Manual USAF Series, Emergency Procedure, Engine Failure During Takeoff, to read as follows:

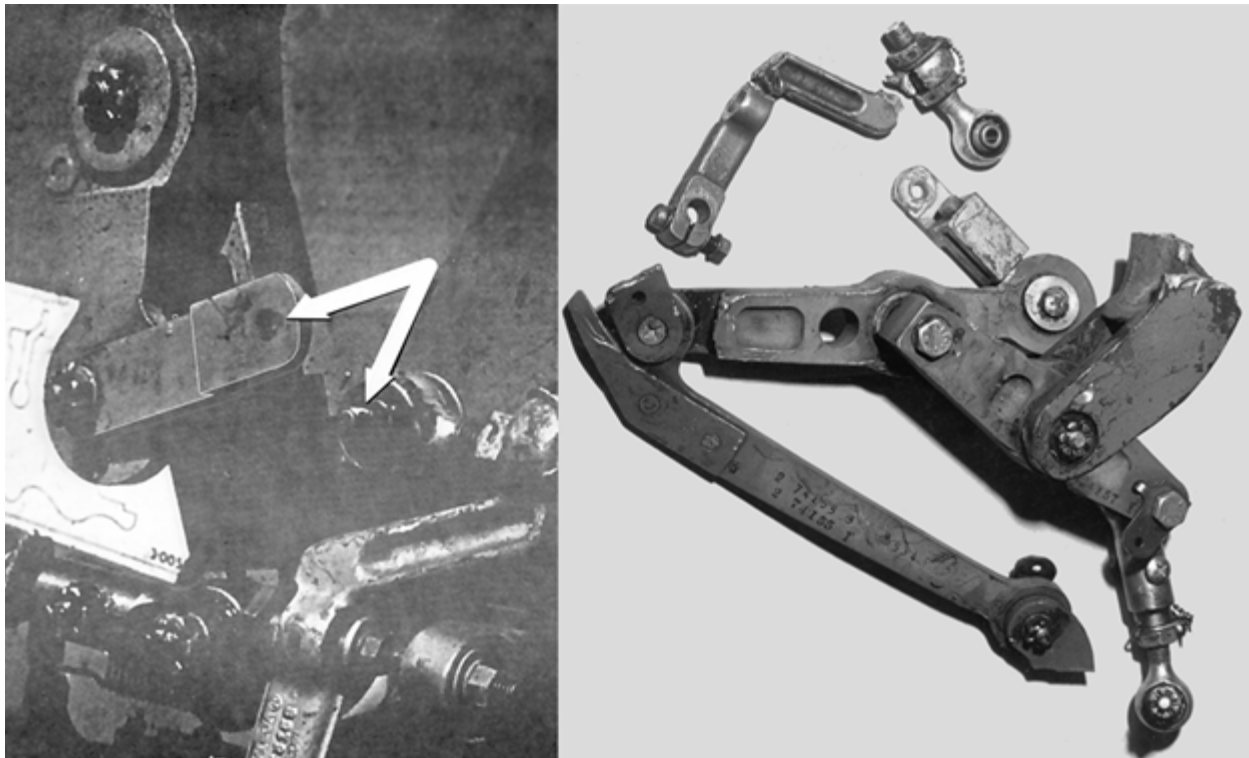
Figure 12. Flight Control Malfunctions.

10.2.1. **Maintenance Factor.** An unknown person failed to install the cotter pin that secures the nut on the connecting bolt and valve push rod for the right aileron. The nut backed off, and the right aileron moved to a near full down position, resulting in a loss of aircraft control.

10.2.2. **Supervisory Factor.** Supervision failed to conduct proper post-maintenance inspections.

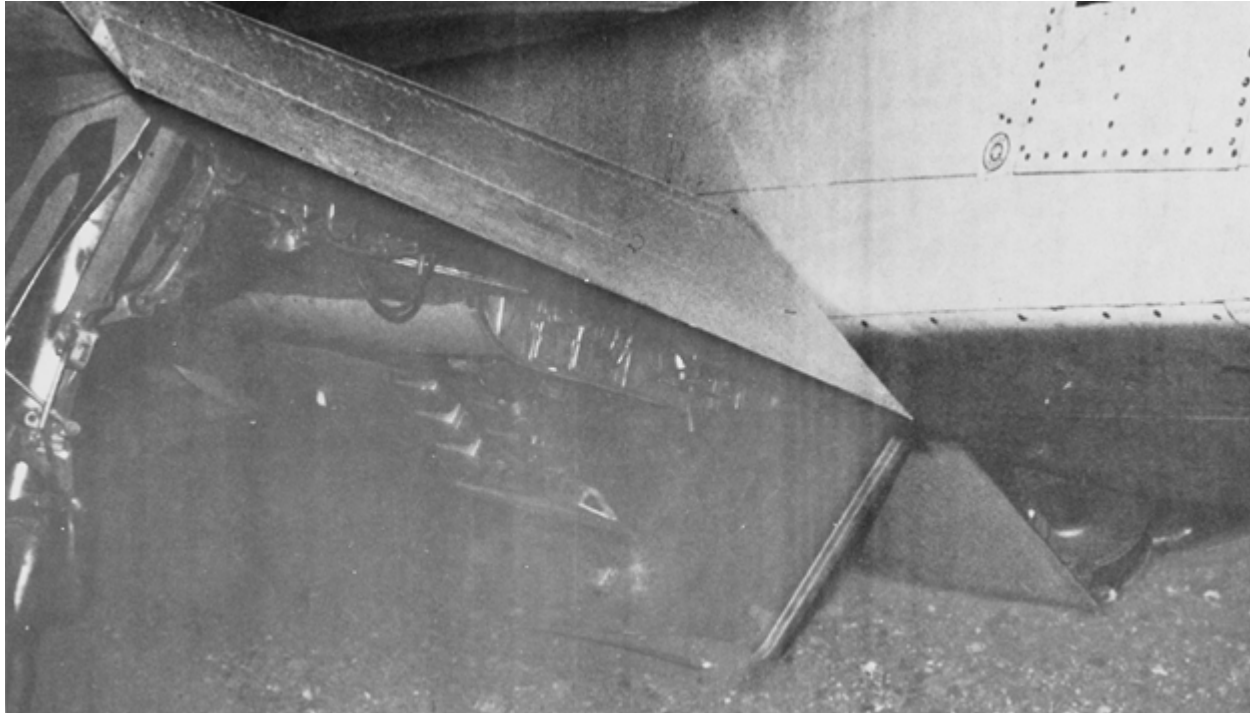
Figure 13. Abort – Runway Departure.

11.2.1. **Operator Factor.** Because crewmembers were accustomed to flying at a location where takeoff and landing data were rarely a factor, they became complacent with their takeoff and landing data (TOLD) calculations. Bottom line: The pilot misjudged the takeoff performance based on poor habit patterns and failed to account for a higher temperature and altitude than he was used to.

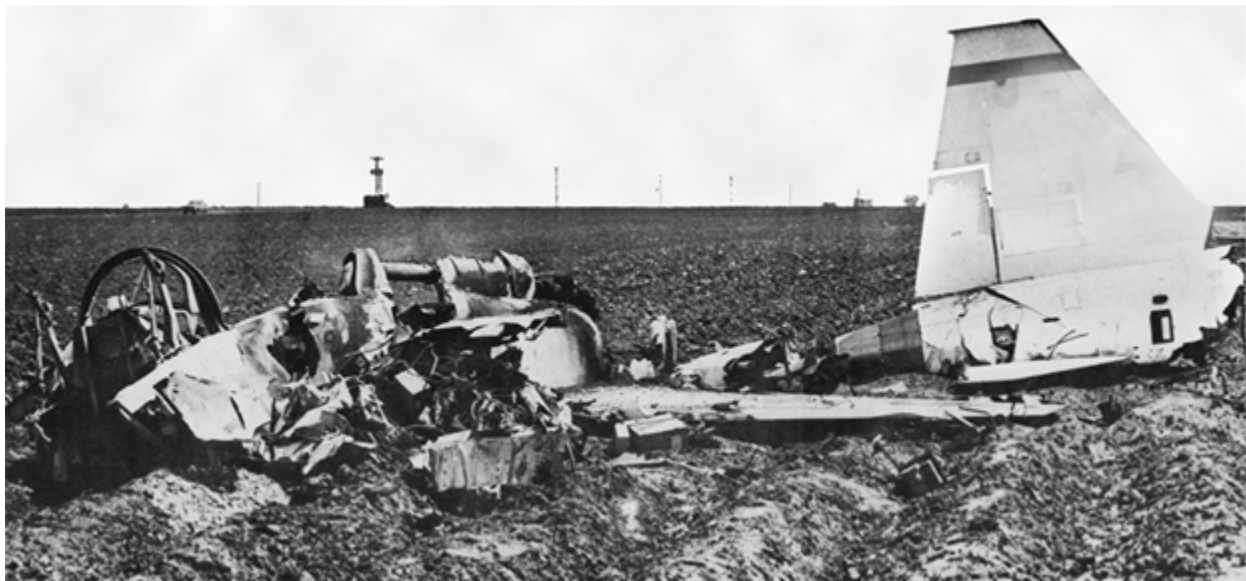
Figure 21. Left Hydraulic Failure and Right Engine Shutdown.

18.2.1. **Maintenance Factor.** A maintenance specialist incorrectly installed the left hydraulic system reservoir cap. The cap came loose during engine run-up for takeoff. As a result, the left hydraulic system reservoir was unpressurized. Using the speed brakes and landing gear during the FCF profile resulted in momentary cavitation of the left hydraulic pump. This cavitation was also accompanied by momentary illuminations of the master caution and left hydraulic caution lights.

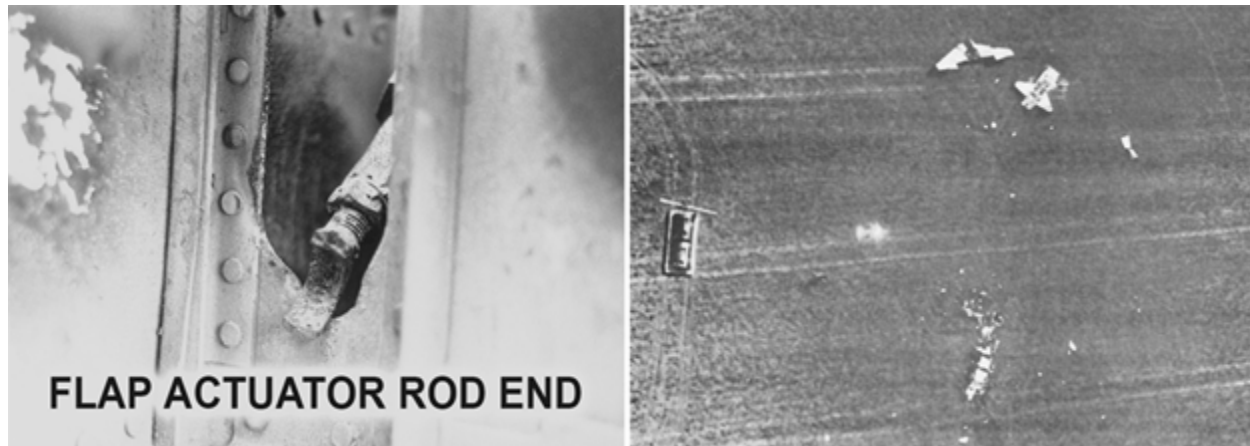
Figure 22. Flight Control Malfunction—Pattern.

19.2.1. **Supervisory Factor.** T-38 flap actuator rod end failures had been documented as early as 5 years before this mishap. The system manager noted an increase in failures 2 years before the mishap. Logistics managers started the process to design and procure an improved rod end, but they did not update the technical data concerning the old rod ends. Specific issues were:

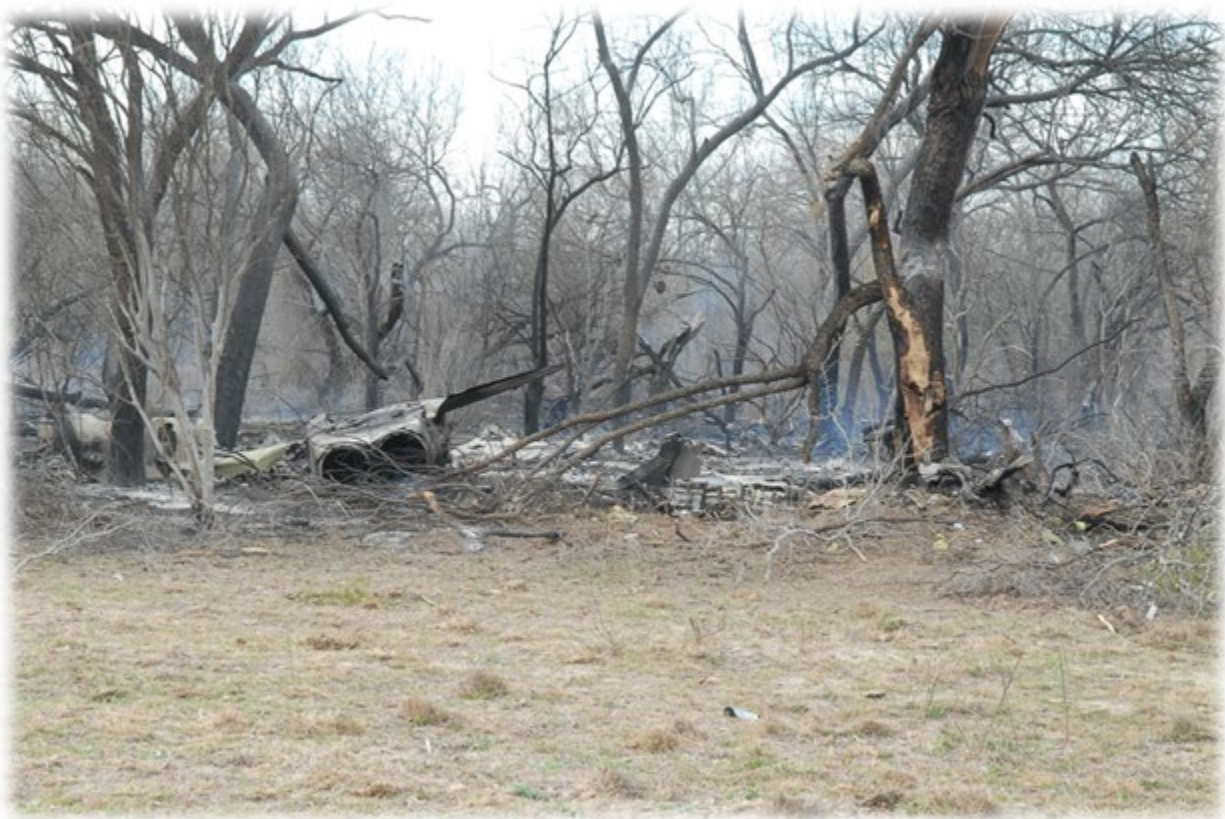
Figure 24. Flaps Extended During Area Maneuvering.

21.2.1. **Operator Factor.** The MP was aggressively maneuvering the flight to reposition the wingman from near the 6 o'clock to a line abreast position which required the MP to swap from looking aft left to looking aft right. Under G, this requires using the

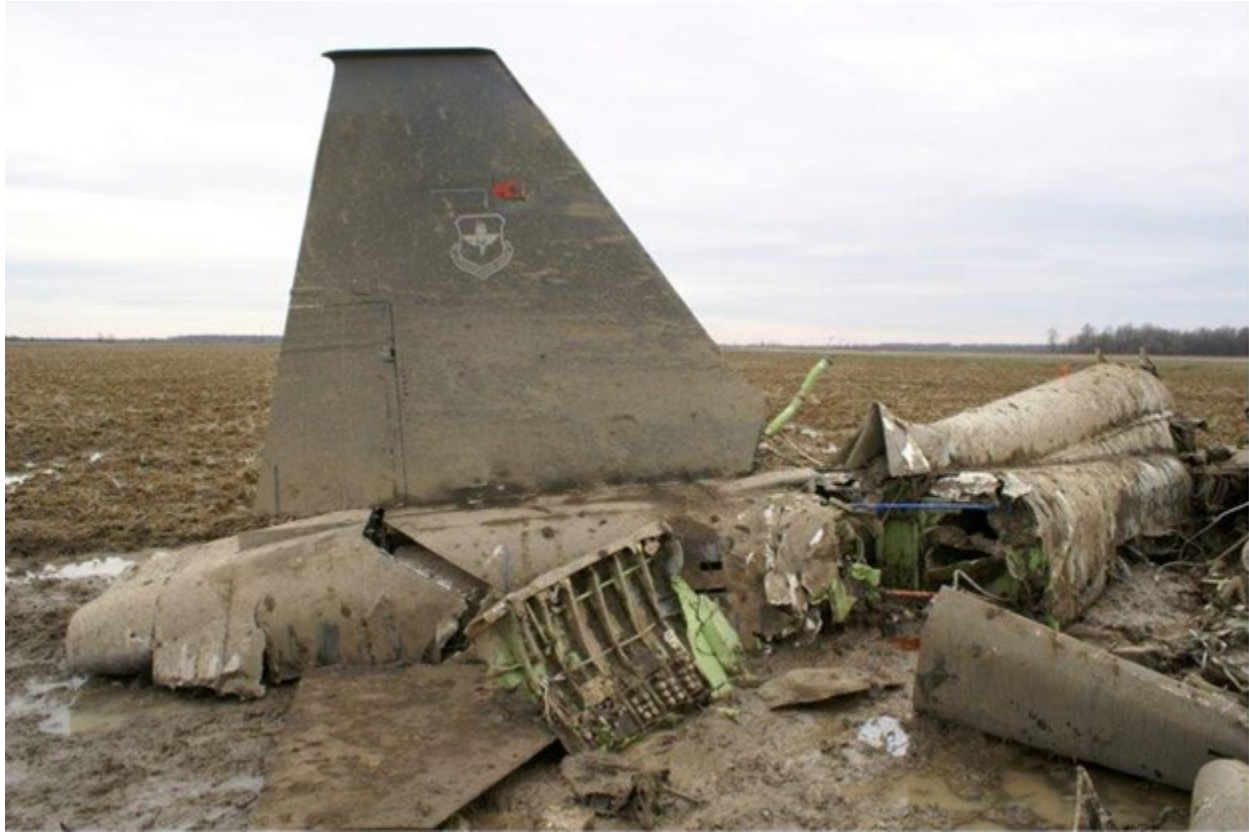
Figure 25. Bird Strike on Low-Level.

22.2.1. **Logistics Factor.** In accordance with local guidance, the first option when a low-level has a SEVERE leg is to fly another route/mission. The other low level routes available had just been closed for weather. The second option is to enter at an alternate entry point. The third option is to fly the affected legs at the top of the block, 1,500 feet above ground level (AGL) minimum, with Operations Supervisor approval. This guidance was based upon old data and did not take into account changes that significantly changed the BASH threat on local low-level routes due to human activity and changes to avian behavior.

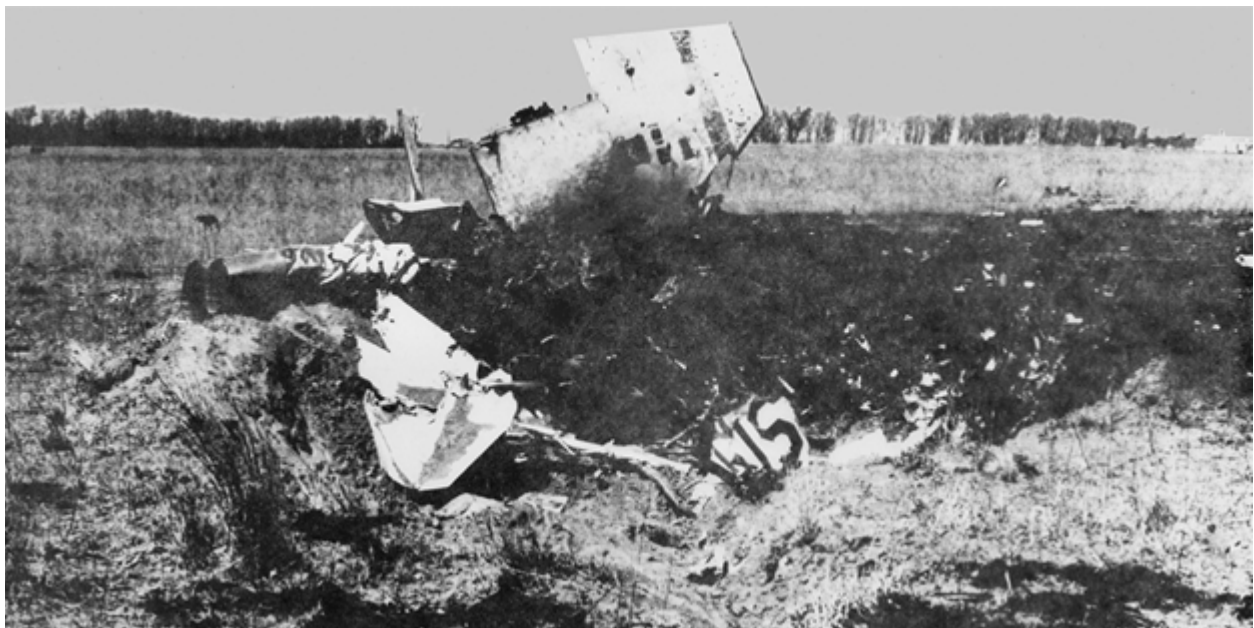
Figure 26. Loss of Control—Traffic Pattern Stalls.

23.2.1. **Operator Factor.** The IP misinterpreted the aircraft response as a spin and caused the oscillations with his anti-spin control inputs. He became severely disoriented, determined recovery was not possible, and ordered ejection.

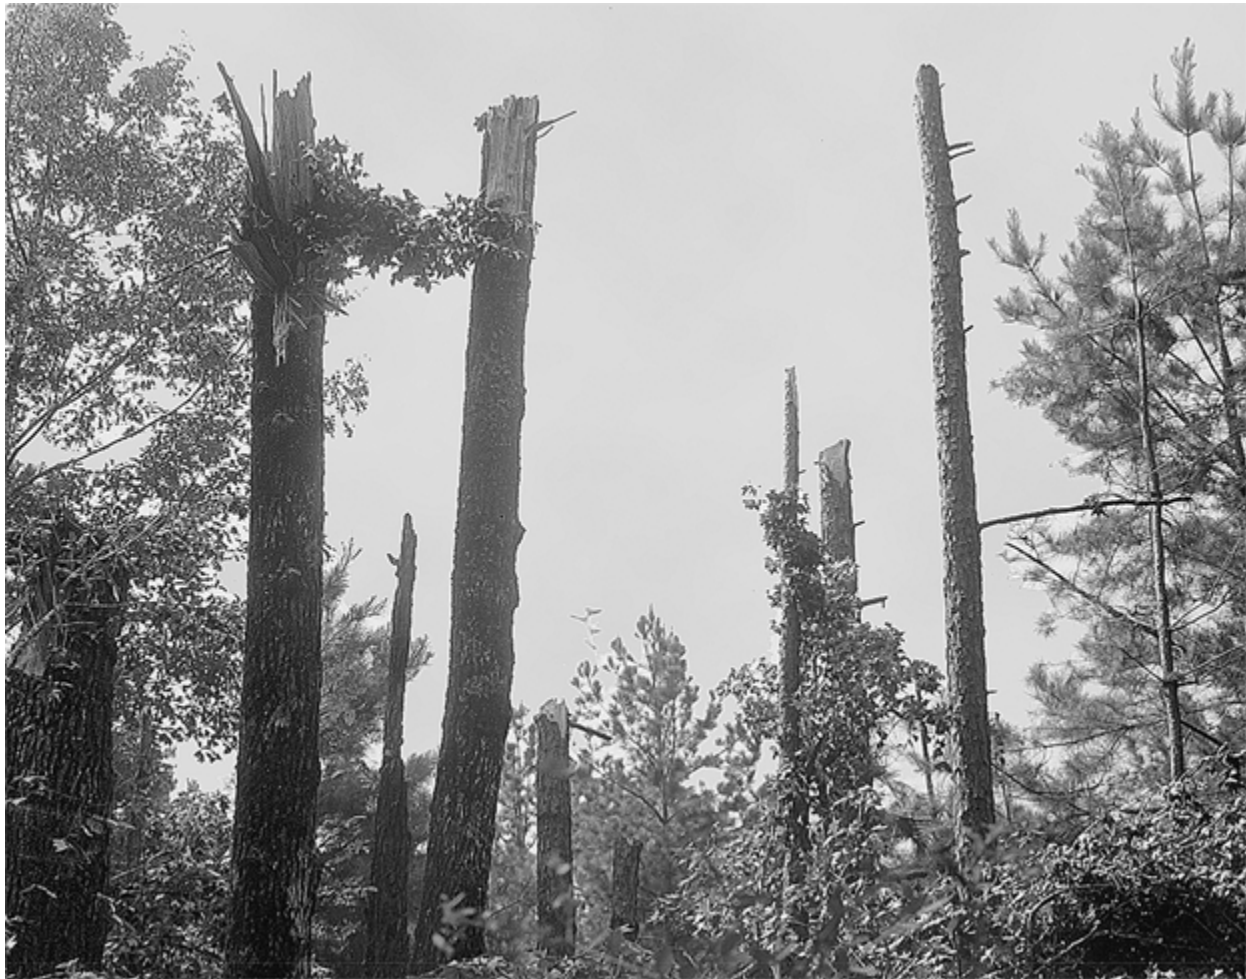
Figure 27. Loss of Control—Intercom Failure.

24.2.1. **Operator Factor.** The SP failed to relinquish control of the aircraft as briefed and vigorously opposed the IP's control inputs, which caused the IP to believe loss of control was imminent.

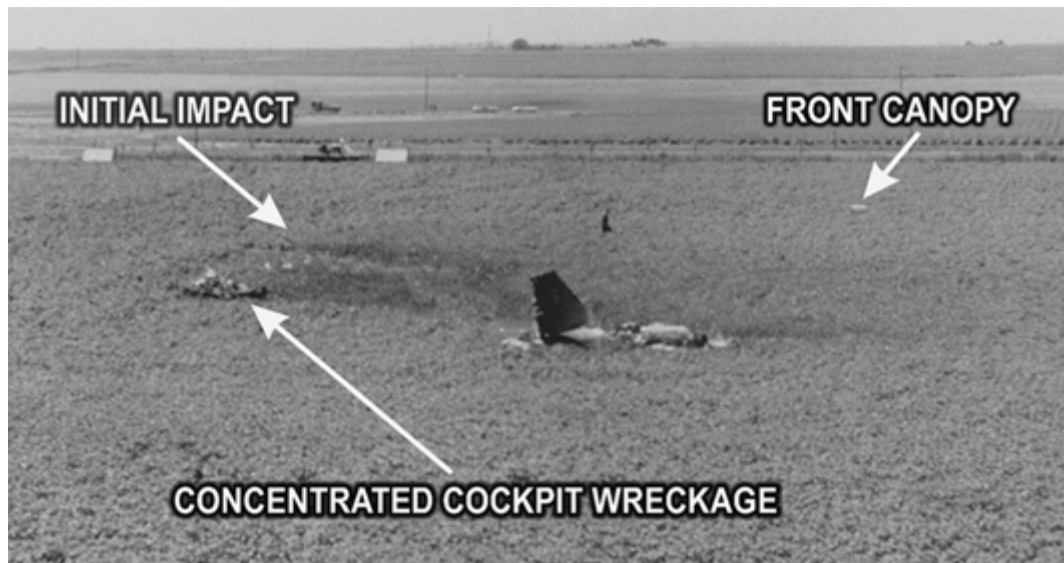
Figure 29. Disorientation—Night Pattern.

26.2.1. **Operator Factor.** The SP probably became disoriented due to G forces, visual illusions, limited visual cues, and limited night experience.

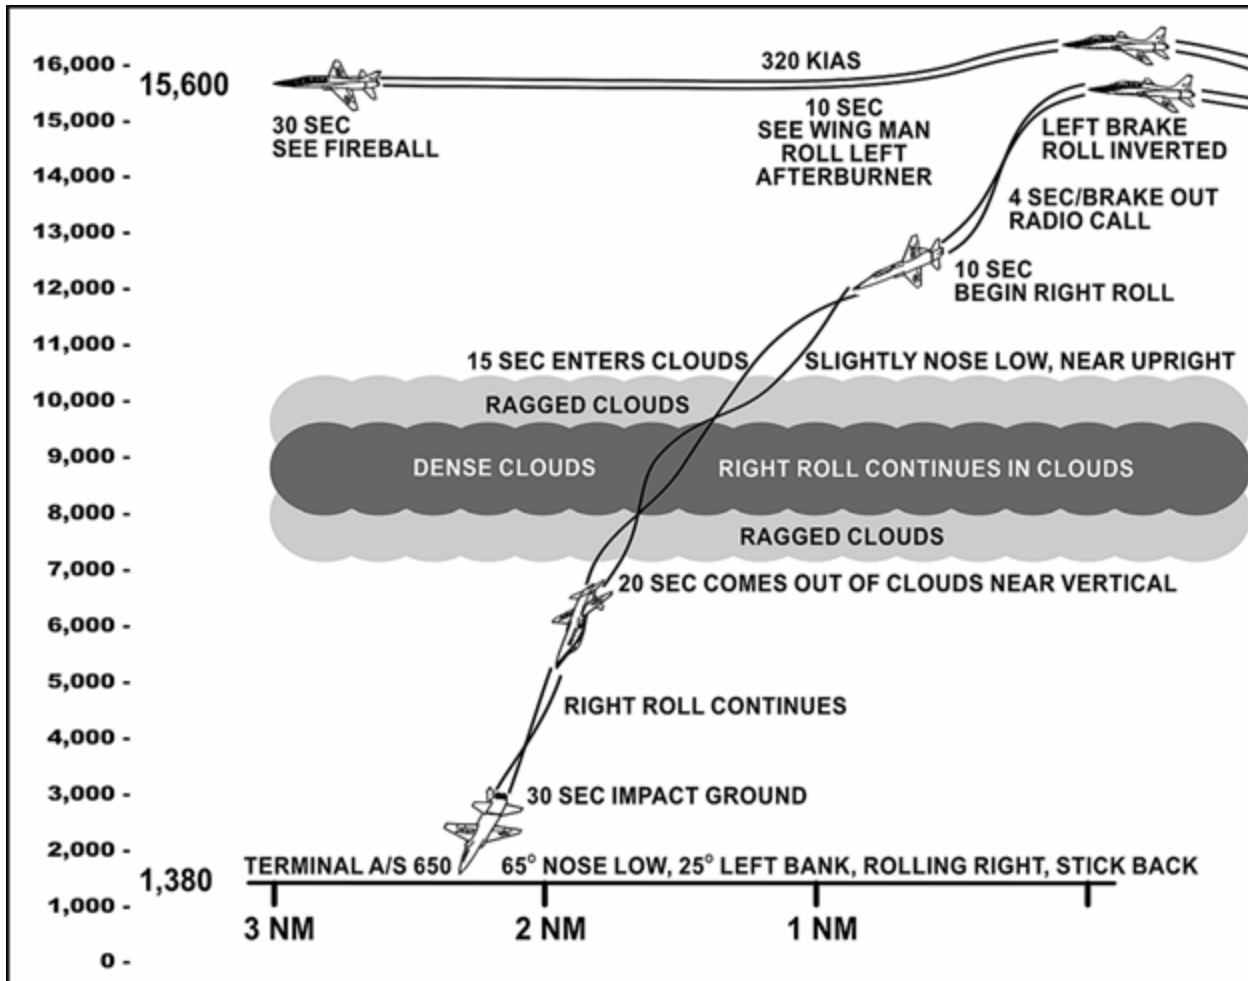
Figure 33. Disorientation – Night Formation.

30.2.1. **Operator Factor.** The mishap aircrew became spatially disoriented prior to, during, or after the breakout due to one or more of the following:

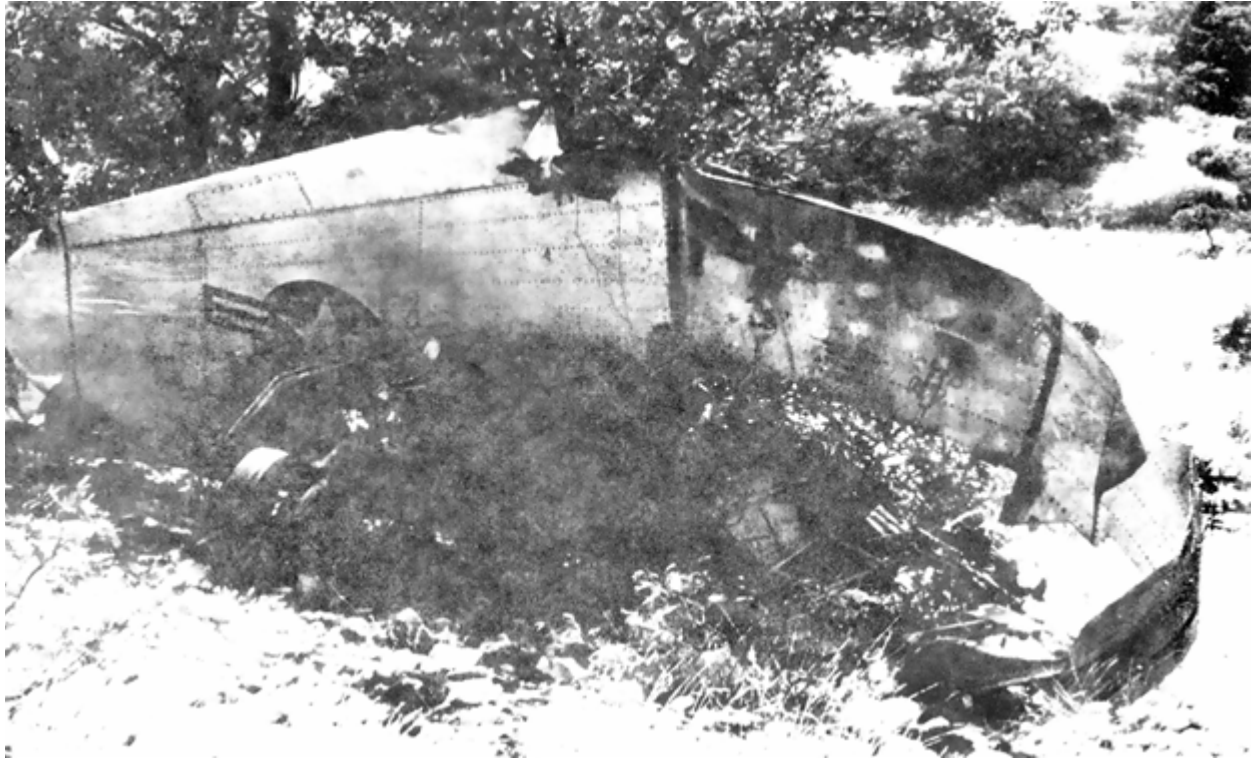
Figure 34. Loss of Control—Flight Control Malfunction.

31.2.1. **Maintenance Factor.** The flap and slab interconnect cable was not connected to the horizontal tail's operating mechanism during installation of the boat tail the night before the mishap sortie. Additionally, the required post-maintenance inspections failed to identify the discrepancy.

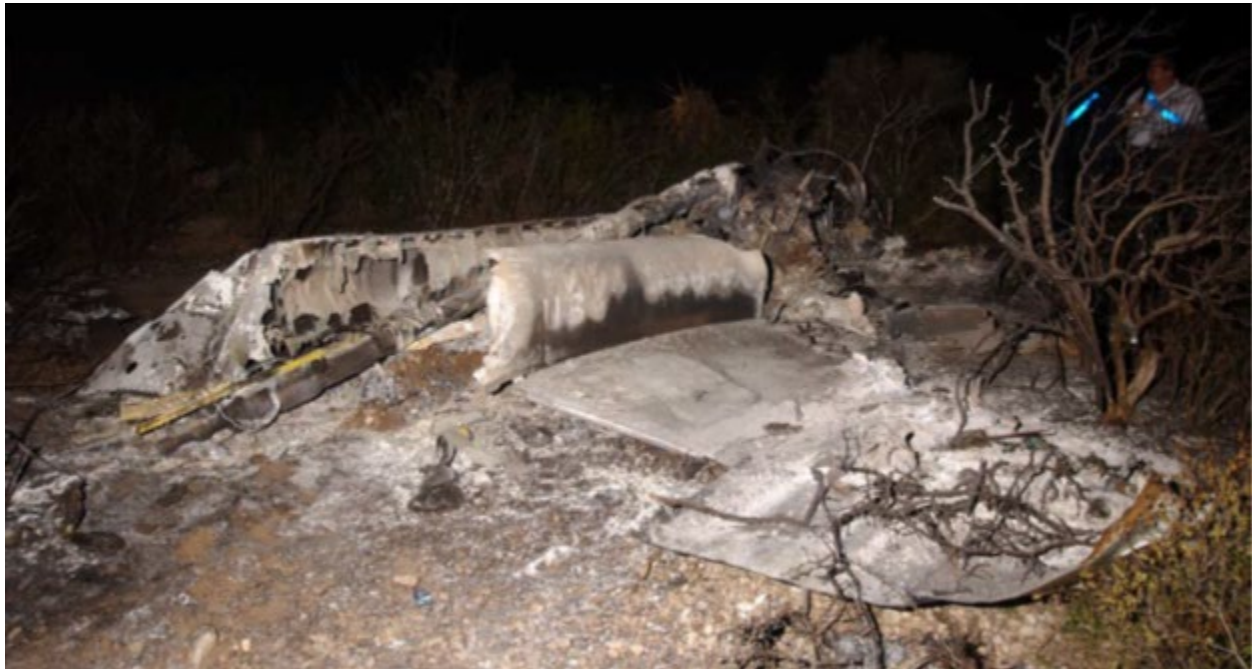
Figure 37. Bird Strike on Low-Level.

34.2.1. Technical analysis found no damage to either engine from organic or inorganic objects (bird remains or canopy fragments) and that both engines were operating normally until impact with the ground. Drag from the damaged front canopy was approximately half the drag of a fully extended speed brake.

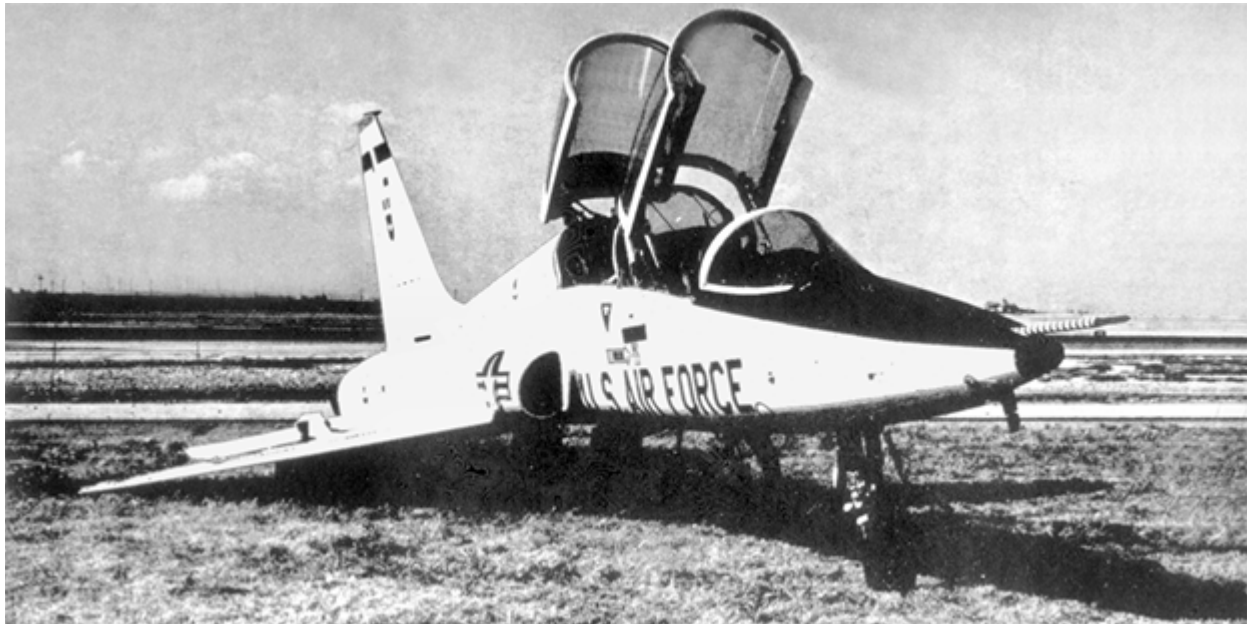
Figure 38. Formation Approach—Runway Departure.

35.2.1. **Supervisory Factor.** The lead aircraft placed the mishap aircraft in an unfavorable position for landing (high airspeed).

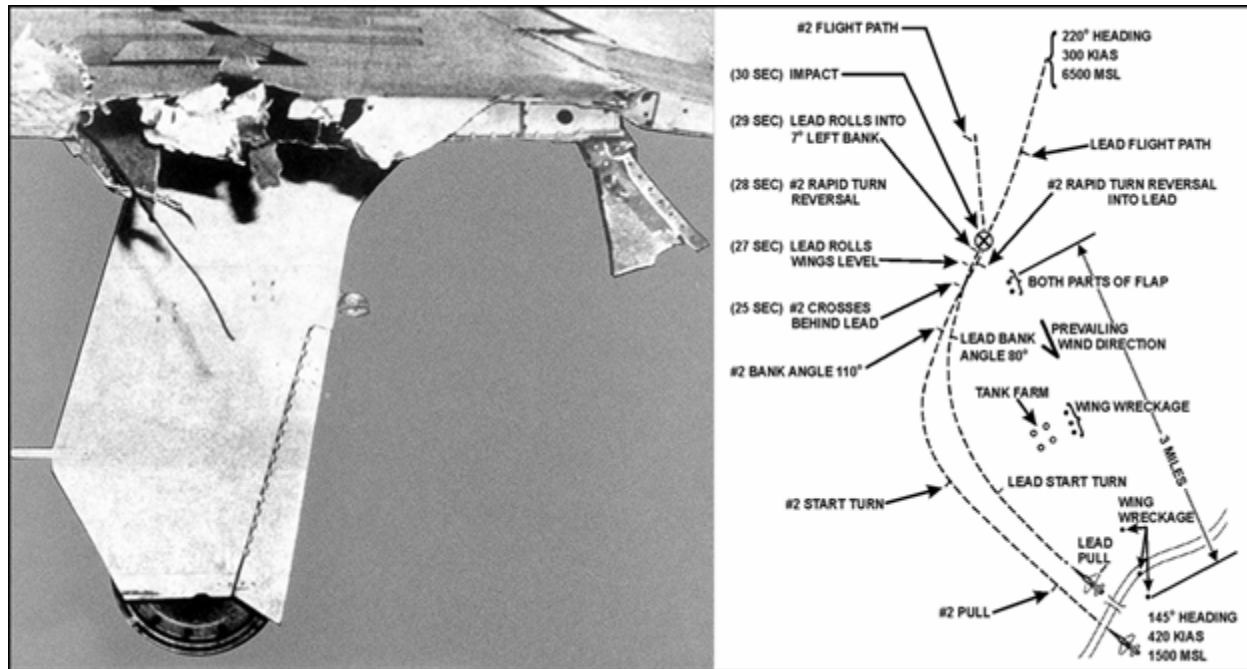
Figure 42. Midair Collision – Formation Low Level.

38.2.1. **Operator Factor.** While departing the low level, Number 2 SP was slow to react to lead's climbing turn and dropped well below and 1,000 to 1,200 feet aft of lead. The SP selected and maintained military power to get back into position, but stayed directly behind lead and failed to perceive the rapidly developing overtake.
