**AIR EDUCATION AND TRAINING
COMMAND HANDBOOK 11-210**

04 FEBRUARY 2020

Flying Operations

ROAD TO WINGS

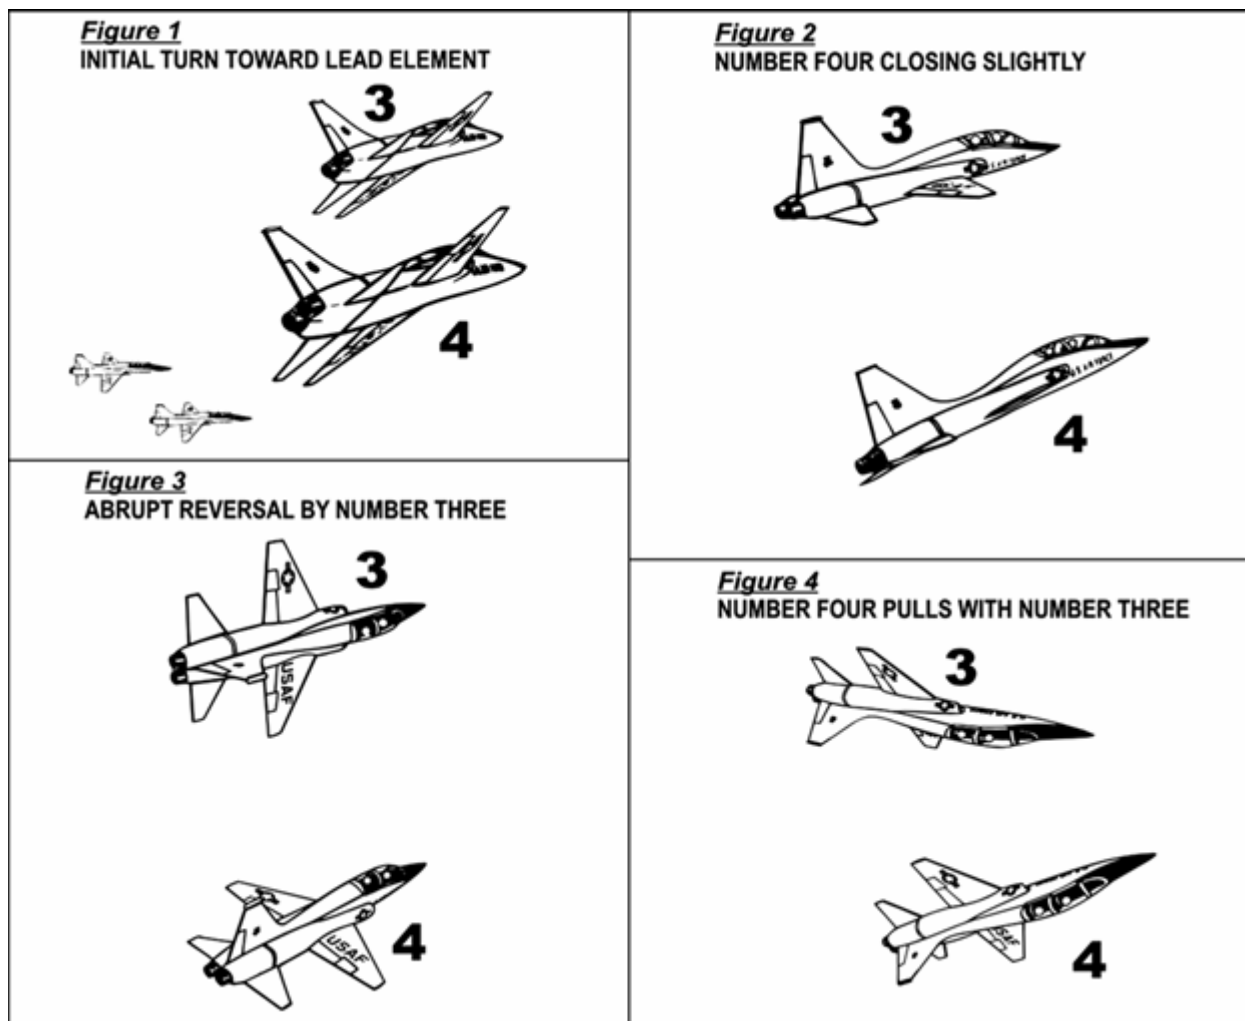
Figure 43. Midair Collision—Four-Ship Tactical Rejoin.

39.2.1. **Supervisory Factor.** Number 4 IP did not sufficiently brief his SP on proper procedures and techniques for executing a tactical turning rejoin. The IP failed to provide instruction on how to fly the maneuver, although this would be the SP's first attempt.

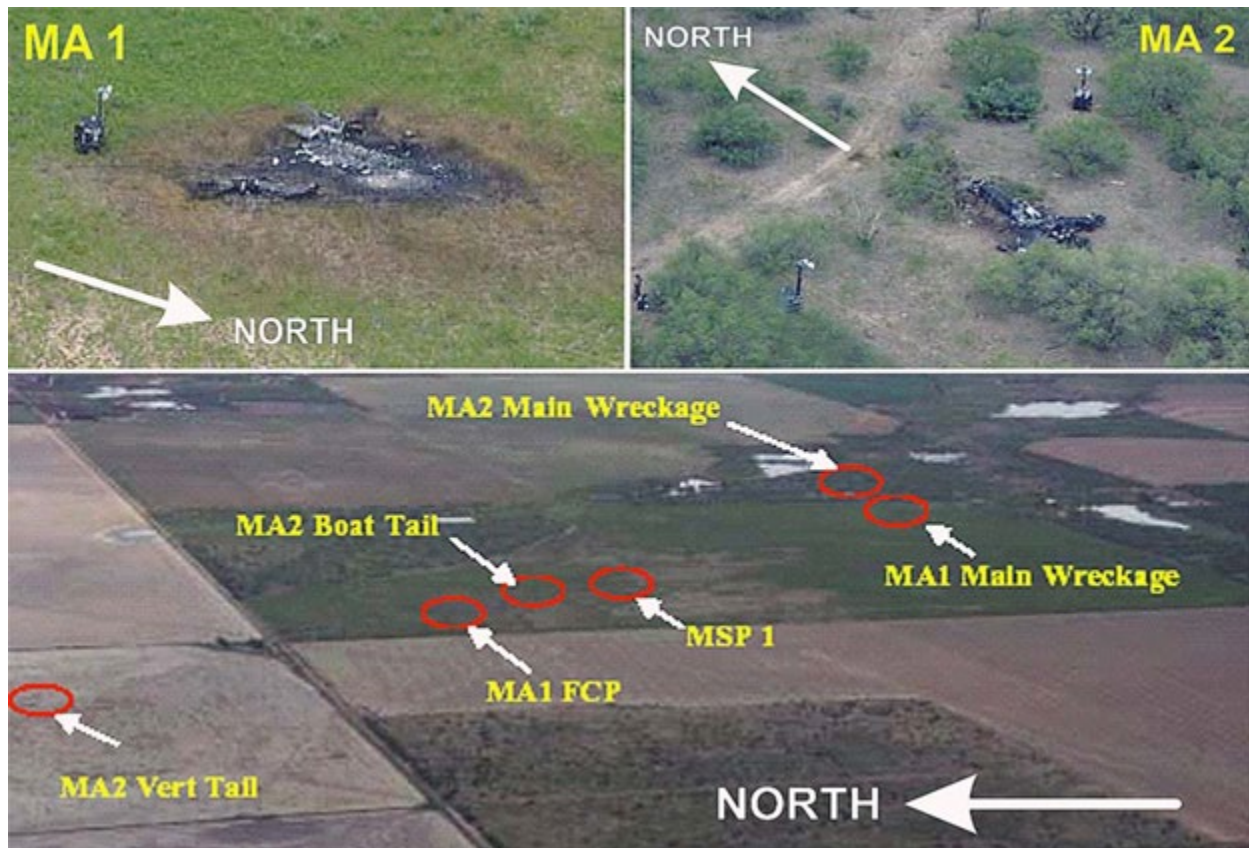
Figure 44. Midair Collision – Two-Ship Fighting Wing.

40.2.1. **Supervisory Factor.** Due to a lack of experience, the IP did not recognize the developing conflict caused by the rapid changes in the lift vector and aspect and the closure resulting from the barrel roll.

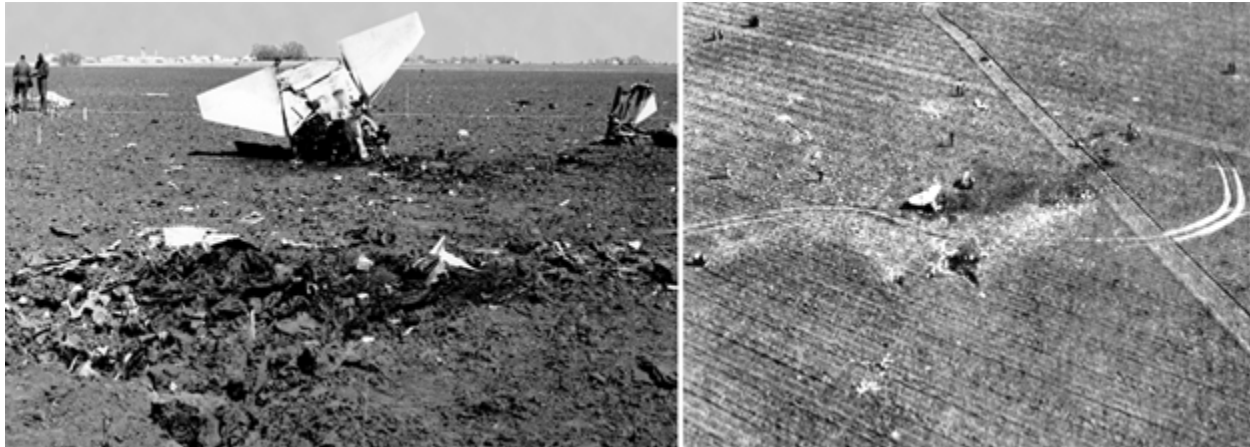
Figure 46. Stall – Final Turn.

42.2.1. **Operator Factor.** The SP stalled the aircraft with insufficient altitude to recover.

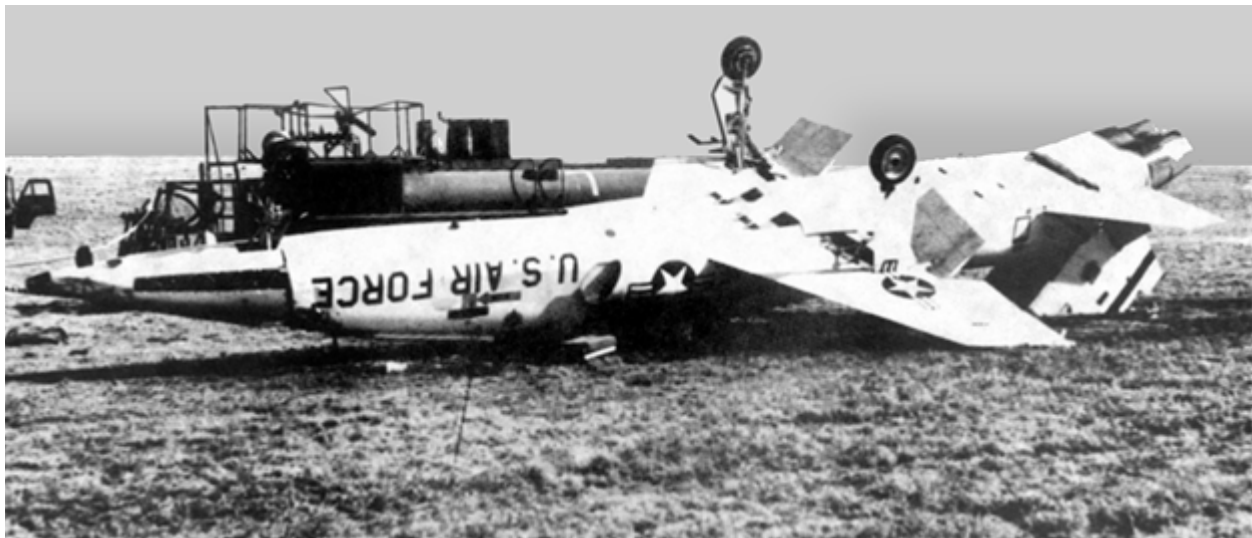
Figure 47. Stall – Touch and Go.

43.2.1. **Supervisory Factor.** The IP delayed taking the aircraft, allowing the SP to place the aircraft in an unrecoverable position.

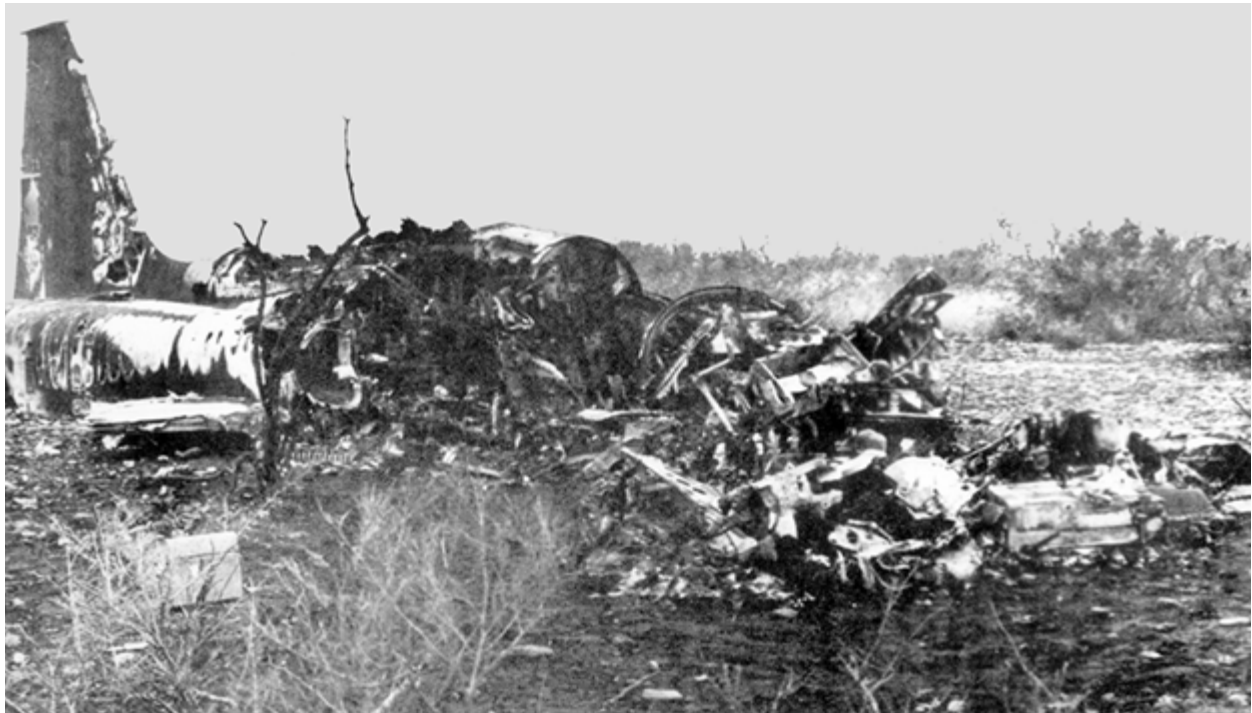
Figure 48. Stall – Final Turn.

44.2.1. **Operator Factor.** The solo SP flew a tighter pattern than lead and inadvertently established a cut off angle on lead in the final turn. The SP was most likely distracted by his aircraft’s malfunction and failed to clear for his flight lead. The SP began an evasive

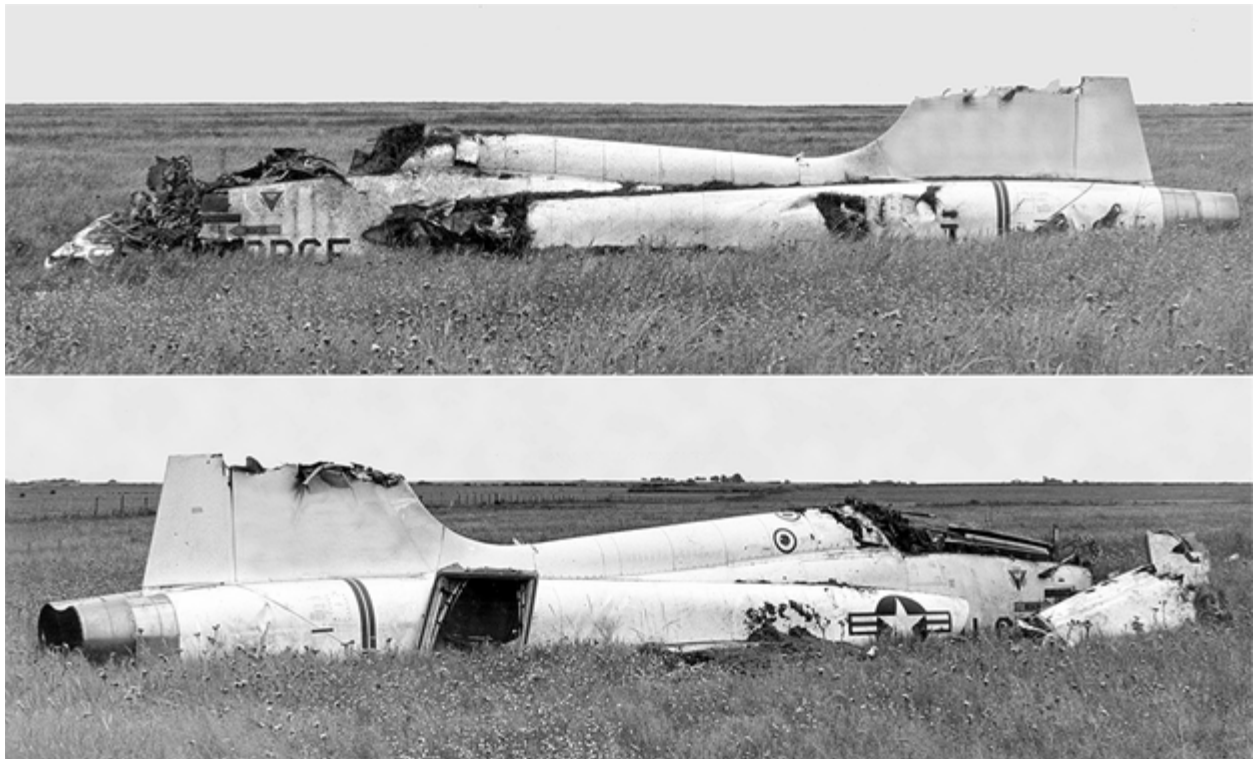
Figure 52. Gear Extension Failure.

48.2.1. Maintenance Factor. The side brace trunnion of the right main landing gear failed due to fatigue, preventing the right main landing gear from extending fully.

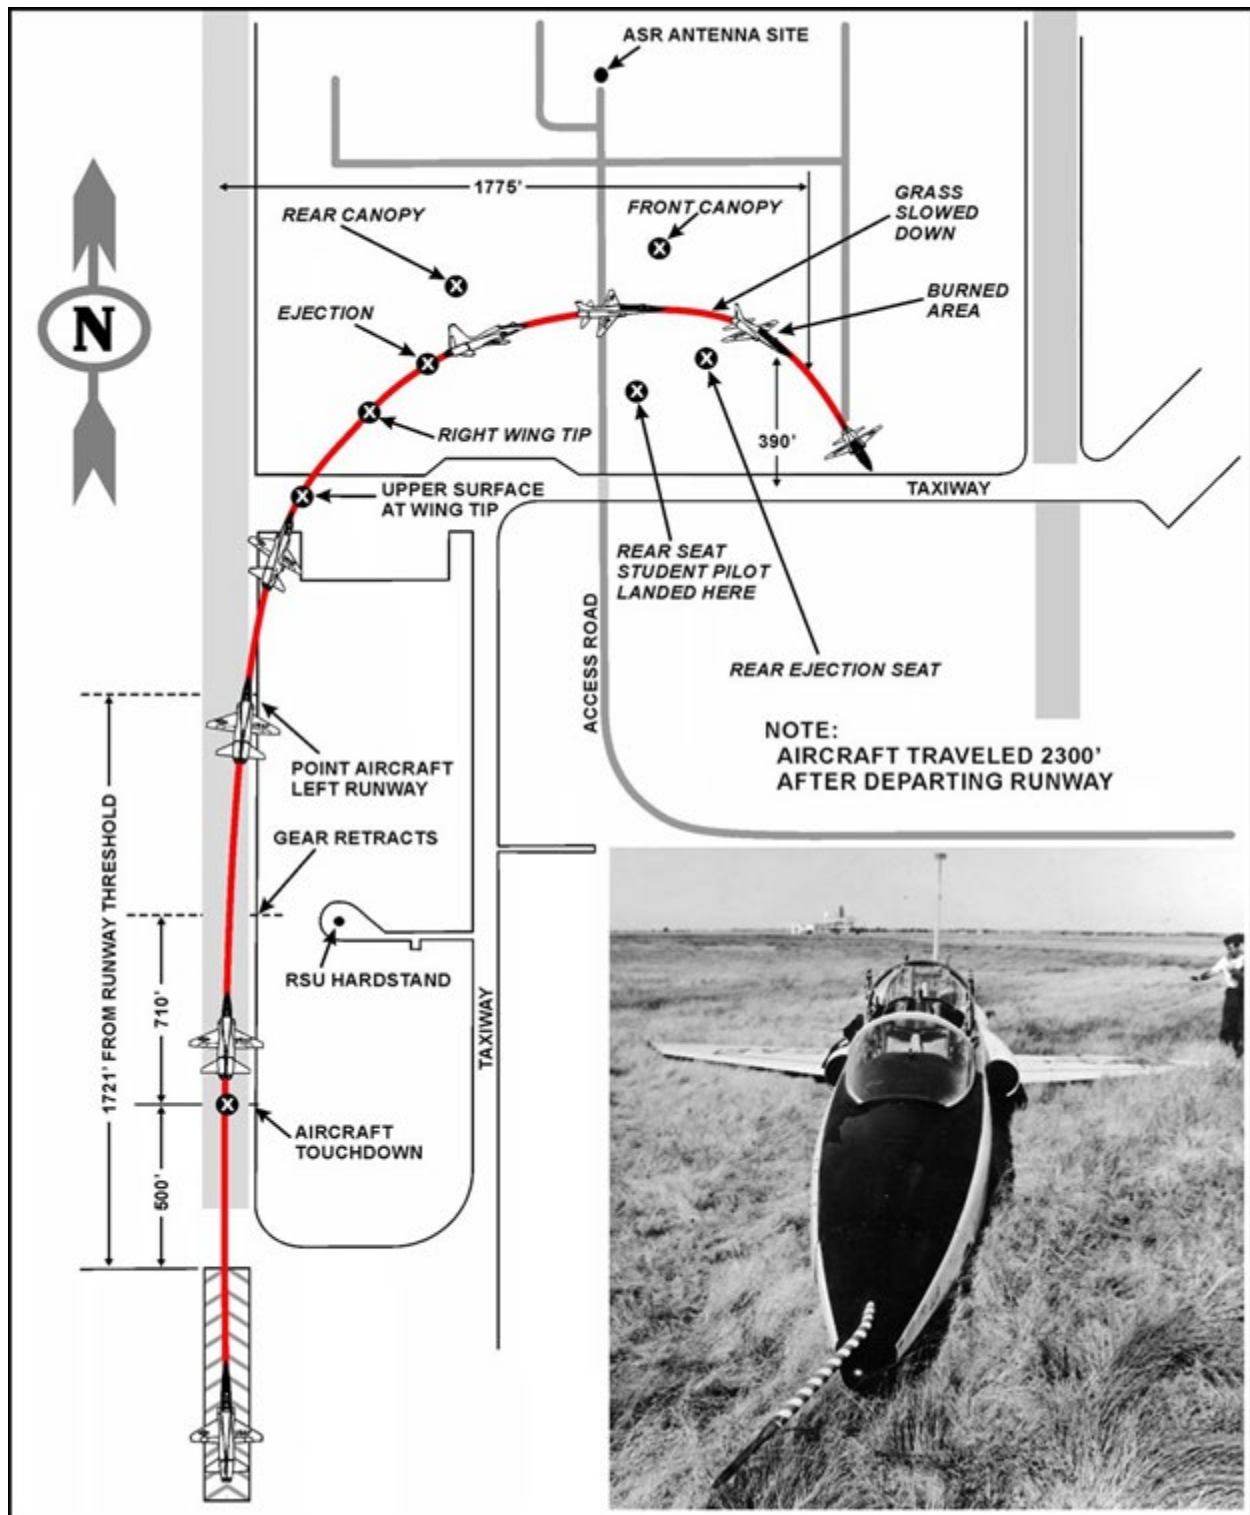
Figure 53. Premature Gear Retraction – Touch and Go.

49.2.1. **Operator Factor.** The FCP SP had been directed to give no instruction to the back seat observer, but he did not follow those directions. Instead, he became

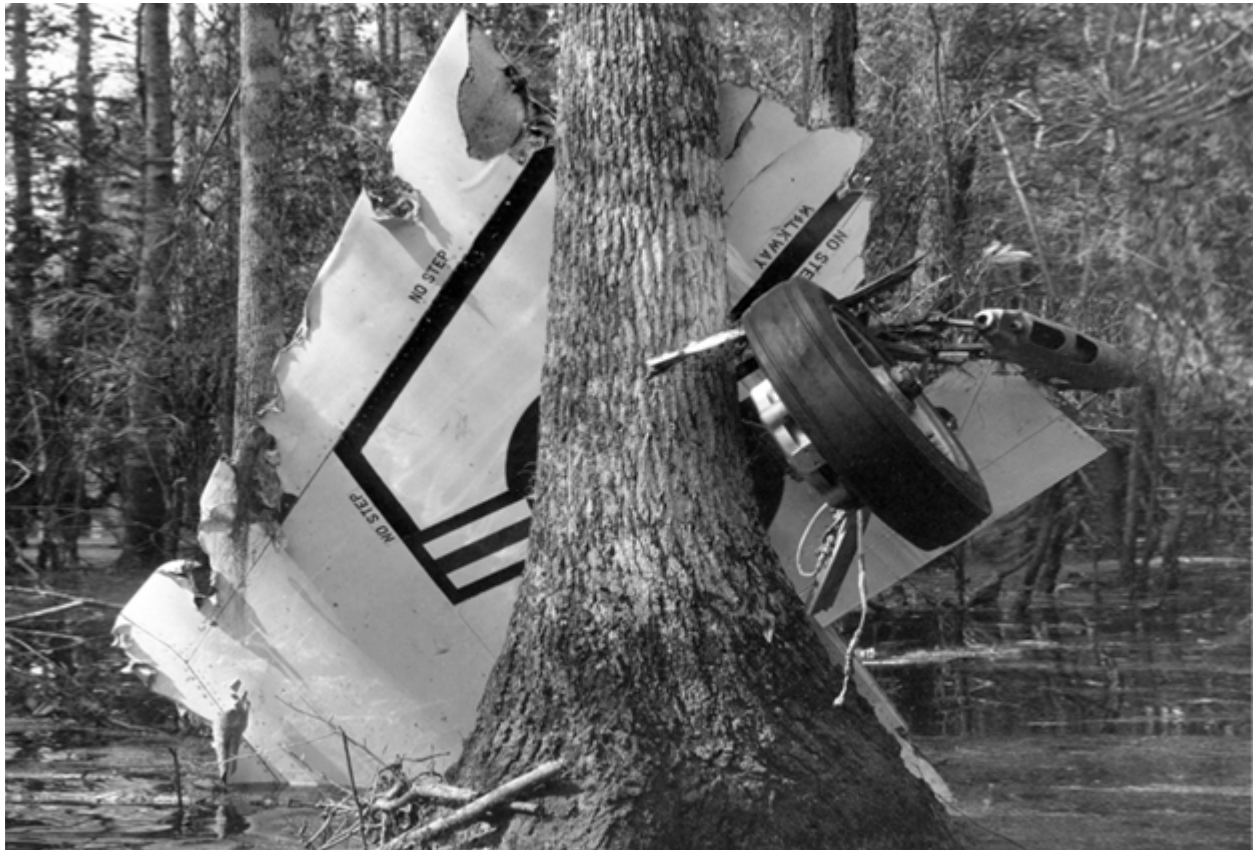
Figure 55. Instrument Approach.

51.2.1. **Operator Factor.** The SP did not attach his zero delay lanyard, set his final approach speed index improperly, was not wearing flight gloves, and had consumed portions of a box lunch in flight. He also remained off frequency for more than 2 minutes on final approach. For an unknown reason, he descended below the normal final approach glidepath, impacting the trees short of the landing runway.

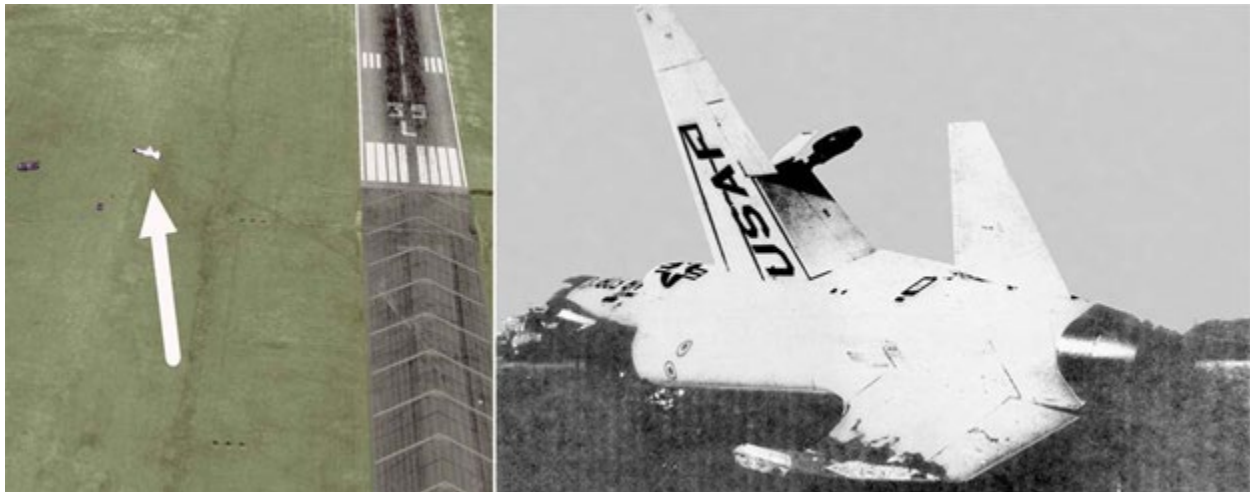
Figure 65. Stall – Final Approach.

61.2.1. **Operator Factor.** The SP got slow on final and failed to add power in time to stop the ensuing sink rate.
