**AIR EDUCATION AND TRAINING  
COMMAND HANDBOOK 11-211**

**12 JUNE 2020**

**ROAD TO WINGS REMOTELY  
PILOTED AIRCRAFT**

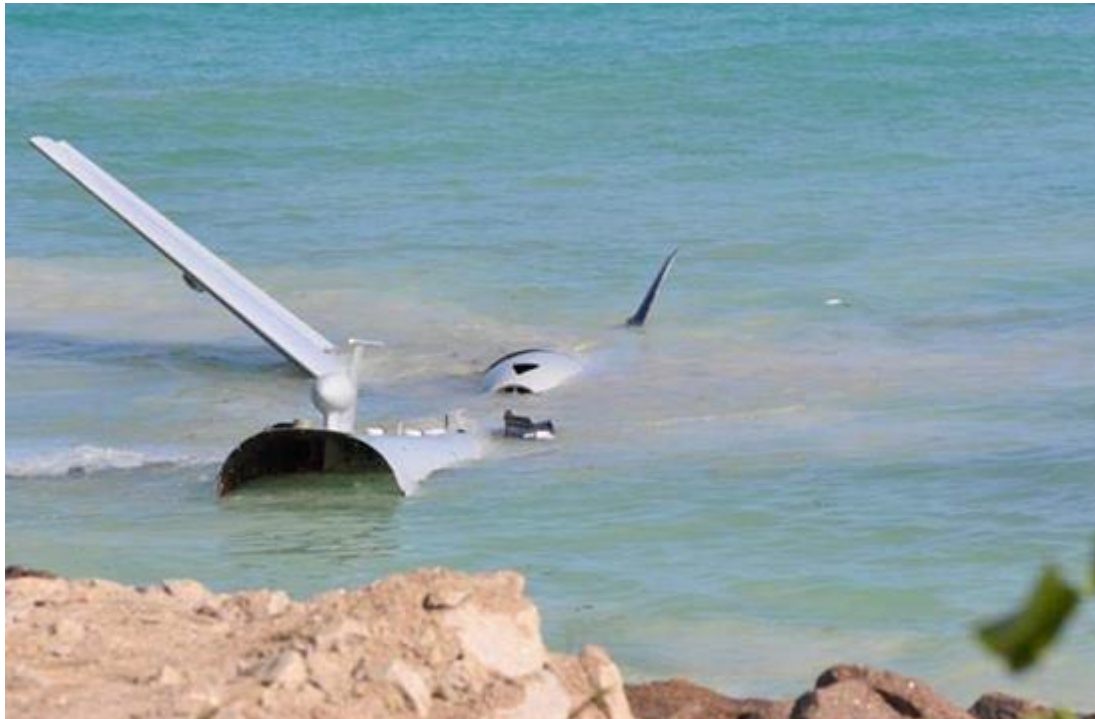
## Figure 1. Engine Failure on Climbout.

1.1.1. The mishap sortie (MS) was launched in support of an operational mission. Prior to takeoff, the mishap aircraft (MA) received "line up and wait" instructions from Tower. The MA entered the runway and shortly after received a "confirm ready" call from Tower. The mishap pilot (MP) did not acknowledge Tower and, upon seeing the desired engine parameters, applied full throttle and took off without having received clearance from Tower. Passing 1,900 feet above ground level (AGL) the mishap sensor operator (MSO) announced "Flaps Override" warning. The MP moved the condition lever to the fuel cutoff position (center detent) and an engine out indication was displayed on both pilot and sensor operator stations. The MSO announced "Engine Out Detected" and the MP began a right turn, commanded landing configuration, and transmitted the loss of the engine to air traffic control (ATC). After completing the turn back to base, the MP executed the ENGINE FAILURE boldface leaving the condition lever in the fuel cutoff position (center detent), allowing the propeller to windmill. The MP then lowered the landing gear control switch. The blue advisory text "Ready to lower landing gear" displayed on the MP's head-up display (HUD) and remained on through the remainder of the flight. The condition lever was moved a second time and placed in the full aft position. The MA impacted the runway 2,000 feet beyond the threshold. Initial impact damaged the payload and the MSO lost video. The MA became airborne two more times before impacting the water.

1.2.1. Operator Factor. The flap retract step in both the TAKEOFF and CLIMB, LEVEL OFF, CRUISE checklists was not accomplished.

1.2.2. Operator Factor. The MP inadvertently moved the condition lever vs. the flap lever when presented with the "Flaps Override" warning. The MA lost power due to fuel starvation caused by the fuel shutoff valve being commanded closed.

1.2.3. Operator Factor. The MP failed to command the landing gear down. The mishap crew (MC) did not confirm the gear were down/locked and reference the BEFORE LANDING checklist during the recovery.

1.2.4. Operator Factor. The flap lever was set to command 16 degrees the entire flight. On landing (with gear not extended) the MA decelerated and accelerated upon touchdown, commanding different flap configurations. This changed the MA's aerodynamics and ultimately led to the multiple touchdowns.

1.4.1. The warning now appears in the HUD when the condition lever is moved out of the full forward position.

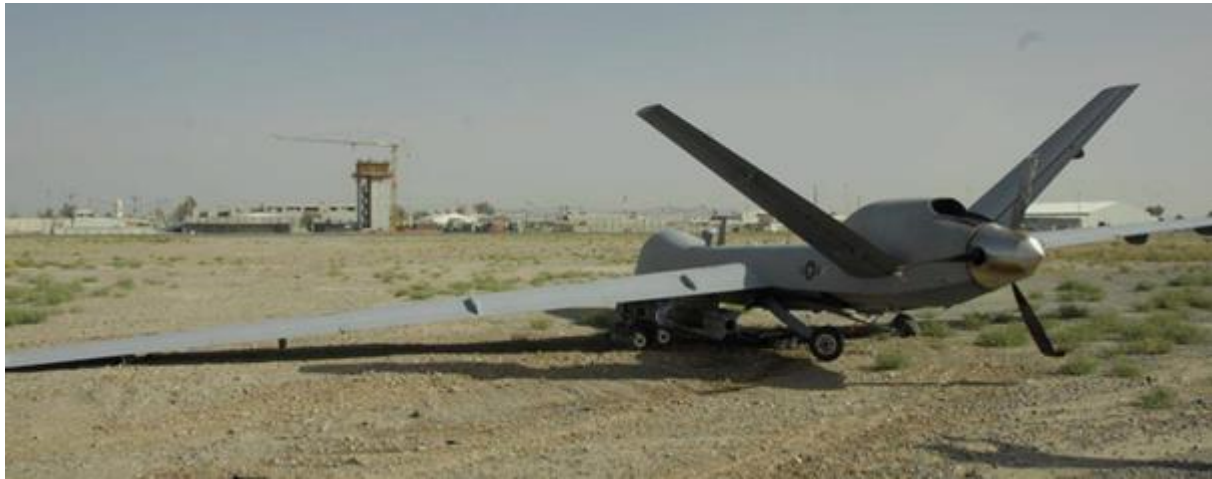
**Figure 2. Pilot Induced Oscillation.**

2.1. Mishap (**Figure 1**). During an operational sortie the MA returned to base early due to Multispectral Targeting System (MTS) issues. The mission control element (MCE) handed back the MA to the launch and recovery element (LRE) and the MP established a descent

profile. On final, the MP had -2.8 degrees (nose down) trim applied throughout the approach. The aircraft weight at touchdown was at the maximum landing weight for normal conditions (considered a heavyweight landing). As a result of Pilot Induced Oscillation (PIO), seven bounces (up to a 5G impact) occurred and go-around calls were made. On the seventh contact the nose gear strut failed and the left main gear sheared. The MA then entered a skid down the runway and departed the prepared surface off the left side of the runway. The MA traveled approximately 3900 feet from initial touchdown to the final resting position; there were no injuries.

2.2.2. Operator Factor. The MP was not proficient in landing a heavy weight MQ-9 in the flight conditions encountered in the MS. Numerous publications make reference to the need to not relax back stick pressure until it is assured the main landing gear are in contact with the runway.

2.2.3. Logistics Factor. The instrumentation, ergonomics, and auditory cues from the ground control station (GCS) are inadequate and provide little additional situational awareness to the operator. The lack of a radar altimeter to display AGL altitude to the pilot during and approach makes the flare and landing phase difficult. The lack of audible cues and a cluttered HUD instrument presentation also increase the confusion of the operator while performing a normal instrument cross check.

2.2.4. Operator Factor. The crew misapplied the landing procedure, failed to recognize a PIO early enough, and once directed to "go around" the pilot failed to properly apply go around and Landing PIO Recovery boldface procedures.

2.4.1. MQ-9 aircraft are now equipped with three laser altimeters. The laser altimeters provide precision altitude readout any time the aircraft is at or below 100 feet AGL.

2.4.2. A pitch command carat on a fixed pitch ladder was added to the HUD.

2.4.3. All operational squadrons now have a certified simulator.

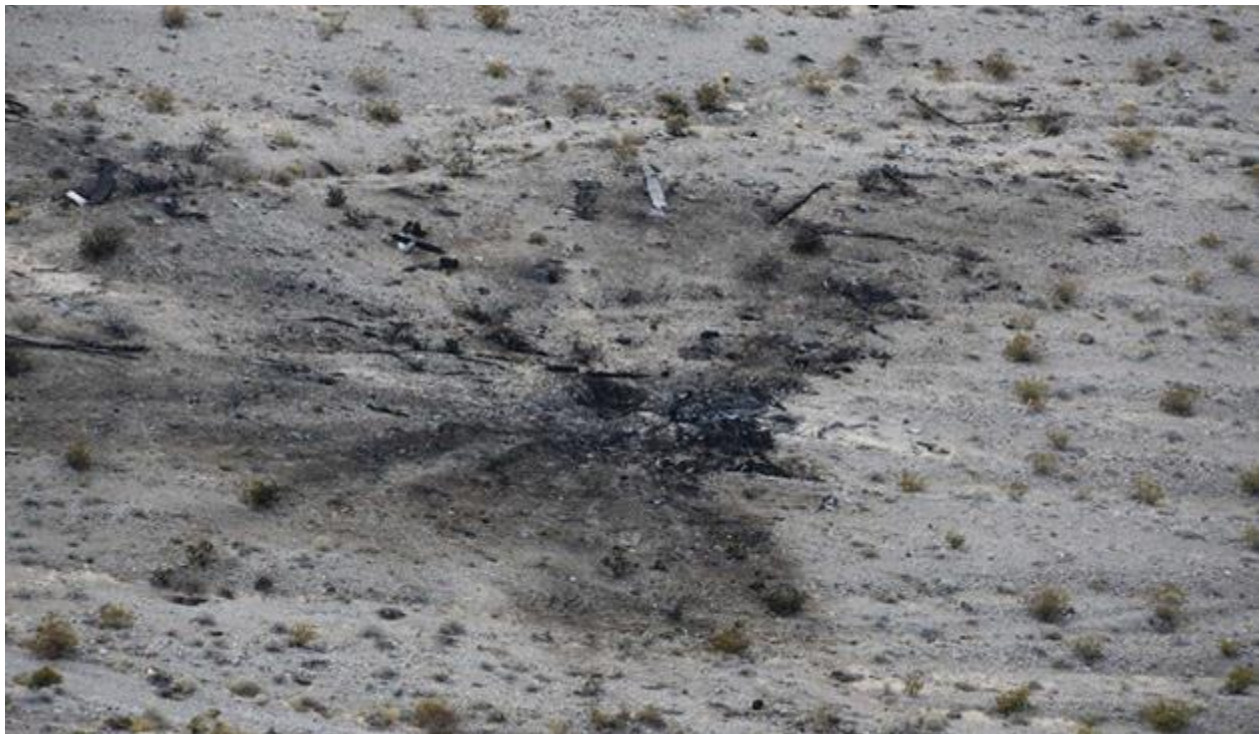
### Figure 3. Area Stall.

3.1. Mishap. The mishap occurred during a transit portion of the sortie, where the MC planned to gain the MA from the LRE crew and fly it to the working area. The MC conducted initial checks and took control of the MA at an assigned altitude of 8,500 feet mean sea level (MSL) with Altitude and Airspeed Hold modes engaged. When the MP updated the initial lost link heading (also applied all of the preset settings to the MA) the aircraft began climbing to attain the preset 9,000 minimum altitude MSL. When the MA continued climbing through 8,500 MSL, the MP acknowledged the climb and commanded Landing Configuration. Commanding Landing Configuration turned off all autopilot functions, including stall protection. The MA was automatically trimmed 9 degrees nose high to correspond with the current aircraft pitch. Power decreased from the autopilot commanded torque setting to the actual throttle position of approximately 30%. The MP made multiple attempts to level off but failed to trim in the correct pitch. The MP also retarded the throttle to idle resulting in airspeed dropping below stall. After the MC acknowledged the stall condition the MP increased the throttle full forward, the MA began a spin, and went lost link. The MA impacted the ground and was destroyed.

3.2.1. Operator Factor. The MP stalled the MA while attempting to recover from a nose high unusual attitude due to poor task management. The MP did not correct the minimum altitude preset value of 9,000 feet prior to taking control of the MA at a lower altitude, which resulted in an unexpected climb. The MP commanded Landing Configuration, while in a nose high attitude, and then focused attention on resolving the incorrect minimum altitude preset and other checklist steps rather than maintaining control of the MA. The MP failed to provide adequate control inputs to correct the nose high condition.

3.2.2. Operator Factor. According to AFI 11-2MQ-1&9 Volume 3, "the sensor operator will inform the pilot of all head-down display (HDD) caution and warning messages during non-critical phases of flight." The MSO failed to communicate a stall warning, in a timely manner, to the MP and the MP failed to respond to the stall warning. The fact that the stall warning tone cannot be silenced should have alerted both the MP and MSO that a critical situation was developing.

3.4.1. The videos and animation from this mishap were added to the MQ-9 academics in order to increase understanding of stall characteristics and considerations.

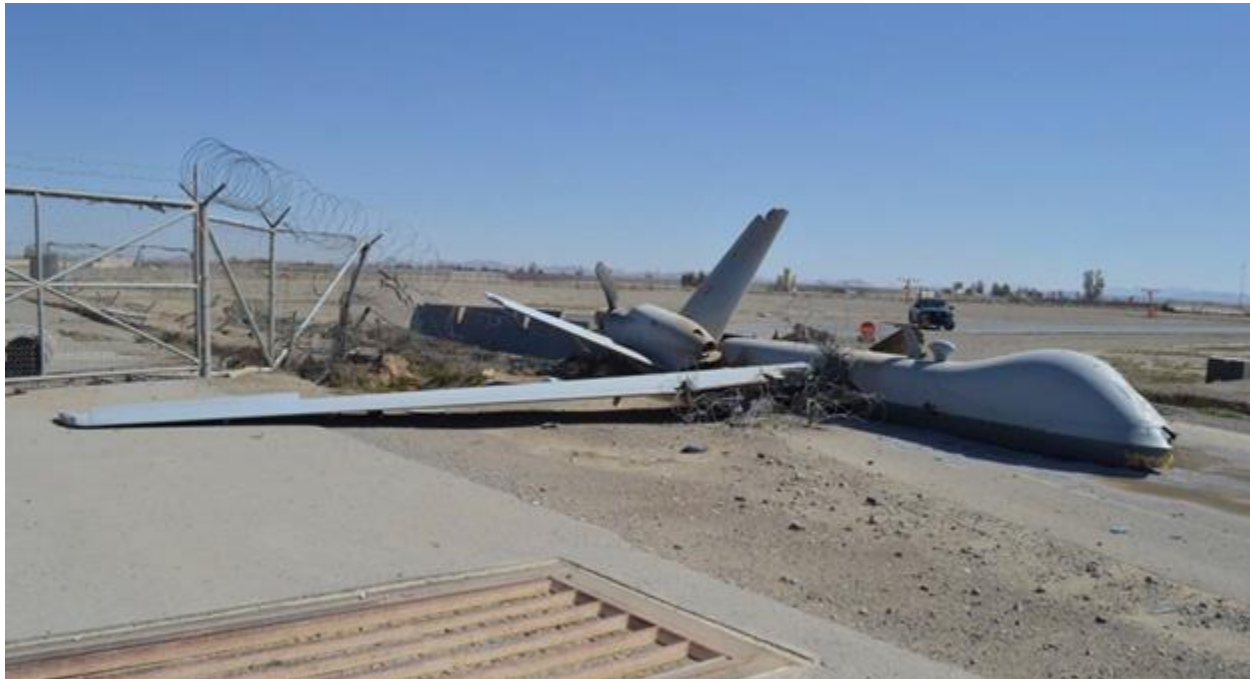
**Figure 4. Short Landing 2.0.**

5.1.1. The mishap sortie was launched as a training mission. The MA then entered the pattern and the MP requested high key to execute a SFO pattern to a low approach. The MP retarded the power, pitched and trimmed for a -5 degree pitch and began a 25 degree bank to the right in accordance with SFO procedures. Abruptly the MA airspeed decelerated from 98 knots indicated airspeed (KIAS) to 87 KIAS. Five seconds after retarding the power and three seconds after the torque had stabilized at 2%, the "BETA" indicator illuminated above the torque gauge. As the MP continued the SFO, the MSO inquired about the aircraft's altitude and directed a go-around. The MP initiated the go around by pulling the nose up and adding full throttle. Three seconds later, the MA struck power lines, went lost link, and impacted the ground.

5.2.1. Logistics Factor. The aircraft going into beta mode caused the MA to have significantly greater descent rates than is normally expected.

5.2.2. Operator Factor. When the MP increased the descent rate to attain the desired approach speed and the speed did not accelerate, the MP fixated on the airspeed and let the altitude and VSI drop out of his cross check.

5.2.3. Operator Factor. The MP was using a camera which provided essentially no visual cues for the altitude state, winds were significantly pushing the MA away from the airfield, and was performing the approach to a runway to which he had never done an SFO.

5.2.4. Operator Factor. The MC went 480 feet below their planned roll out altitude on final without being established on final or having the runway in sight before calling for a go around.

5.4.1. Improved thermal crossover in simulators to provide more accurate conditions when using the IR nose camera.

5.4.2. Added verbiage to AFI 11-2MQ-1&9 Volume 3 requiring crewmembers to terminate the maneuver if not in a position to land and to make an intra-cockpit base key/one mile final (straight-in approach) call on SFOs.

5.4.3. CRM training included a case study of this mishap.

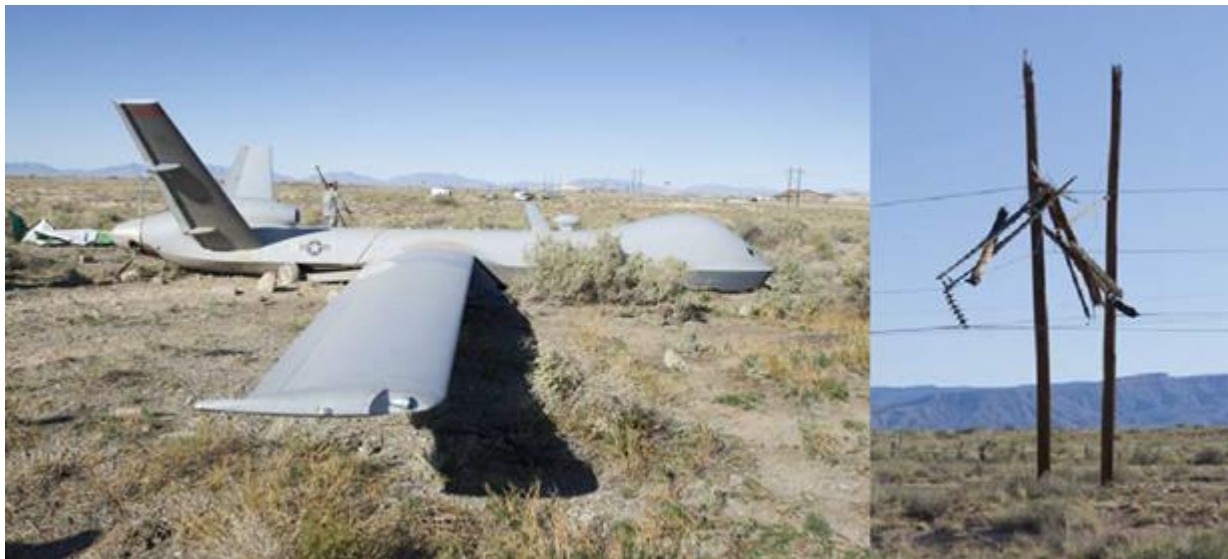
## Figure 5. Short Landing.

4.1. Mishap. The MS was scheduled as an Intelligence Surveillance and Reconnaissance (ISR) mission in support of a contingency operation. The MP planned to perform a simulated flameout (SFO) for currency purposes. After the MA hit low key and turned to final, the MP struggled to identify the runway environment (the nose infrared (IR) camera was selected). The throttle was at idle and airspeed was below approach speed and slightly above stall speed. When reaching approximately 100 ft AGL, the MP advanced the throttle full forward in

conjunction with the go-around callout. The MA impacted the perimeter fence and ground 900' short of the runway. The MA was destroyed on impact.

4.2.1. Operator Factor. The MP stalled the MA while attempting to go around from a low approach at the termination of an SFO maneuver. The MP allowed the MA to get low and slow due to improperly executed procedures and lack of situational awareness because of being fixated on searching for the runway. The MSO did not make appropriate low airspeed and altitude calls and the MC did not adhere to AFI guidance when a go around was required.

4.4.1. Training and T.O. guidance for use of the MQ-9A Gen2IR nose camera was added.

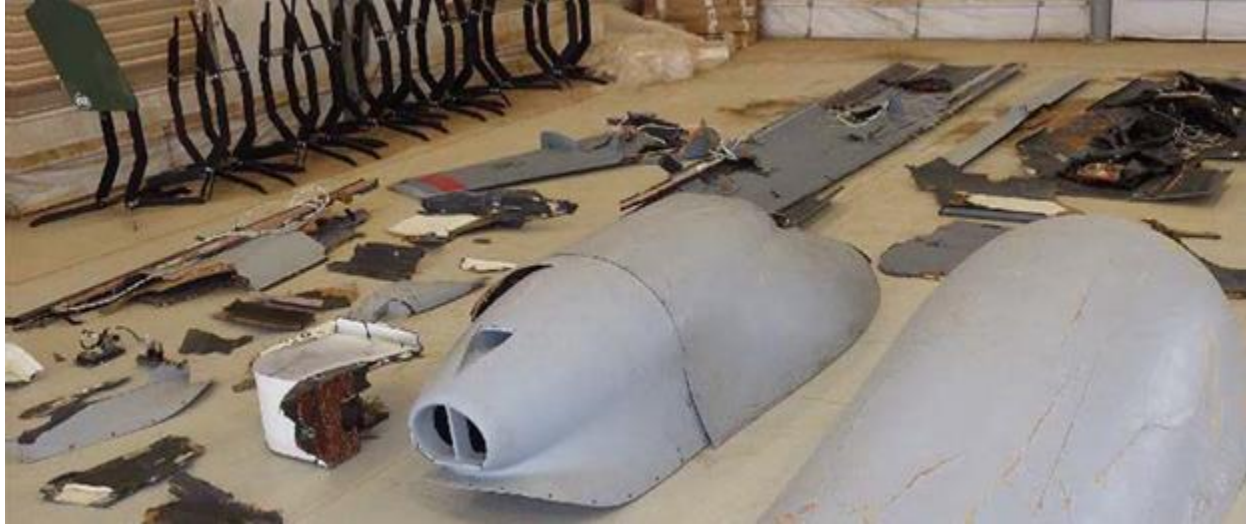
**Figure 6. Weather Stall.**

6.1. Mishap. The MS was scheduled as an MQ-9A operational contingency sortie. The briefed forecast weather for the MC was scattered clouds with haze on departure and decaying thunderstorms in the vicinity. After handoff, the MSO identified a potential cloud layer in their

flight path and the MC ran and completed the Airframe Icing Checklist. The MSO began to scan with the MTS and verbally identified the edge of a thunderstorm directly in front of them. After the MA entered the weather (including severe turbulence) Landing Configuration was commanded by the MP. The MA automatically trimmed to 14 degrees nose-high to correspond with current mishap ground control station (MGCS) commanded pitch trim. Airspeed decreased from 116 KIAS to 92 KIAS and angle of attack (AOA) increased to 23 degrees. The MA began to stall and depart controlled flight. Return Link (RL) and Command Link (CL) were lost and subsequently regained returning pitch trim and power to the previous settings. The MA's attitude returned to a high positive pitch and low airspeed resulting in a second stall. The MA did not recover and impacted the water.

6.2.1. Operator Factor. The MC failed to recognize deteriorating weather, did not execute a weather avoidance maneuver in a timely manner, and inadvertently flew into hazardous weather.

6.2.2. Operator Factor. The MP commanded landing configuration while in a nose high attitude which set an unusually high pitch trim, and failed to recognize an unusual attitude and failed to perform a recovery maneuver due to an inadequate crosscheck. Without sufficient control stick inputs, compounded by poor CRM, the MA's unusual attitude quickly progressed to a stall and then a spin. The departure from controlled flight caused the MA to lose RL and CL. When the MA regained links, the MP again failed to recognize the MA's nose high attitude due to an insufficient crosscheck, and allowed a secondary stall to develop without any corrective action.

6.4.1. Implemented a deliberate Operational Risk Management (ORM) process that limits inexperienced crew members from flying on the same crew to the maximum extent possible and ensures risk is accepted at the appropriate level.

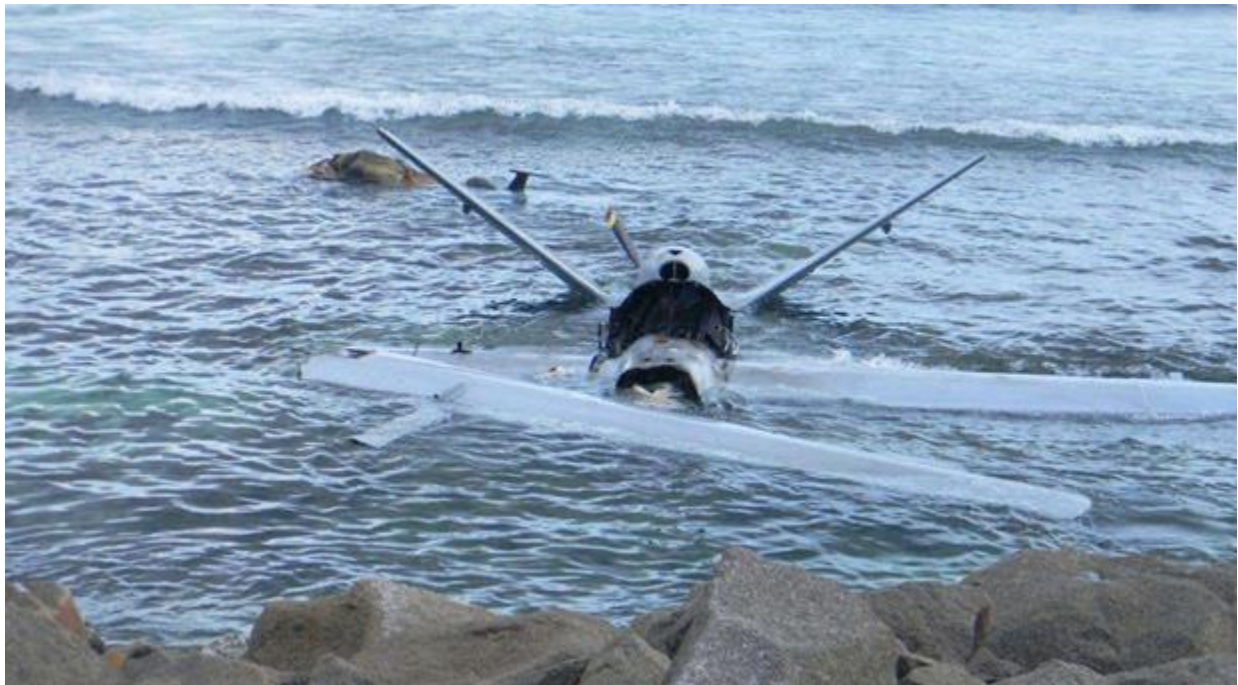
### Figure 7. Long Landing.

8.1.1. The MS was supporting an operational mission. On takeoff and at approximately 2500ft AGL, the engine failed and the “Engine out detected” illuminated with the associated warning tone. The MP immediately cross-checked the engine instruments and verified the engine out condition. The MP then made a right turn away to set up for an approach to land on the opposite direction runway. The MC completed the CAPs and continued with the ENGINE FAILURE checklist. Simultaneously, the MP declared an emergency with the tower controller and requested firefighting support and a straight-in approach. The MA touched down approximately half way down the runway, with 5,000ft remaining, at 132 KIAS. The MA continued off the runway and impacted a rock breakwater and came to rest in the ocean.

8.2.1. Operator Factor. The MC continued the approach after completing the ENGINE FAILURE checklist despite excess energy and an incorrect pattern entry point. The MP thought it was possible to trade the excess altitude for increased airspeed in the remaining distance to the runway and still land the MA.

8.2.2. Operator Factor. The excess speed in the round out and flare caused the MA to float significantly down the runway before touching down. There was no reverse thrust capability with the engine inoperative. The wheel brakes were the MP’s only tool to stop the MA, but were not sufficient to stop within the distance remaining.

8.2.3. Logistics Factor. The engine failed due to fuel starvation caused by an electrical short which forced electrical closure of the fuel shut-off valve.

8.4.1. A Time Compliance Technical Order (TCTO) requiring the replacement of the Engine Start Module (ESM) was expanded and reissued.

8.4.2. The unit operating the aircraft added SFO and other emergency procedures training and currency to the local training program. Additionally, members are required to perform SFO landing patterns before flying operational sorties.

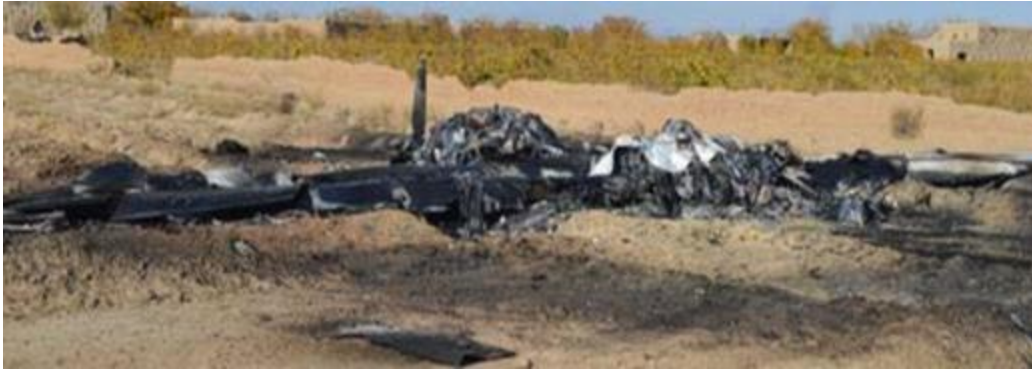
**Figure 8. High Pressure Takeoff.**

9.1.1. The MA was scheduled to launch on an ISR mission sortie. During taxi, the MP noted unusual torque jumps during power applications. While taxiing the oil pressure exceeded both the caution and warning limits and this was noticed by the MC minutes later. After lift-off the MSO noted the oil pressure was high and called for an abort. The MP acknowledged the abort, but stated the MA was already airborne and decided they couldn't land again on the runway remaining. The MP elected to continue the climb out and declared an emergency requesting a closed pattern. At approximately 500ft AGL, the engine torque and engine speed decreased and the automatic engine restart activated. Torque and engine speed increased and the automatic engine restart ceased. Seconds later, the engine failed. The MP applied the CAPs for engine failure and moved the condition lever aft. The MA crash landed and was destroyed.

9.2.1. Operator Factor. The MP fixated on power shortcomings during taxi procedures and failed to recognize several instrument indications that identified high oil pressure which should have forced an abort while on the ground.

9.2.2. Operator Factor. Shortly before takeoff a check of the engine instruments was verbalized. The crew failed to notice the visual indicator of high oil pressure and consequently failed to abort prior to takeoff.

9.2.3. Logistics Factor. The MA suffered mechanical failure of a compressor bearing which resulted in an un-commanded engine shutdown.

9.4.1. Additional maintenance practices were incorporated to minimize oil system anomalies.

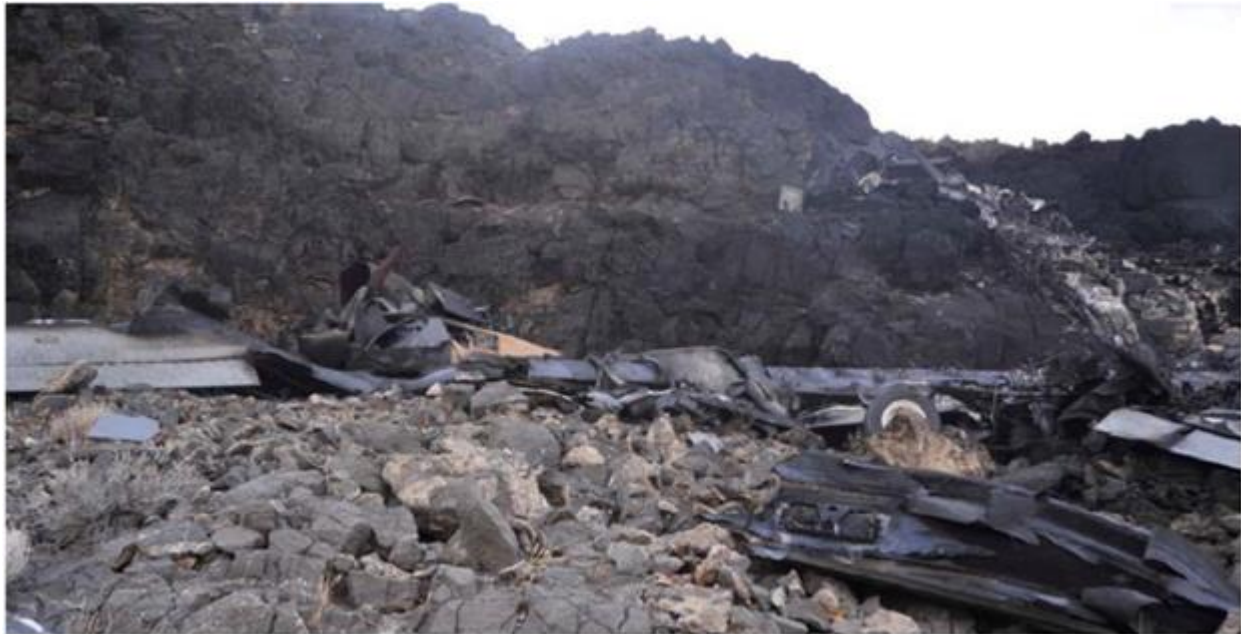
**Figure 9. Controlled Flight Into Terrain.**

10.1.1. This sortie was generated to support a Launch and Recovery syllabus event. After conducting multiple SFOs, the MC came off the perch with negative VSI up to -2366 feet per minute (fpm). The MA experienced degraded links just prior to impacting mountainous terrain.

10.2.4. Operator Factor. During the pattern downwind the MIP failed to recognize an abnormal descent rate of the MA with an excessive negative VSI. As a result of excessive VSI, the MA was well below pattern altitude when turning to an extended final approach.

10.2.5. Operator Factor. Continuing the abnormal descent rate, the MC experienced a degraded downlink signal (impairing their video) due to high terrain obstruction.

10.4.2. A caution was added to the Technical Order (TO) 1Q-9(M)A-1 describing aircraft performance when pulling power to flight idle.
