**AIR EDUCATION AND TRAINING
COMMAND HANDBOOK 11-210**

04 FEBRUARY 2020

Flying Operations

ROAD TO WINGS

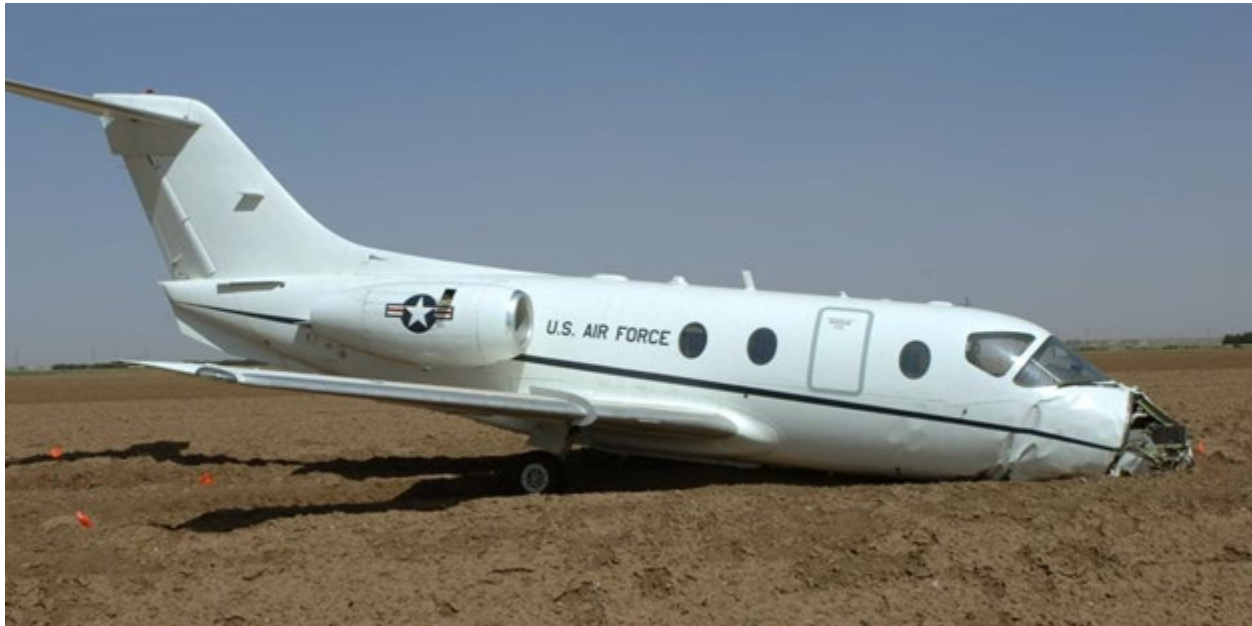
Figure 3. Microburst During Circle to Land.

3.1. **Mishap. Figure 3.** The mishap crew (MC) was on their second flight of a day-night out and back. They took off with the intent to fly a Localizer Approach at the departure airfield and circle to another runway, then stay in the pattern for more approaches. The MC was aware of rain showers in the vicinity of the airport, gusty surface winds, blowing dust, and strong winds at altitude of approximately 35-40 knots. During the circling approach as the MC aligned on final, the mishap aircraft (MA) experienced a downdraft with a vertical velocity (VV) of approximately 2,000 feet per minute (fpm). The MA continued to descend during the go around with a peak VV of negative 4,800 fpm. The mishap instructor pilot (MIP) took the aircraft and executed a maximum performance recovery, but the MA continued to descend with a VV between negative 1,500 to 3,100 fpm. The MA impacted a field a half mile short of the runway with a VV of approximately negative 1,000 fpm and received significant damage. The MC egressed the aircraft and were not injured.

3.2.1. **Supervisory Factor.** Compared to the FAA, the Air Force did not emphasize the same level of windshear and microburst training. Air Force training lacked academic instruction and simulator instruction to cover these topics.

3.2.2. **Operator Factor.** The weather forecast showed an upper level low and associated trough rotating towards the mishap airfield with a chance for isolated thunderstorms. Just prior to the mishap sortie, observed winds and PIREPs indicated a windshear of 18 knots. According to T.O. 1T-1A-1, this indicates a severe windshear and flight crews are required to delay takeoffs and discontinue approaches. The deteriorating conditions were also reaffirmed by other aircraft in the area and the tower controller who reported blowing dust, poor visibility, and moderate to extreme turbulence.

3.2.4. **Operations Factor.** The Weather System Processor (WSP) at the airfield did not provide accurate alerts to controllers of windshear, microbursts, and gust front hazards due to system limitations and/or undetected system faults.

3.2.5. **Operator Factor.** The MC did not know or reference T.O. guidance about severe windshear, did not know the definition for their aircraft, and as a result took off in conditions prohibited by the T.O.

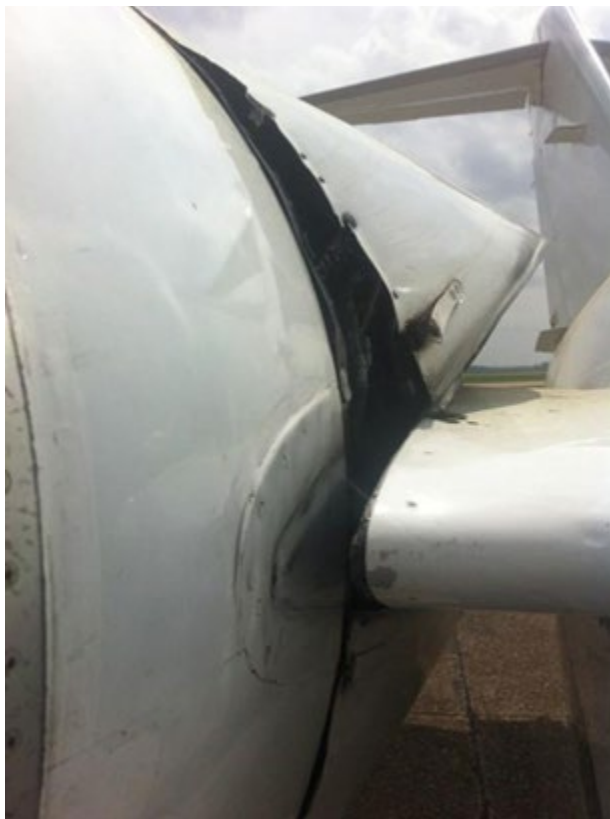
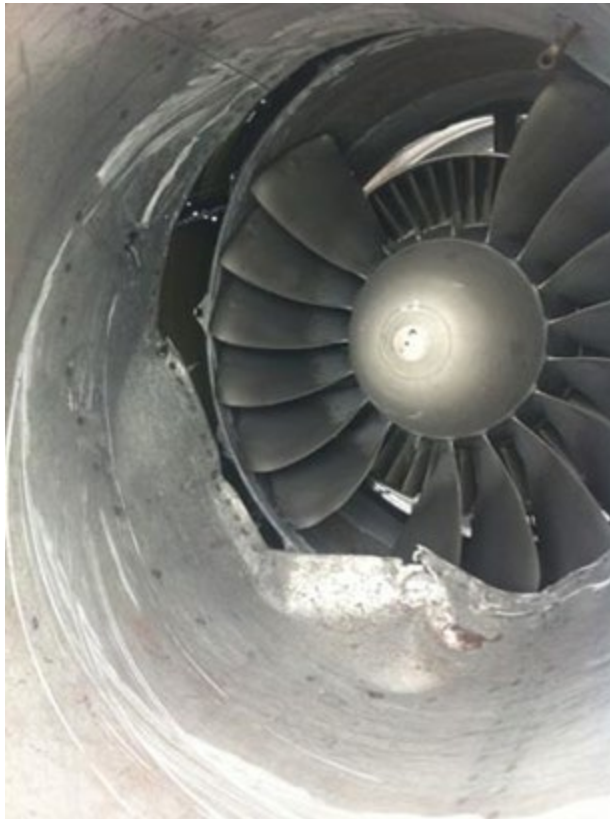
Figure 4. Bird Strike During Touch and Go.

4.1. **Mishap.** **Figure 4** and **Figure 5.** The mishap sortie was a two-ship formation sortie that split for patterns at a local outfield. During the climbout following a touch and go, the mishap aircraft (MA) struck at least one mourning dove followed by a loud bang, associated whining noise, and brief violent vibration. Next, the Master Warning System red light started flashing and a right fire detector failure light illuminated followed by a fire bell and associated right engine fire switch light illuminated. The mishap crew (MC) discharged both fire bottles into the mishap engine, but the engine fire light remained on. The MC did not elect to shut down engines in order to provide available thrust. The MIP maneuvered the MA for an uneventful landing and emergency ground egressed on the runway. There were no injuries and no external indications of fire on the MA.

4.2.1. **Logistics Factor.** Four compressor fan blades were liberated from the engine and caused cascading damage to the rest of the engine and damage to the nacelle and engine pylon. In addition, the fan case fractured into two pieces with the forward section loosely attached to the engine. The extensive damage from such a small bird weighing 3 to 6 ounces was found to not meet the bird ingestion requirements set by the FAA since there are civilian variants of the same engine. Further investigation revealed 7 other similar mishaps involving the same engine on the sub-fleet of Beechcraft™ 400/T-1A. The failure mode of this engine is unique to the Beechcraft™ aircraft and a result of an unrecognized design deficiency involving a dynamic interaction between the engine's fan blades and the fan case.

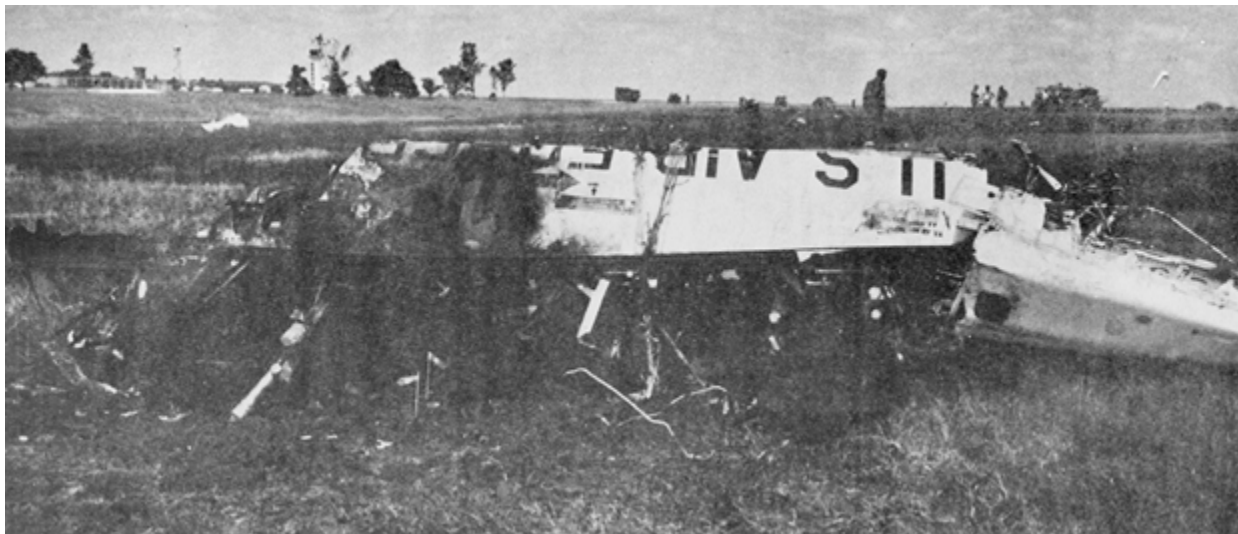
Figure 6. Stall.

5.1. **Mishap. Figure 6.** The mishap was a dual mission, and the aircraft crashed shortly after takeoff. Acceleration and rotation appeared normal with liftoff about 3,000 feet down the runway. Once airborne, the aircraft quickly rotated to an abnormally high pitch attitude. As the aircraft climbed to its maximum height of around 150 feet above ground level (AGL), the left wing dropped noticeably and the aircraft began to descend. As the nose appeared to drop toward the horizon, the aircraft suddenly rolled right to approximately 90 degrees of bank. At some point during this sequence, the pilot retracted the gear and flaps. The pilot maneuvered back toward a wings level position, but the rate of descent continued to increase. The pitch attitude remained slightly nose high. The crew was unable to recover the aircraft, and it impacted the ground 6,800 feet from brake release. Parameters at impact were 17 degrees of right bank, 5 degrees nose high, and approximately 198 knot indicated airspeed (KIAS). Neither crewmember ejected and both were fatally injured.

5.2.1. **Operator Factor.** The pilot apparently stalled the aircraft just after liftoff with insufficient altitude to recover.

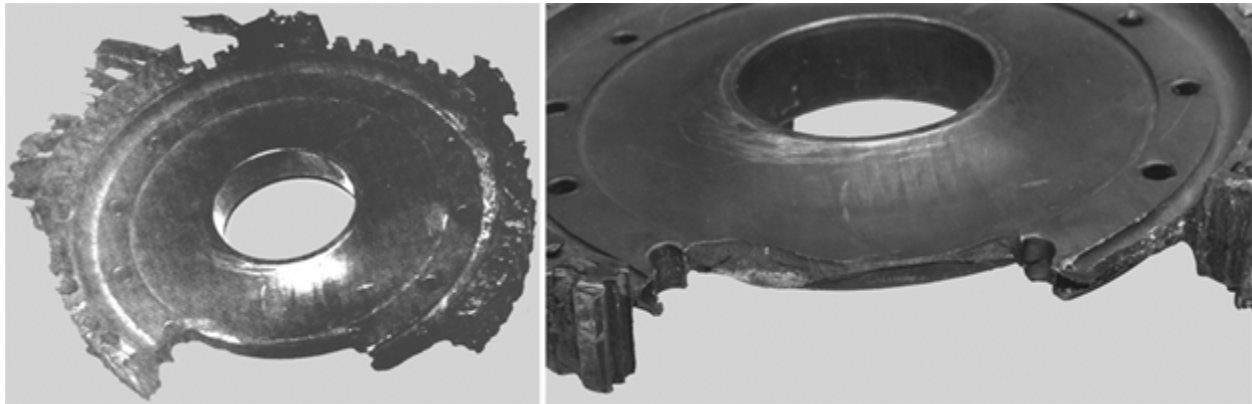
Figure 14. Engine Failure and Loss of Flight Controls.

12.1. **Mishap. Figure 14.** The mission was flown by two IPs on a cross-country flight. The RCP pilot completed a normal rolling takeoff. After liftoff, both pilots heard a loud bang as the RCP pilot retarded the throttles out of afterburner. The RCP pilot noted the left engine rpm decaying through 40 percent and retarded the throttle to idle. The FCP pilot assumed command of the aircraft and declared an emergency. The right fire light illuminated 3 to 4 seconds later, and the aircraft began a slight roll to the left with an uncommanded pitch-up.

12.2.1. **Maintenance Factor.** The stage two turbine wheel on the left engine developed a crack as a result of a machining defect. During initial takeoff, the stage two turbine wheel failed, causing an uncontained engine failure. Turbine parts penetrated the engine firewall, allowing hydraulic lines to be exposed to hot combustion gases. The hydraulic lines burned through depleting pressure in both hydraulic systems. The aircraft became uncontrollable as the hydraulic pressure depleted.

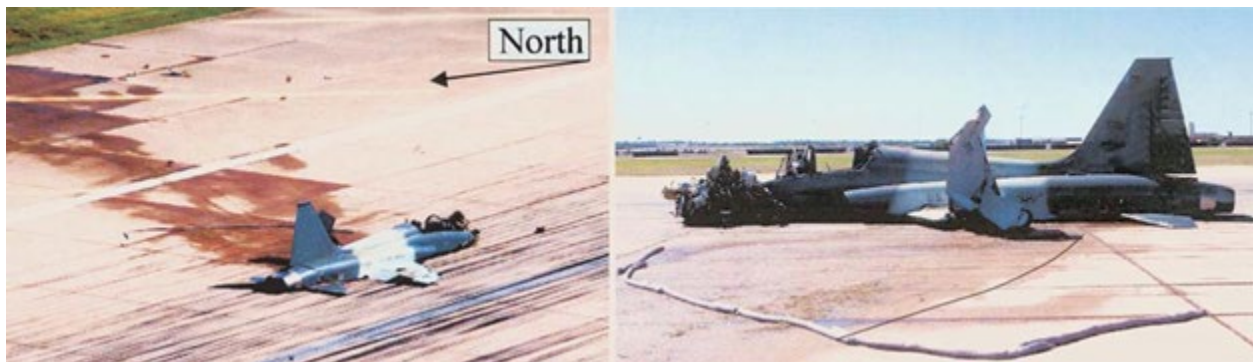
Figure 15. Loss of Control—Poor Transfer of Aircraft Control.

13.1. **Mishap. Figure 15.** The mishap sortie was a pre-solo contact sortie. The SP performed the takeoff and lifted off at approximately 155 knots. The SP was using stick only

to control the aircraft and had his feet flat on the floor. The aircraft rolled right immediately after takeoff, and the SP overcorrected with left aileron causing the aircraft to roll into approximately 60 degrees of left bank. The SP told the IP something was wrong. The IP stepped on the rudder to counter the roll, but did not communicate transfer of control to the SP. The SP continued to fight the roll with ailerons. He did not know the IP was making rudder inputs because his feet were still on the floor. The combined and uncoordinated efforts of both aircrew members resulted in a rolling pilot induced oscillation (PIO). As the aircraft rolled back and forth reaching 90 degrees of bank in both directions, the IP commanded bailout. The crew ejected successfully just prior to the aircraft striking the ground. The aircraft departed the runway, skidded through the grass, and came to rest in the center of the adjacent parallel runway.

13.2.1. **Maintenance Factor.** The aircraft had previously been written up for an uncommanded rolling motion. Maintenance determined the stability augments caused the roll, but they did not consult with Operations before releasing the aircraft for flight. If they had, Operations would have known that the type of rolling motion described in the original AFTO IMT 781, ARMS Aircrew/ Mission Flight Data Document, write-up would not have come from a stability augments malfunction and would have ordered a functional check flight (FCF) prior to release. The roll was more likely caused by elongated holes in one of the wingtips where the wingtip attached to the main wing, allowing the wingtip to shift out of position.

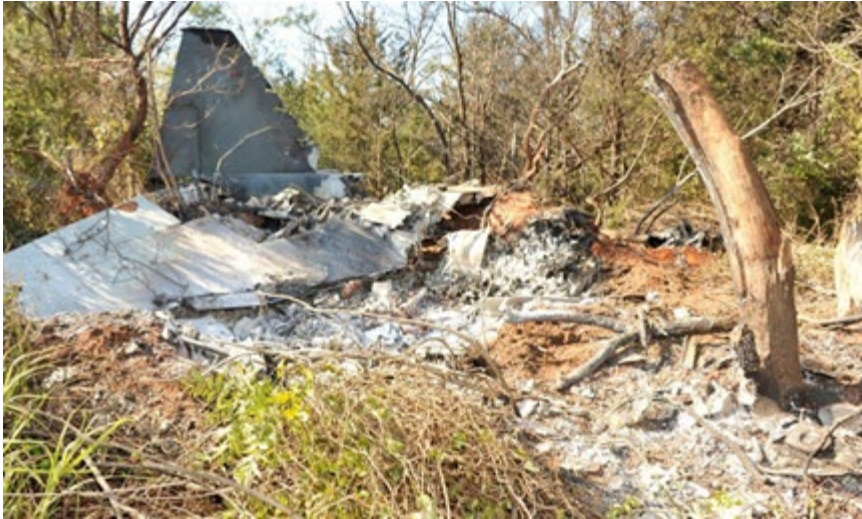
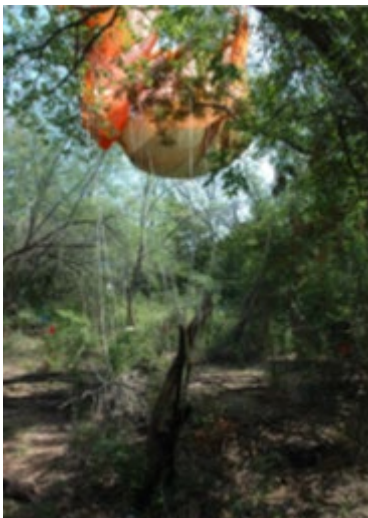
Figure 16. Bird Strike on Touch and Go.

14.1. **Mishap.** **Figure 16** and **Figure 17.** During the touch-and-go, the mishap aircraft (MA) struck a white cattle egret causing the near total loss of the front cockpit canopy and induced severe aerodynamic drag forces on the MA. In response to the shattered canopy, the MA slowed. The mishap instructor pilot (MIP) selected MAX power on both engines, and started a climbing right hand turn. The MIP commanded and initiated the low altitude ejection approximately five seconds before the MA hit the ground. The mishap crew successfully ejected, but the nature of the low altitude ejection resulted in nonlife-threatening injuries. The MA hit the ground in a low speed, steep dive impact approximately 2 miles south of the airfield and was destroyed.

14.2.1. **Logistics Factor.** The birdstrike fractured the front canopy and resulted in a compressor stall of both engines, placing the MA in a limited thrust condition. The T-38 canopy did not have any performance requirements for birdstrike resistance when it was designed. Previous mishaps and engineering analysis identified a vulnerability in the front canopy that could lead to the catastrophic fracture of the canopy and possible FOD ingestion into one or both engines. Previous recommendations had been made to redesign the canopy, but the risk was accepted to preserve the through-the-canopy ejection ability and due to prohibitive cost limitations and aircraft performance factors.

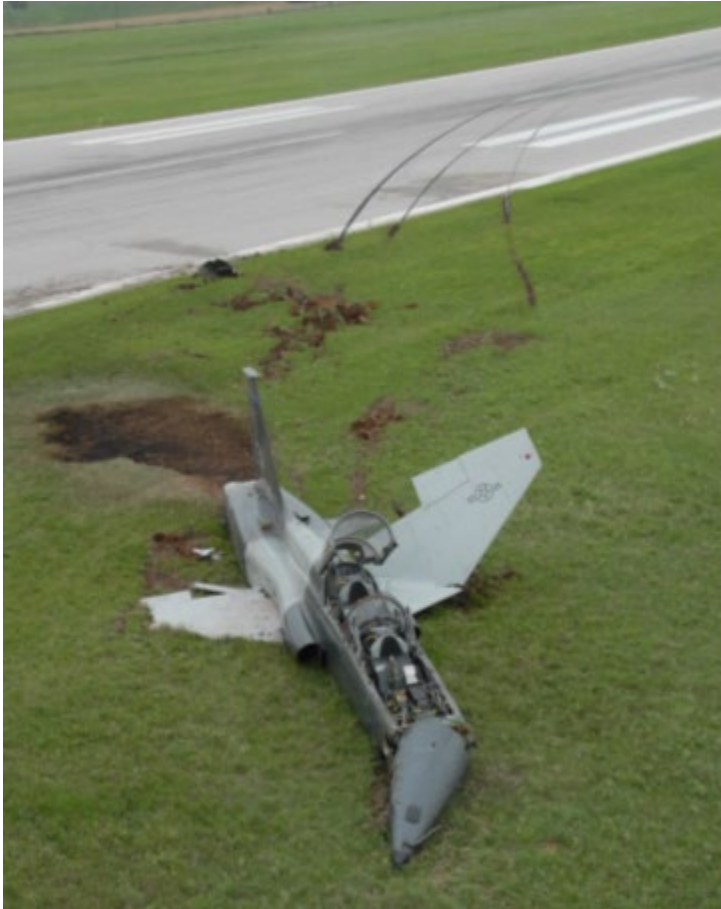
Figure 18. Loss of Directional Control on a Formation Takeoff.

15.1. **Mishap. Figure 18.** The student pilot (SP) and instructor pilot (IP) were number two in a two-ship formation takeoff. While lining up on the right half of the runway, the SP pilot made a delayed left turn and overcorrected back to the right, stopping the aircraft with the nosewheel canted to the right. Upon brake release, the aircraft immediately veered right. The SP made multiple brake and rudder inputs in an attempt to maintain directional control during takeoff roll, causing yaw oscillations of the aircraft. As the aircraft oscillated right a third time and neared the edge of the runway, the IP made the decision to abort the takeoff and took control of the aircraft. The aircraft then veered sharply to the left and departed the runway. Upon departing the runway, the landing gear collapsed, the right wing and horizontal stabilizer dug into the ground causing the aircraft to become airborne and roll 360 degrees while in the air. The aircraft was destroyed and both pilots sustained minor injuries.

15.2.1. **Operator Factor.** The mishap crew did not ensure the aircraft's nosewheel was aligned with the runway heading during lineup and this misalignment also went unnoticed by the flight lead. This required an immediate correction upon brake release and led to a directional control problem in close proximity to the element mate.

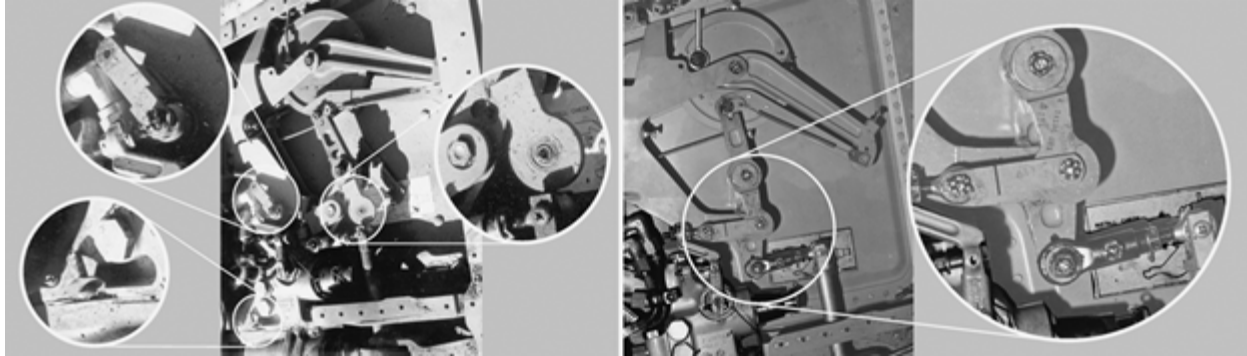
Figure 19. Flight Control Malfunction—Area.

16.1. **Mishap. Figure 19.** The mishap aircraft was on a local instrument training mission. After level off at 22,000 feet, the SP initiated a descending right turn, but was unable to stop the right roll after entering the turn. The IP took control of the aircraft, reduced airspeed, and regained partial control after several right rolls. The IP had marginal control authority with full left aileron and full left rudder. Two chase aircraft confirmed both ailerons were flush with the flap s, which were set at 60 percent. The crew maintained control of the aircraft for 43 minutes while discussing possible options with operations supervision. The aircrew elected to eject versus attempting to land. The IP began a right turn to proceed to the controlled bailout area. During the turn, the aircraft continued rolling right and would not recover. (The aircraft was at 19,000 feet and 180 KIAS.) The IP ordered ejection, and both crewmembers ejected successfully with only minor injuries. The aircraft was destroyed upon impact.

16.3. Maintenance Factor. At an unknown time, maintenance personnel removed the cotter pin securing a screw in the left aileron operating mechanism, but did not replace it. The left aileron operating mechanism became disconnected during the flight, allowing the left aileron to move full down. The aircrew eventually lost control of the aircraft and ejected.

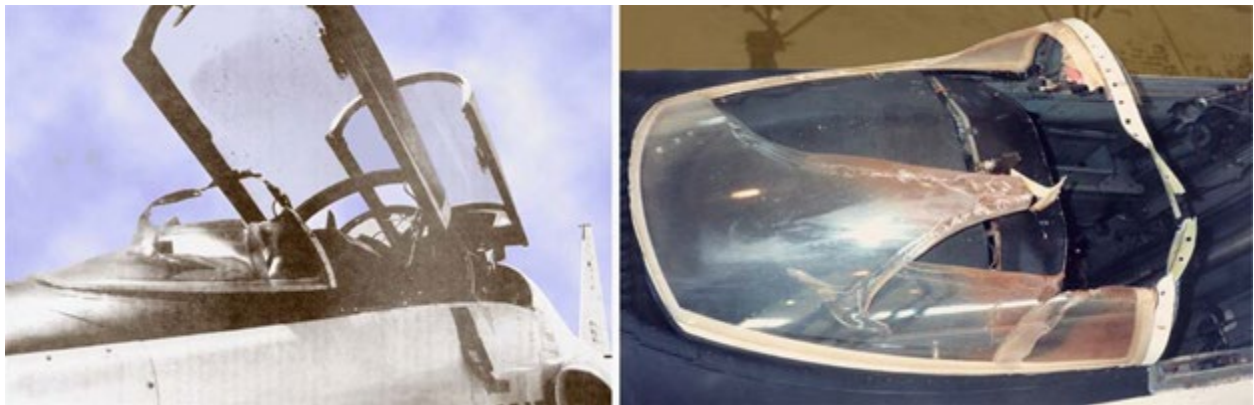
Figure 23. Bird Strike—Low-Level Sortie.

20.1. **Mishap.** **Figure 23.** The mission was a two-ship low-level navigation sortie. The mishap aircraft (lead) was flying a syllabus support sortie flown by two IPs. Approximately halfway through the low level, a bird penetrated the front windscreen, fatally injuring the IP in the front seat. The IP in the rear seat was not injured and recovered the aircraft with assistance from the wingman.

20.2.1. **Operator Factor.** The mishap crew saw birds twice on the low-level prior to the mishap. In one instance, the front seat IP assumed control and maneuvered the aircraft to avoid a bird. Approximately 6 minutes later, an adult turkey vulture penetrated the windscreen. The mishap aircraft was in straight-and-level flight, 500 feet AGL, and traveling at 400 KIAS. The front seat IP received fatal head injuries from bird and windscreen debris.

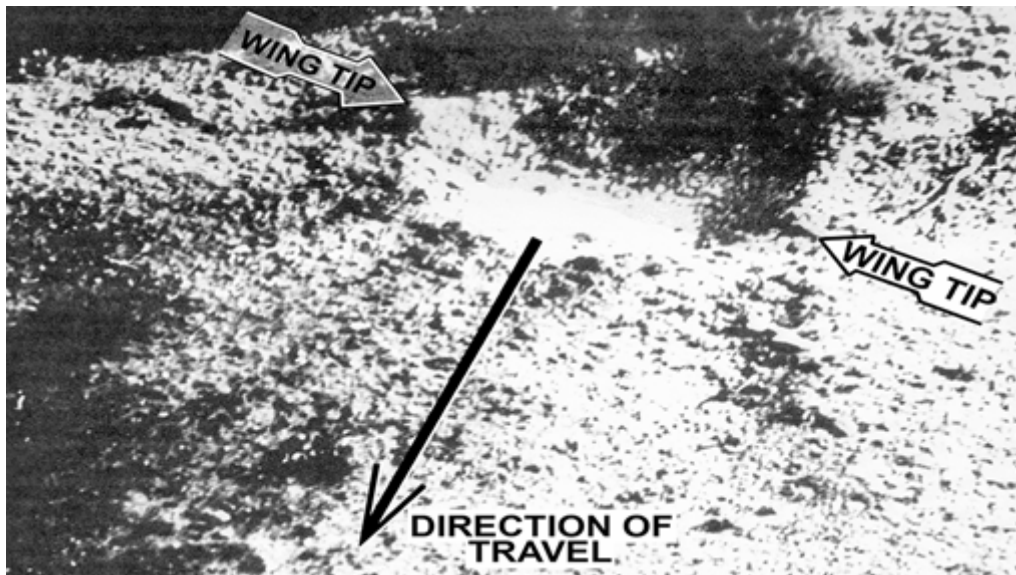
Figure 28. Loss of Control – Area.

25.1. **Mishap. Figure 28.** The mishap sortie was a solo contact mission, which included aerobatic maneuvers in the local area and normal traffic patterns and landings back at the field. Air traffic control lost radar contact with the aircraft approximately 13 minutes after it arrived in the assigned area. Subsequent investigation revealed the aircraft impacted the ground nearly vertical at high speed. The SP had not attempted to eject and was fatally injured.

25.2.1. **Operator Factor.** Eyewitness statements indicate the SP was performing aerobatic maneuvers below the minimum established altitude. While attempting a high performance aerobatic maneuver, the SP placed the aircraft in a high-speed, vertical dive with insufficient altitude to recover.

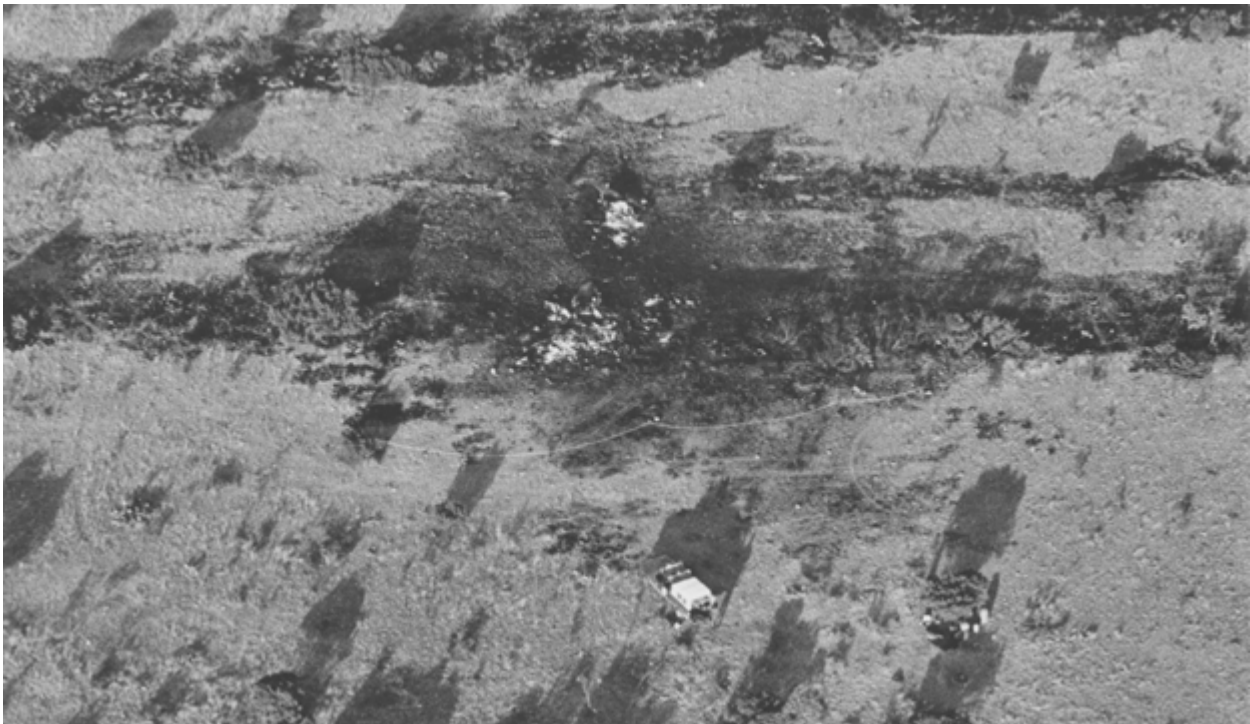
Figure 30. Loss of Control – Area.

27.1. **Mishap. Figure 30.** The mission was the SP's last UPT sortie. After level-off at 23,000 feet, the IP assumed aircraft control, flew into the area, and executed an aileron roll and split S. The IP returned aircraft control to the SP, who began an Immelmann. The SP selected afterburners and began a high G pull at 350 knots to initiate the Immelmann, exceeding aircraft G limits in the process. The SP stated his intention to lower the flaps at approximately 30 to 45 degrees nose high and 300 knots. As the aircraft approached 150 knots and pure vertical, the IP took control of the aircraft to attempt a recovery. The aircraft continued upward, and the airspeed decreased rapidly. The aircraft departed controlled flight at 25,500 feet MSL. The IP made several attempts to recover the aircraft, but all were unsuccessful. The SP ejected at 9,500 feet AGL, and the IP ejected at 2,000 feet AGL. Neither crewmember was injured, but the aircraft was destroyed upon impact.

27.2.1. **Operator Factor.** The SP initiated an Immelmann well below the minimum prescribed entry airspeed. In addition, he overstressed the aircraft on pull up.

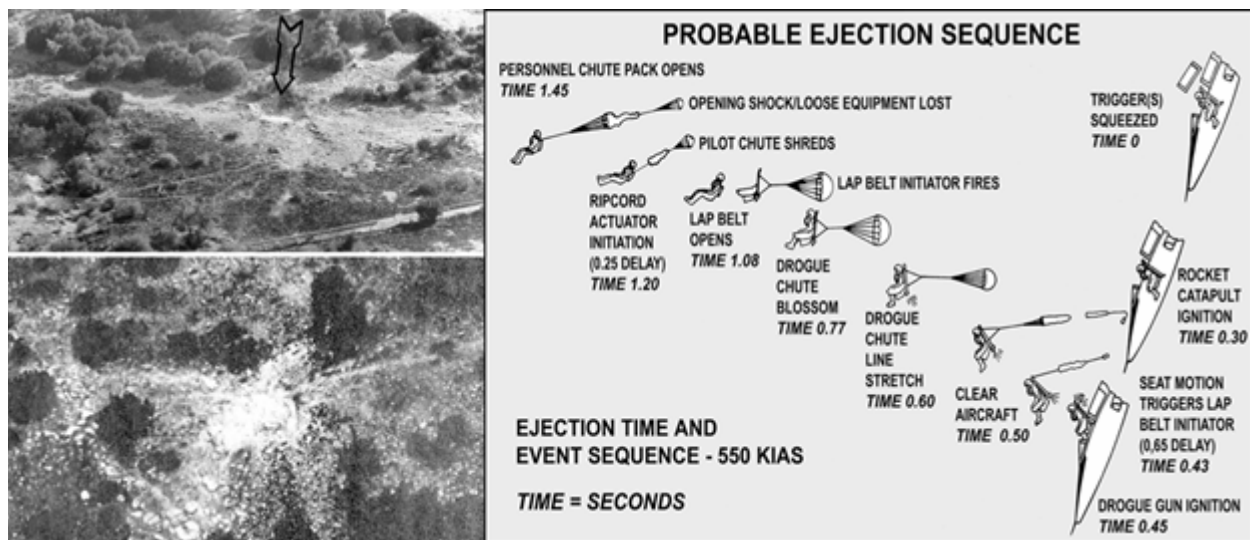
Figure 31. Loss of Control – Area.

28.1. **Mishap. Figure 31.** The mishap aircraft was on a single-ship team sortie (two students). The SP in the RCP was acting as an observer. Takeoff and departure to the working area were uneventful. Thirteen minutes after the crew entered the area, air traffic control lost radar and radio contact. The SP in the FCP had attempted a high speed ejection, but was fatally injured. The SP in the RCP had not ejected and was also fatally injured. The aircraft was destroyed upon impact.

28.2.1. **Operator Factor.** It appears the SP in the FCP entered a high-speed dive during the last portion of a barrel roll, possibly due to disorientation. He determined recovery was impossible. He ejected at high speed and sustained fatal injuries during the ejection.

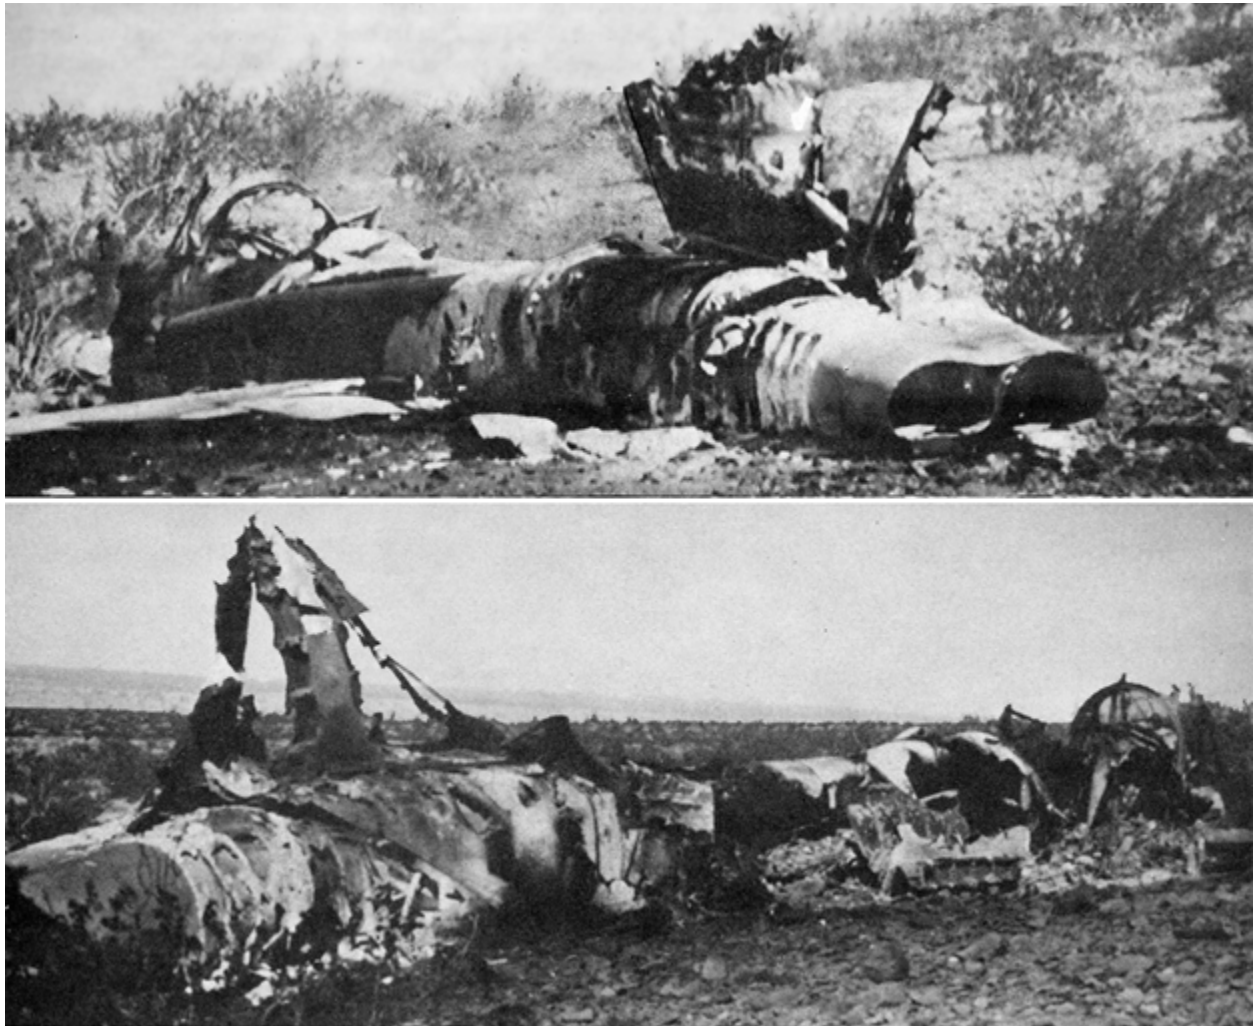
Figure 32. Loss of Control – Night Cruise.

29.1. **Mishap.** **Figure 32.** The mission was a single-ship, navigation flight evaluation. After 40 minutes of uneventful flight, the aircrew declared an emergency for a flight control problem. The crew started a descent and proceeded to an emergency airfield. During the descent, the IP transmitted the crew’s intention to eject. Both crewmembers ejected successfully and were uninjured, but the aircraft was destroyed upon impact.

29.2.1. **Logistics Factor.** An undetermined component of the stability augments system (SAS) malfunctioned during straight-and-level, unaccelerated flight. The aircraft suddenly yawed to the left and then began rolling left.

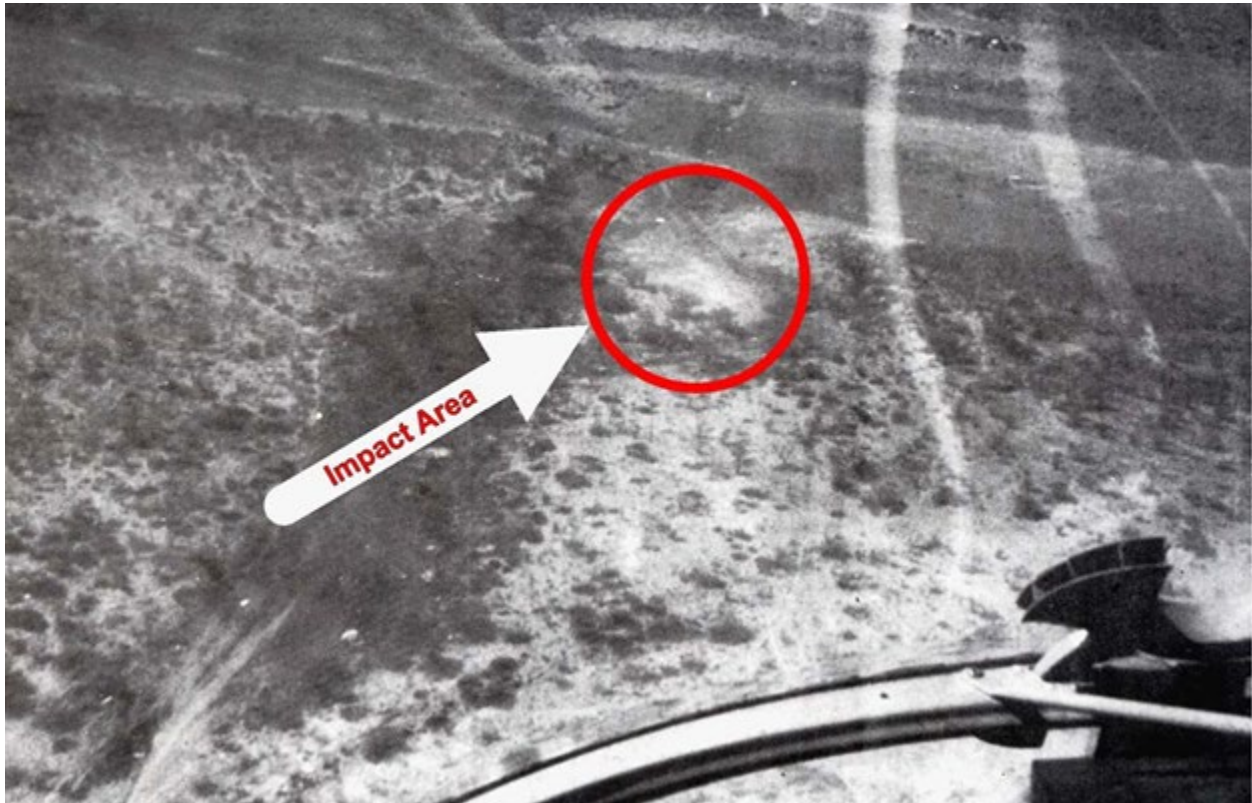
Figure 35. Loss of Control – Area.

32.1. **Mishap.** **Figure 35.** The mission was a dual contact sortie and the SP's first ride in the T-38. Takeoff and departure were uneventful. The IP was demonstrating a split-S. As the aircraft approached a nose-low, inverted attitude, he sensed the nose was not tracking or the G-load increasing as expected. The IP made several attempts to regain the proper nose track with no perceptible success. He decided the aircraft could not be controlled and commanded a bailout. Both crewmembers ejected successfully, but the aircraft was destroyed upon impact.

32.2.1. **Unknown Factor.** For an undetermined reason, the aircraft pitch trim actuator was positioned to the full nose-down position. An electrical short in the control stick trim circuit, a stuck trim button, or an inadvertent pilot input may have induced the full nose-down trim position.

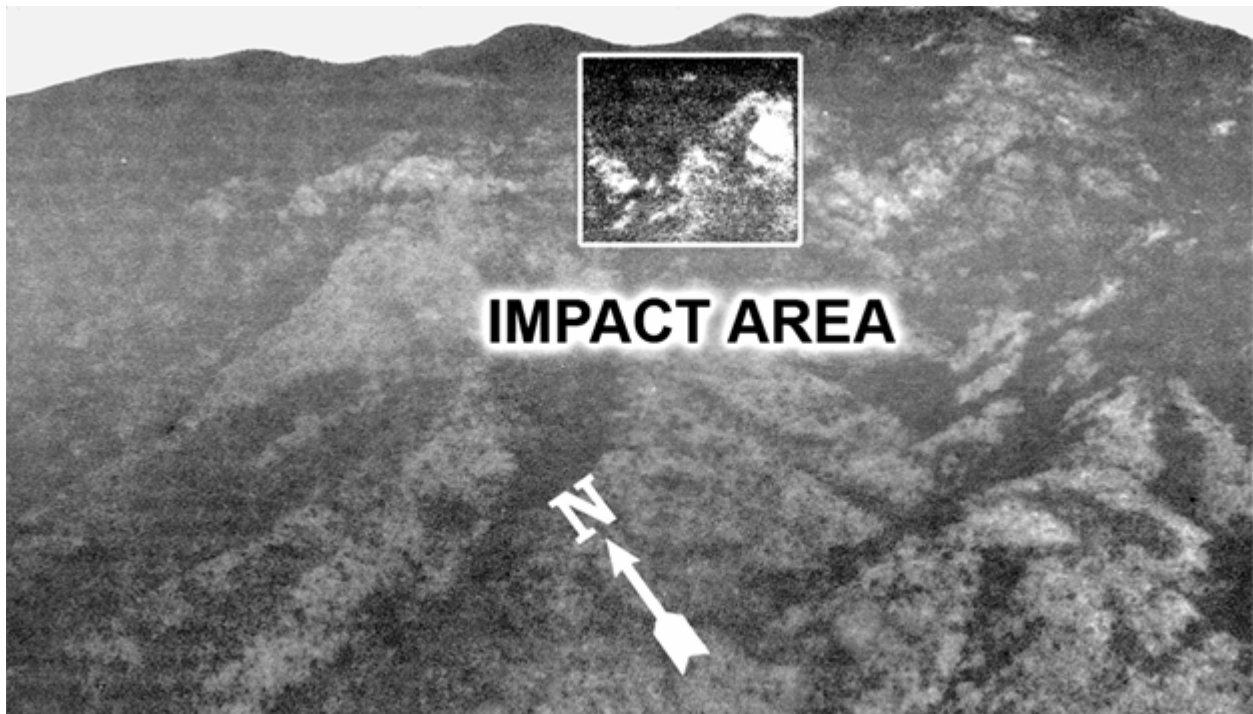
Figure 36. Ground Collision – Low Level.

33.1. **Mishap.** **Figure 36.** The mission was a dual, low-level student training sortie flown in the local area. The aircrew departed VFR to the entry point and then obtained an instrument flight rules (IFR) clearance to fly the low-level route in accordance with local filing procedures. The aircraft impacted the ground between points B and C of the low level route. Neither crewmember attempted to eject and both were fatally injured. The aircraft impacted the ground and was destroyed.

33.2.1. Supervisor Factor. Command directives did not provide adequate guidance for accomplishing route aborts when encountering IMC on low level navigation sorties.

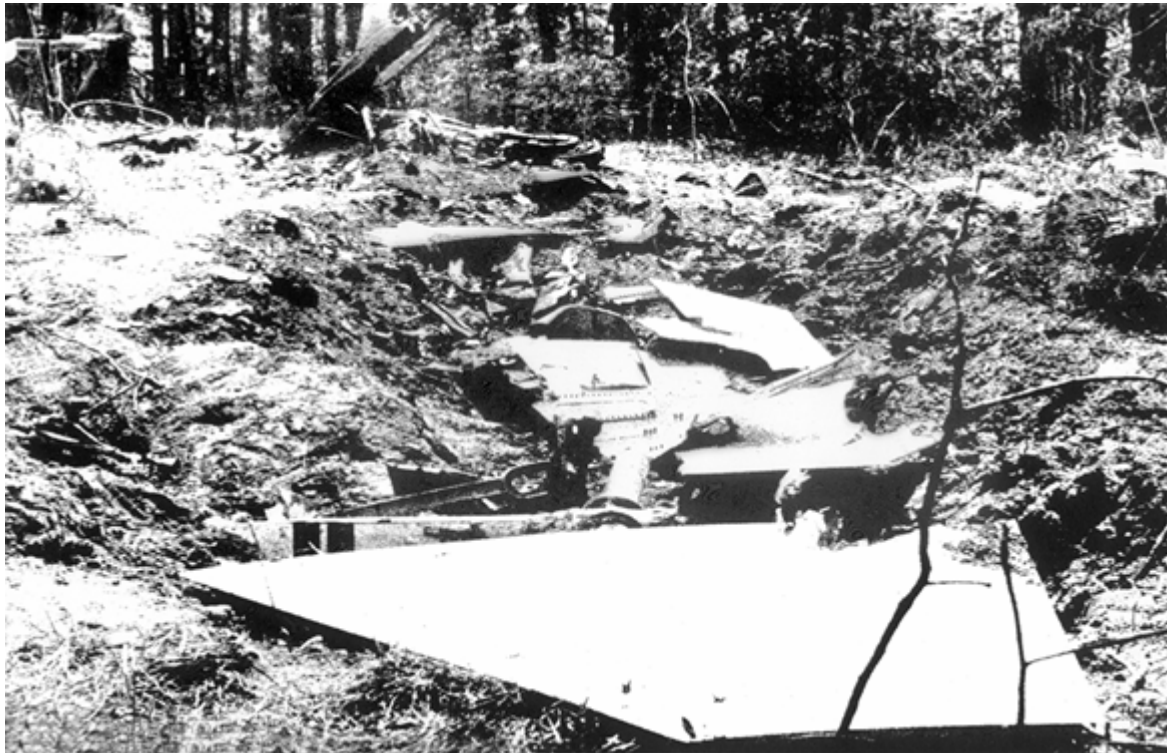
Figure 39. Midair Collision – Breakout.

36.1. **Mishap. Figure 39.** The mishap mission was an IP formation continuation training (CT) sortie. The flight was performing an extended-trail, lazy-eight maneuver. The wingman was on lead's right side as the formation descended to enter the maneuver. During the descent to the start of the pull-up, the wingman crossed behind lead to the left side. Lead pulled up into the nose high portion of the lazy eight and then began to roll left. On the inside of the turn, the wingman closed to what he estimated to be 1,000 feet and just aft of line abreast. Because he felt he was too far forward, constituting a hazard to the flight, he called "breaking out." Both crews lost sight of each other during the breakout and collided. All four crewmembers ejected successfully, but both aircraft were destroyed.

36.2.1. **Supervisory Factor.** The flight briefing did not adequately cover overshoot or breakout procedures from trail formation.

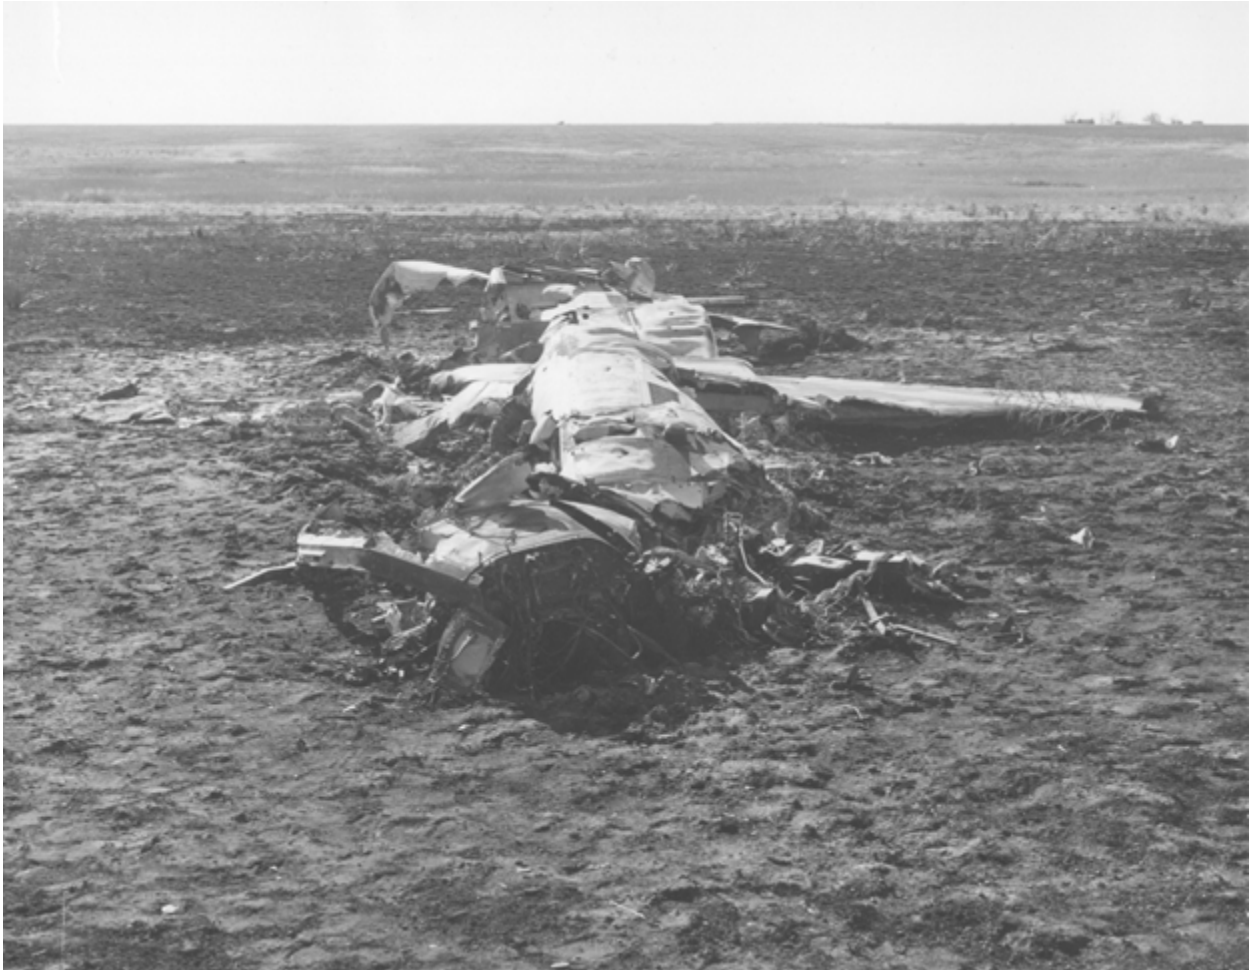
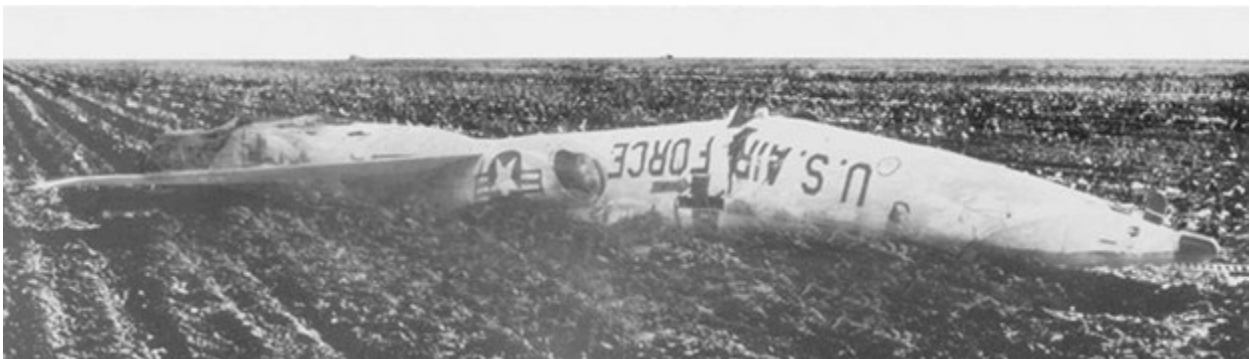
Figure 40. Midair Collision – Four-Ship Rejoin.

37.1. **Mishap. Figure 40 and Figure 41.** The mishap mission was a four-ship formation training sortie. All aircraft were dual with IPs in the RCPs. Takeoff, departure, and area entry were uneventful. During the profile, the flight executed a pitchout for a left turning rejoin at 24,000 feet MSL. Lead was at 45 degrees of bank for the rejoin IAW the brief. Number 2 rejoined uneventfully to lead's left side. Numbers 3 and 4 were aft of the normal rejoin line, placing the lead element in the sun. Number 4 IP, who was flying the aircraft, lost sight of the lead element and asked the SP if he had them in sight. The SP said he did. Number 4 IP had sight of Number 3 and continued his rejoin. Number 3 crossed behind the lead element to the outside of the turn in a slight overshoot. Lead watched Number 4 stagnate momentarily on the inside of the turn and then cross under. Lead looked to the other side of the aircraft where he expected Number 4 to appear. In the meantime, Number 4 had moved behind Number 2 and continued forward and up, striking Number 2 in the left aft section. Both aircraft sustained extensive damage. Number 4 SP was fatally injured in the collision. Number 4 IP suffered severe back injuries, but was able to eject. Both crewmembers in the

Number 2 aircraft were able to eject without injury. Both aircraft were destroyed upon ground impact.

37.2.1. **Supervisory Factor.** Operational guidance was inadequate and implied element rejoins at altitude were permitted.

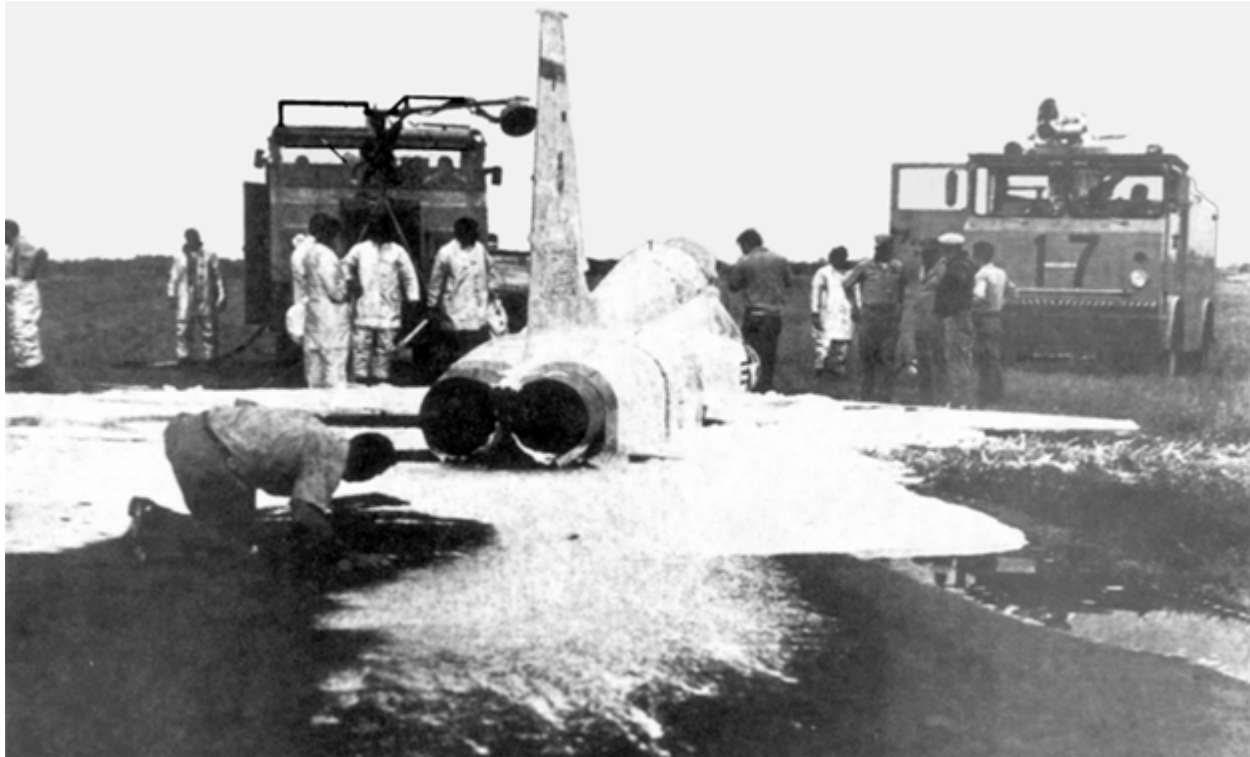
Figure 45. Gear Up Landing.

41.1. **Mishap. Figure 45.** The mission was a solo contact flight. The SP accomplished area work and returned to the traffic pattern to practice normal patterns. He accomplished three normal patterns, but then had to divert when the only usable runway was closed due to a barrier engagement. (Another solo student inadvertently landed no flap.) The SP received clearance from RAPCON and proceeded to the alternate base along with two dual T-38s. He arrived with minimum fuel and was given landing priority. Approach control vectored the SP to final approach, told him to perform his landing check, and released him for a VFR landing. He touched down 2,000 feet past the approach end with the landing gear retracted. The aircraft skidded approximately 4,000 feet before stopping. The SP egressed the aircraft without injury.

41.2.1. **Supervisory Factor.** The senior RSU controller did not maintain control of traffic during an upgrade and allowed an SP to land no flap and engage the barrier, closing the runway.

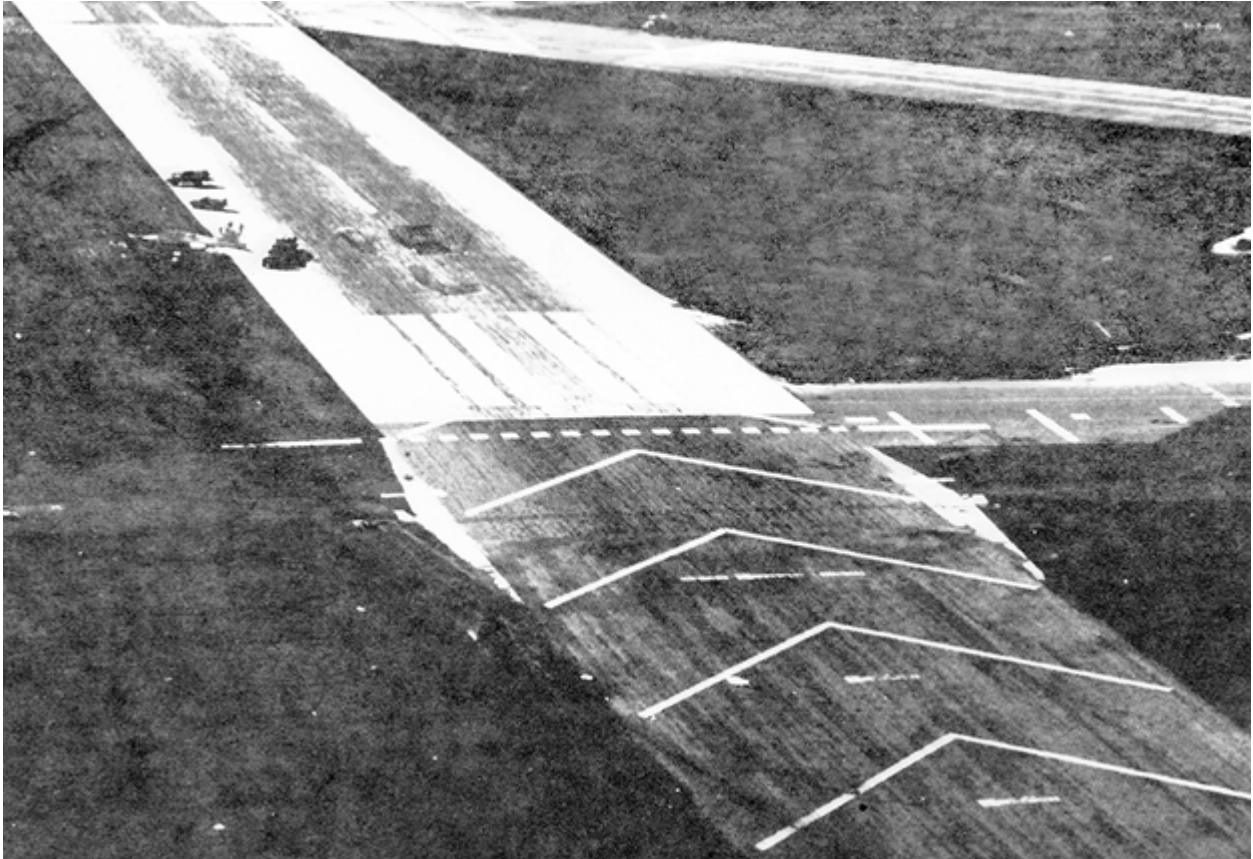
Figure 49. Final Approach Crash – Traffic Conflict.

45.1. **Mishap. Figure 49.** This mishap occurred because of a traffic pattern conflict between two T-38s during final approach and landing. Both aircraft were SP solos. The mishap aircraft was Number 2 in a four-ship formation and had rolled out on final from an overhead pattern when another aircraft passed it on an emergency straight-in approach. The emergency aircraft continued to an uneventful landing. The mishap aircraft attempted a go-around, but apparently encountered wake turbulence and impacted the runway overrun. Although the aircraft was destroyed, the SP egressed with only minor injuries.

45.2.1. **Supervisory Factor.** The RSU controller did not take positive action to prevent a dangerous conflict between aircraft in the traffic pattern. Although the straight-in aircraft made an inaccurate position report that detracted slightly from the controller's situational awareness, the RSU still had sufficient visual cues to see the conflict developing.

45.2.2. **Operator Factor.** The mishap SP failed to clear properly.
