**AIR EDUCATION AND TRAINING
COMMAND HANDBOOK 11-210**

04 FEBRUARY 2020

Flying Operations

ROAD TO WINGS

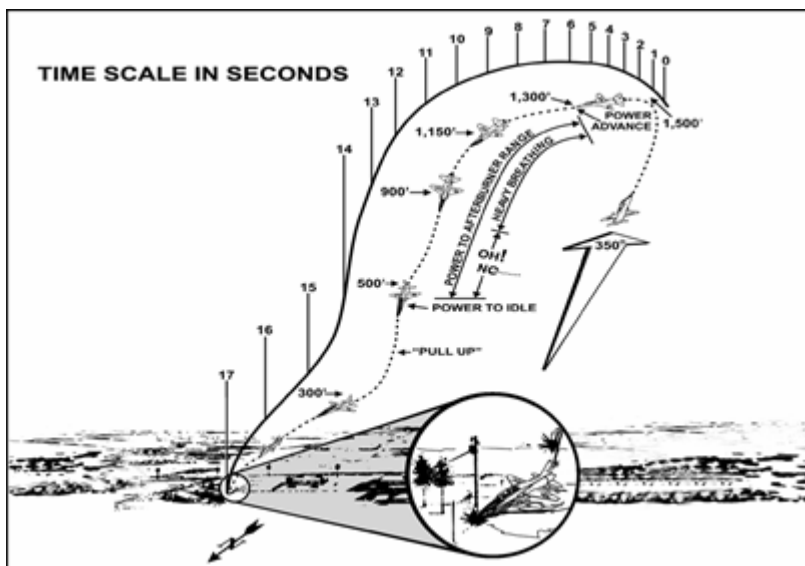
Figure 50. Stall – Final Turn.

46.1. **Mishap.** **Figure 50.** The SP completed a normal takeoff and departure for a contact mission. He reported an 8-mile initial approximately 35 minutes later. He pitched out and configured normally, made his gear down call, and began the final turn. He initially rolled to 30 to 35 degrees of bank, but slowly increased the bank to approximately 60 degrees. The aircraft pitched down to an extremely nose low attitude, and the aircraft continued rolling through inverted back to nearly wings level. The aircraft nose came up slightly, but the aircraft continued its rapid rate of descent. The aircraft impacted the ground 30 degrees nose low and with 8 degrees of left bank. The SP was fatally injured, and the aircraft was destroyed.

46.2.1. **Operator Factor.** The SP stalled the aircraft in the final turn and was unable to recover. Maintenance investigation determined the aircraft was functioning properly.

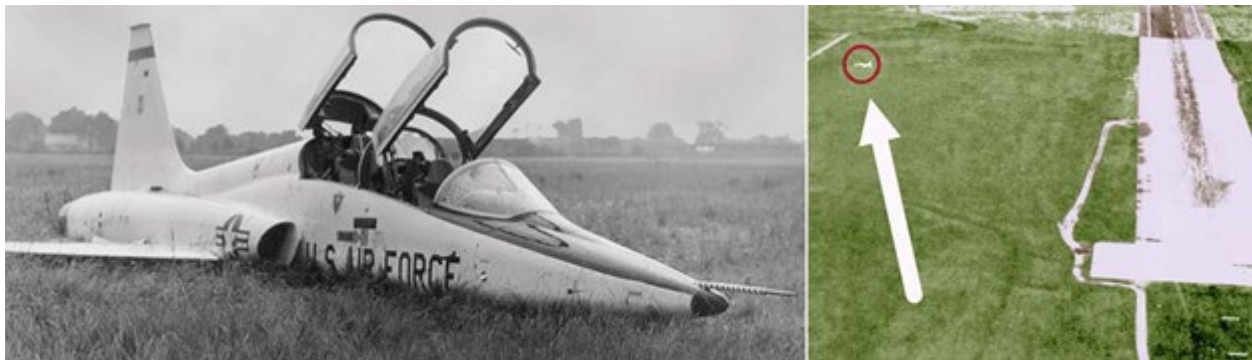
Figure 51. Short Landing – Wind Shear.

47.1. **Mishap. Figure 51.** This mishap occurred during landing at a cross-country airfield. The mishap aircraft was lead of a two-ship formation, which had split to perform individual instrument approaches. The mishap aircraft was directed to go around from its first approach because another aircraft was on the runway. Lead flew a closed pattern rather than another radar pattern due to rapidly approaching bad weather. The aircraft encountered a severe wind shear on final associated with the storm. The IP was unable to compensate; and the aircraft impacted short of the runway, sheared the gear, and skidded approximately 1,600 feet. The aircraft came to rest 700 feet left of the runway. Neither crewmember was injured.

47.2.1. **Operator Factor.** The pilot was advised of violent weather 3 NM west of his destination, but underestimated the potential impact on his recovery.

47.4.1. Modified the Instrument Refresher Course (IRC) to include information on gusts, wind shear, and other hazards associated with thunderstorms.

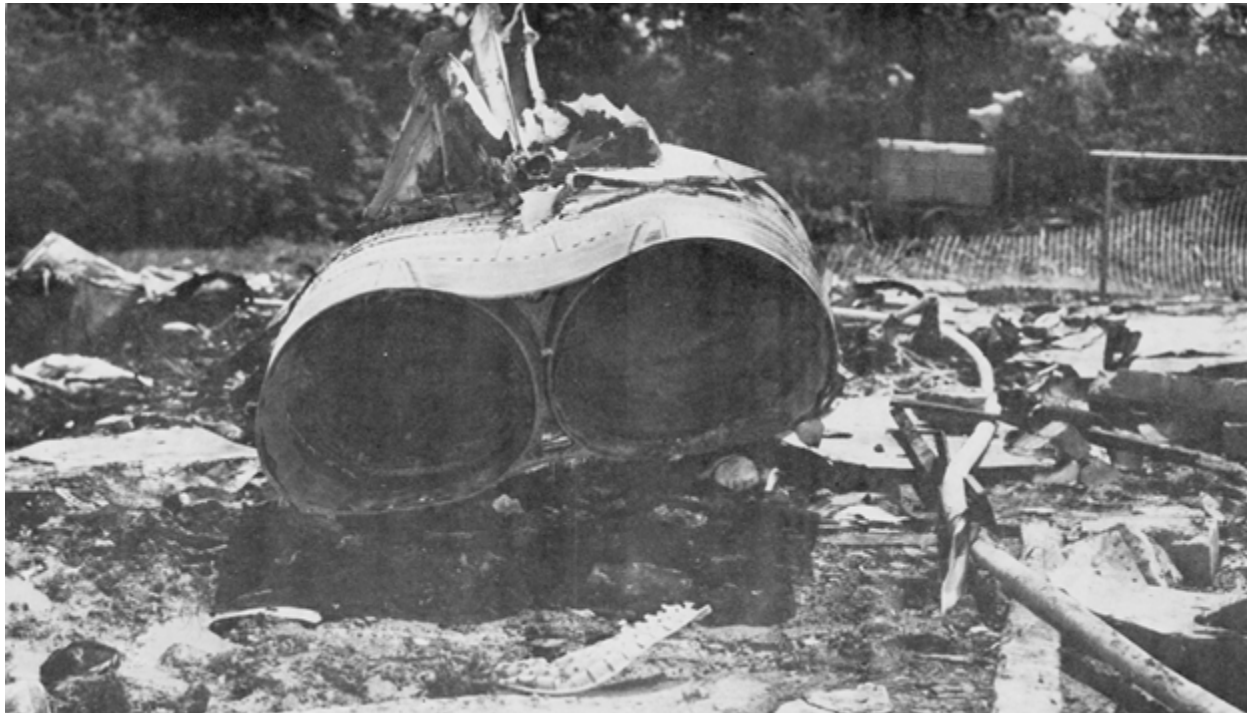
Figure 54. Final Approach Crash – Wake Turbulence.

50.1. **Mishap. Figure 54.** The mission was an instrument navigation check ride for the student. The aircraft crashed while going around on a TACAN final. Approach control had asked the aircrew to slow to final approach speed during the penetration because they were following a LOGAR L-382 (a civilian stretch C-130). The aircrew was also followed by a T-39 carrying a code 06 (very important person) and had discussed keeping their speed up on final to accommodate the T-39. The aircrew reported the FAF to the tower, who told them the L-382 was on short final. The tower then instructed them to go around due to insufficient spacing. (The L-382 was 1 1/2 to 2 NM in front, and the T-39 was 4 NM behind.) Just after the aircrew acknowledged the go-around instructions, the aircraft abruptly rolled left to 60 to 90 degrees bank, slightly nose low. It flew through several small trees 2 1/2 NM north of the runway approach end, struck a curb, became airborne again, and finally crashed into a brick home. The home was unoccupied at the time. Both crewmembers were fatally injured, and the aircraft was destroyed.

50.2.1. **Supervisory Factor.** The aircrew and air traffic controller had not been given sufficient information or guidance concerning the severity of “heavy” aircraft wake turbulence.

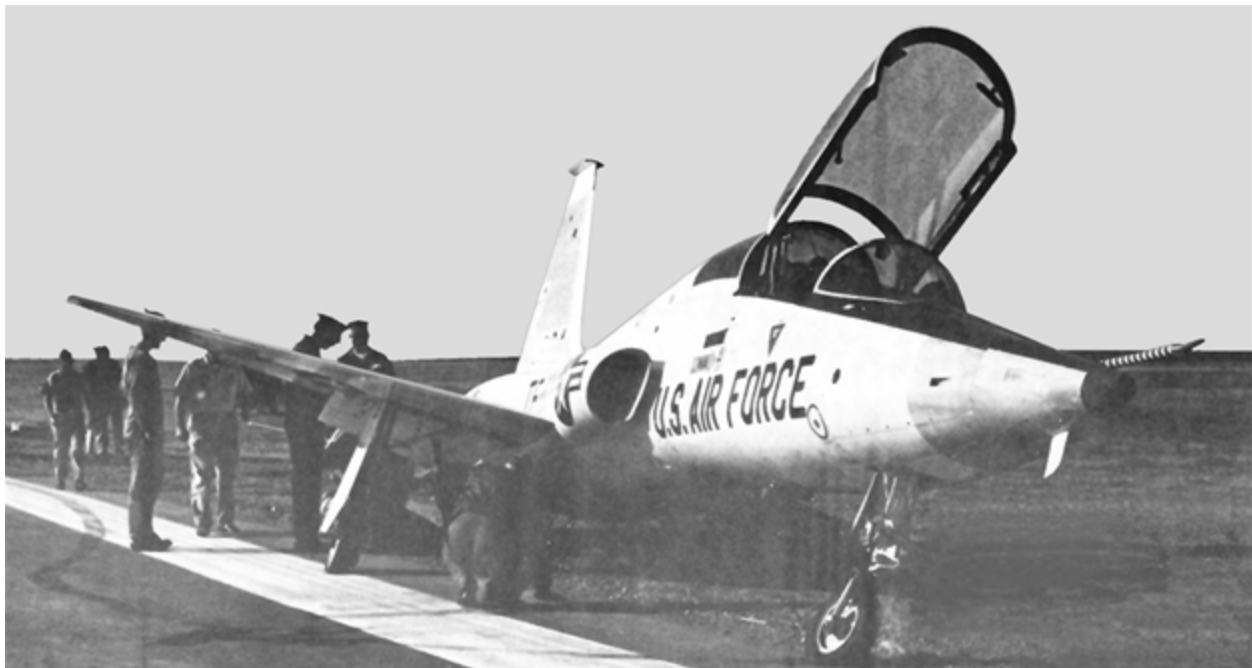
Figure 56. Runway Departure – Brake Malfunction.

52.1. **Mishap.** **Figure 56.** The flight was the first sortie of a solo student out-and-back navigation mission. The SP lost aircraft control while braking during a landing at the non-Air Force out base. The left main landing gear departed the left side of the runway and struck an exposed concrete lighting pad, destroying the left main gear and substantially damaging the left wing and horizontal stabilizer. The aircraft came to rest on a taxiway at the departure end of the runway, and the SP egressed without injury.

52.2.1. Maintenance Factor. Maintenance personnel had not properly corrected a previously identified defective brake. The defect created a differential braking action, causing the aircraft to drift left as the SP applied the brakes.

52.2.2. **Operator Factor.** The SP failed to use the remaining brake, rudder, and/or nose wheel steering to remain on the runway.

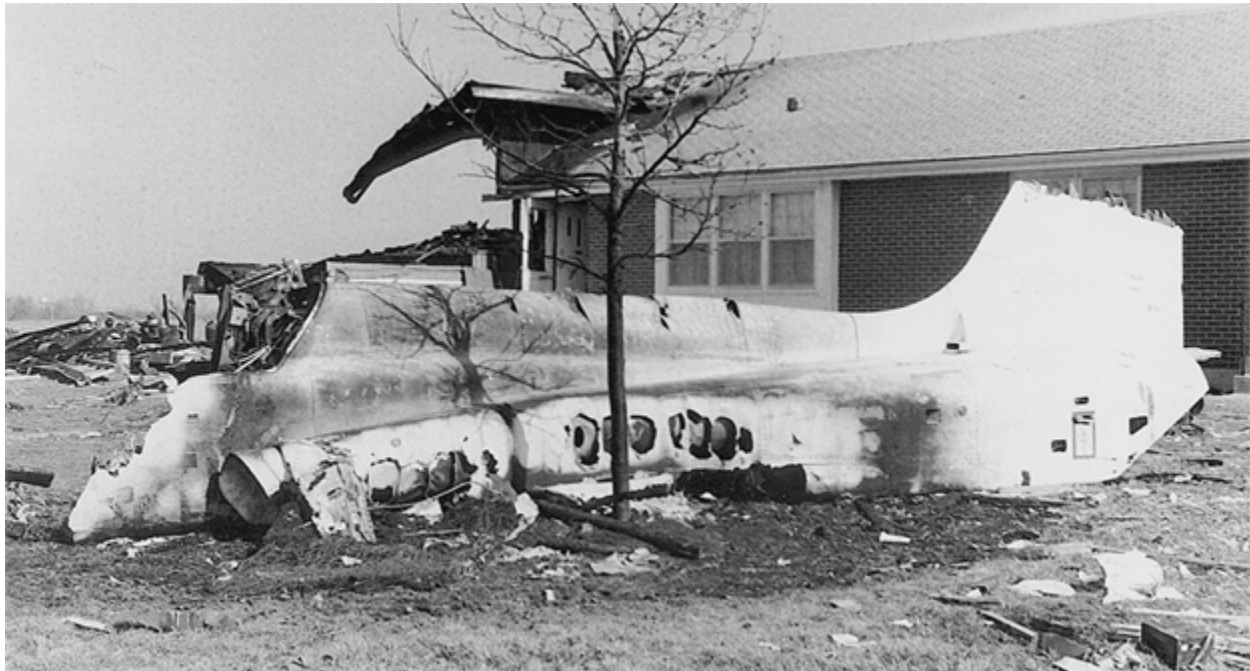
Figure 57. Circling Approach.

53.1. **Mishap. Figure 57.** The mission was a day dual out-and-back navigation training sortie. The SP needed a circling approach to complete syllabus training requirements. The flight proceeded normally until the approach at the destination base. The crew requested a TACAN to circle for an opposite direction low approach, followed by radar vectors to initial. The SP flew the TACAN final approach to the north and then circled to the east. The aircraft crashed in the final turn, impacting an open field approximately 1 1/4 miles from the runway approach end and 350 feet right (west) of the runway extended centerline. The aircraft slid another 650 feet after impact and struck a residential home. Neither crew member attempted to eject and both were fatally injured. The aircraft was destroyed upon impact.

53.2.1. **Supervisory Factor.** The IP had never flown a circling approach in the T-38 as a rated crewmember. Circling approaches were not a required maneuver during local upgrade training or on standardization evaluations.

53.2.2. **Operator Factor.** The aircrew used inadequate downwind displacement, exceeded bank angle limits, and descended below the circling minimum descent altitude (MDA) with a high sink rate, which neither recognized.

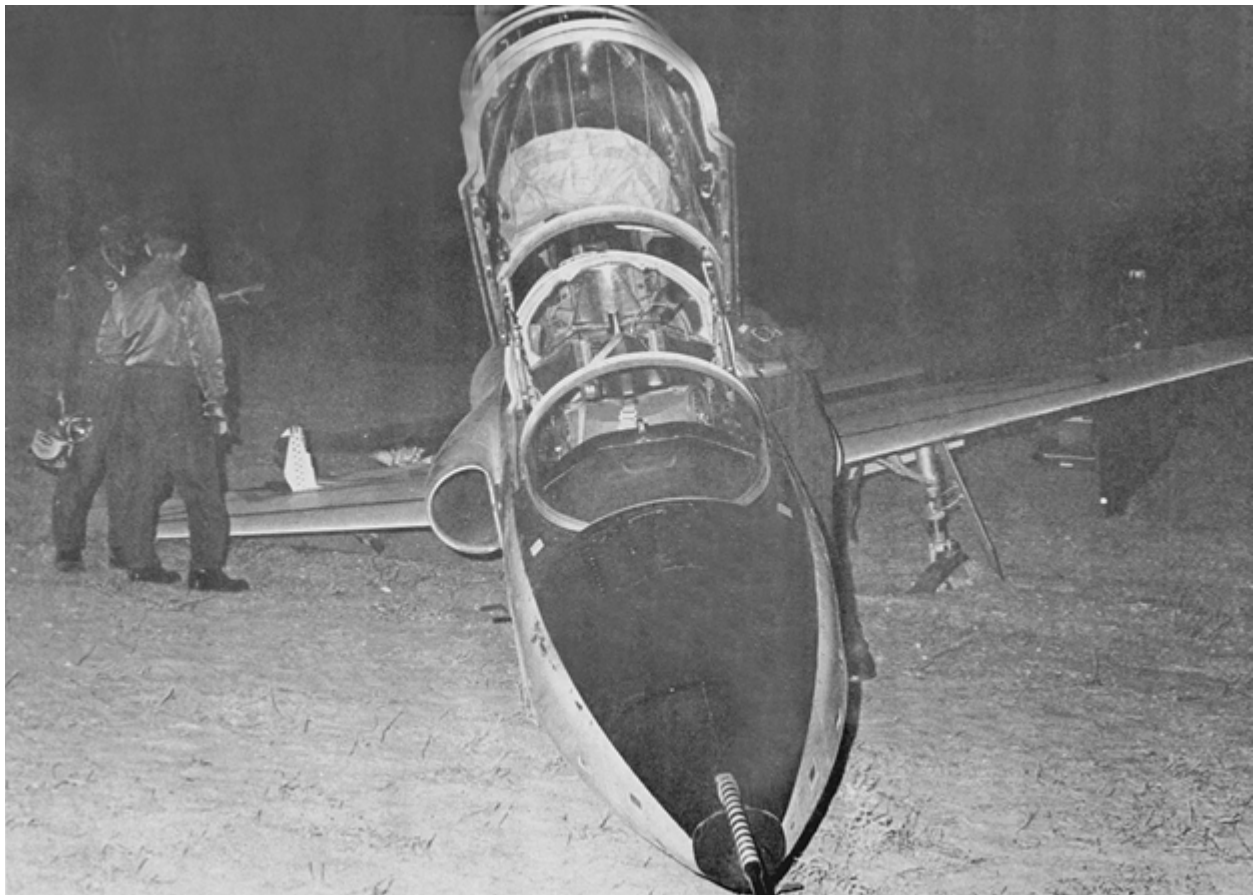
Figure 58. Circling Approach.

54.1. **Mishap. Figure 58.** The flight was the first sortie of a dual student overnight cross-country training mission. The SP executed a high altitude penetration, ILS low approach, missed approach, and practice no-gyro ASR approach at the first cross-country base. The IP (in the RCP) assumed control of the aircraft to demonstrate a circling approach to a full-stop

landing. The IP rolled out on a half to three-quarter mile final at 600 to 800 feet AGL. He was steep with a higher-than-normal rate of descent. He pulled back on the stick and added power just before touchdown in an effort to reduce the rate of descent and extend the touchdown point. It was not enough, however, and the nose gear and right main gear failed upon runway contact. The left main gear remained extended, and the aircraft skidded approximately 1,500 feet on the left gear, nose section, and right wingtip before departing the left side of the runway. The aircraft skidded an additional 400 feet after departing the runway. Both crewmembers egressed without injury, but the aircraft sustained substantial damage.

54.2.1. **Operator Factor.** The IP flew a poor circling approach, resulting in an excessively steep final. He failed to recognize the approach was unsafe and landed with an extremely high rate of descent.

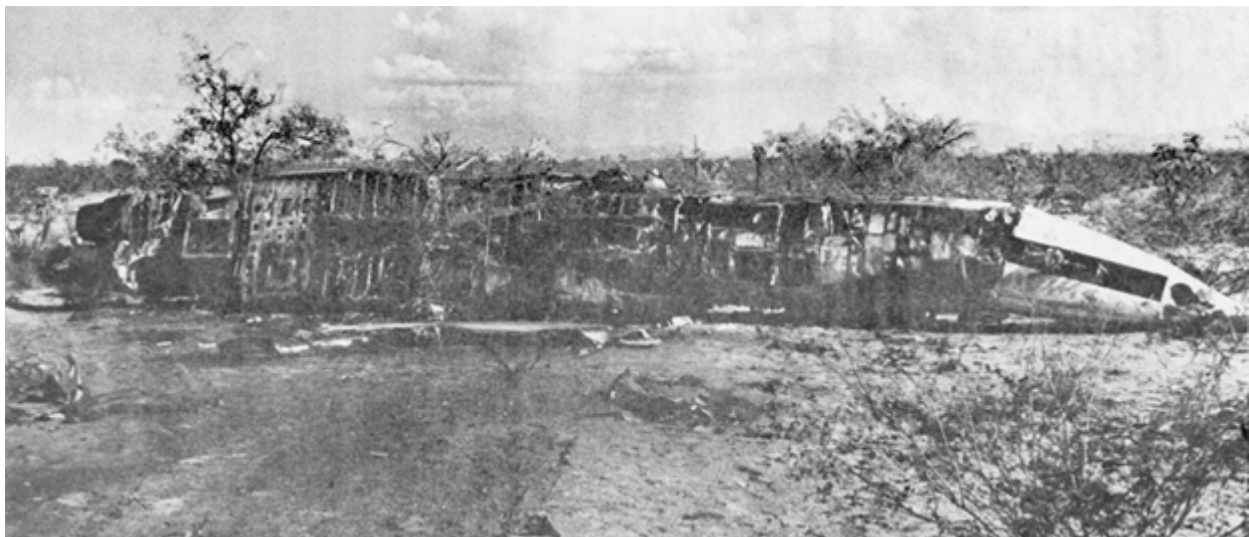
Figure 59. Instrument Approach.

55.1. **Mishap. Figure 59.** The mishap aircraft was on an instrument proficiency flight for two IPs with approaches at an enroute field. Air traffic control cleared the crew for a TACAN penetration and approach at the initial approach fix. Weather was VMC with 7 statute miles (SM) visibility. The RCP pilot flew the penetration and was 2,000 feet high at the FAF. He initiated a steep descent to get to the MDA, but overshot the level off and descended rapidly through the MDA about 2 NM from the approach end. The FCP pilot took control of the aircraft and selected maximum afterburner on both engines. However, the aircraft continued its descent and touched down 500 feet short and 1,400 feet to the right of the runway. The aircraft skidded for approximately 1,500 feet, struck a large area of vegetation and a flood control ditch, and finally came to rest. The aircraft was engulfed in flames. The RCP pilot egressed without assistance, but firefighters had to extract the FCP pilot, who was unconscious. Both pilots received major injuries, and the aircraft was destroyed.

55.2.1. **Operator Factor.** The RCP pilot flew a TACAN penetration and was 2,000 feet above the minimum FAF altitude. He flew an excessively steep final to get down to the MDA by the missed approach point, but did not use enough power at level off to stop the high sink rate and descended below the MDA.

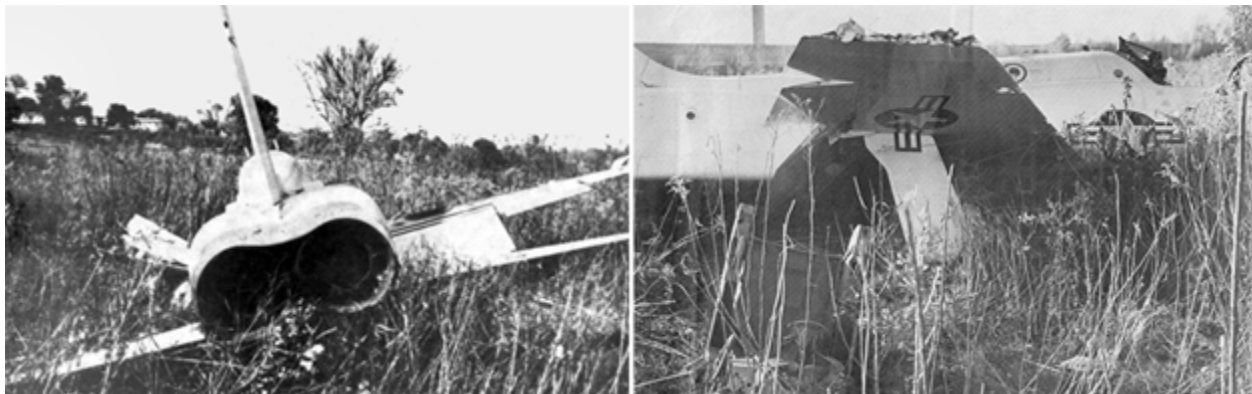
Figure 60. Runway Departure – Crosswind.

56.1. **Mishap. Figure 60.** The mission was an accelerated copilot enrichment (ACE) team sortie. The flight was uneventful until the crew returned to base for an overhead pattern for a full-stop landing. The crosswind component at the time of landing was 12 to 23 knots from the right. The aircraft touched down about 500 feet down the runway in the center. It shortly became airborne again, in left bank. As it departed the left side of the runway, the left wing struck a 3-foot-high snow fence that was 150 feet from the runway edge. The aircraft bank increased to 50 degrees, and the left wing struck the ground. The aircraft rolled back to the right, and all three landing gear impacted the ground. The RCP pilot ejected successfully. The aircraft continued forward on the ground, crashed through another snow fence, crossed a closed runway, and became airborne once more at the edge of a bluff. The FCP pilot ejected as the aircraft became airborne. Although the seat separated from the aircraft, the pilot did not get a full parachute before landing and was fatally injured upon impact. The aircraft continued another 836 feet before impacting an unprepared field 45 feet below the top of the bluff.

56.2.1. **Operator Factor.** Both pilots failed to adequately plan for the gusty crosswinds. The RCP pilot indicated they had computed the correct airspeed to include a gust factor, but the airspeed reference markers were both set at the basic approach airspeed. The mishap pilot failed to use prescribed crosswind landing procedures. (Proper procedures are to crab for landing, land on the upwind side, and perform no aerobrake.) He landed without a crab in the center of the runway and performed a normal aerobrake, causing the aircraft to drift and become airborne. The pilot overcontrolled during the go-around and inadvertently stalled the aircraft.

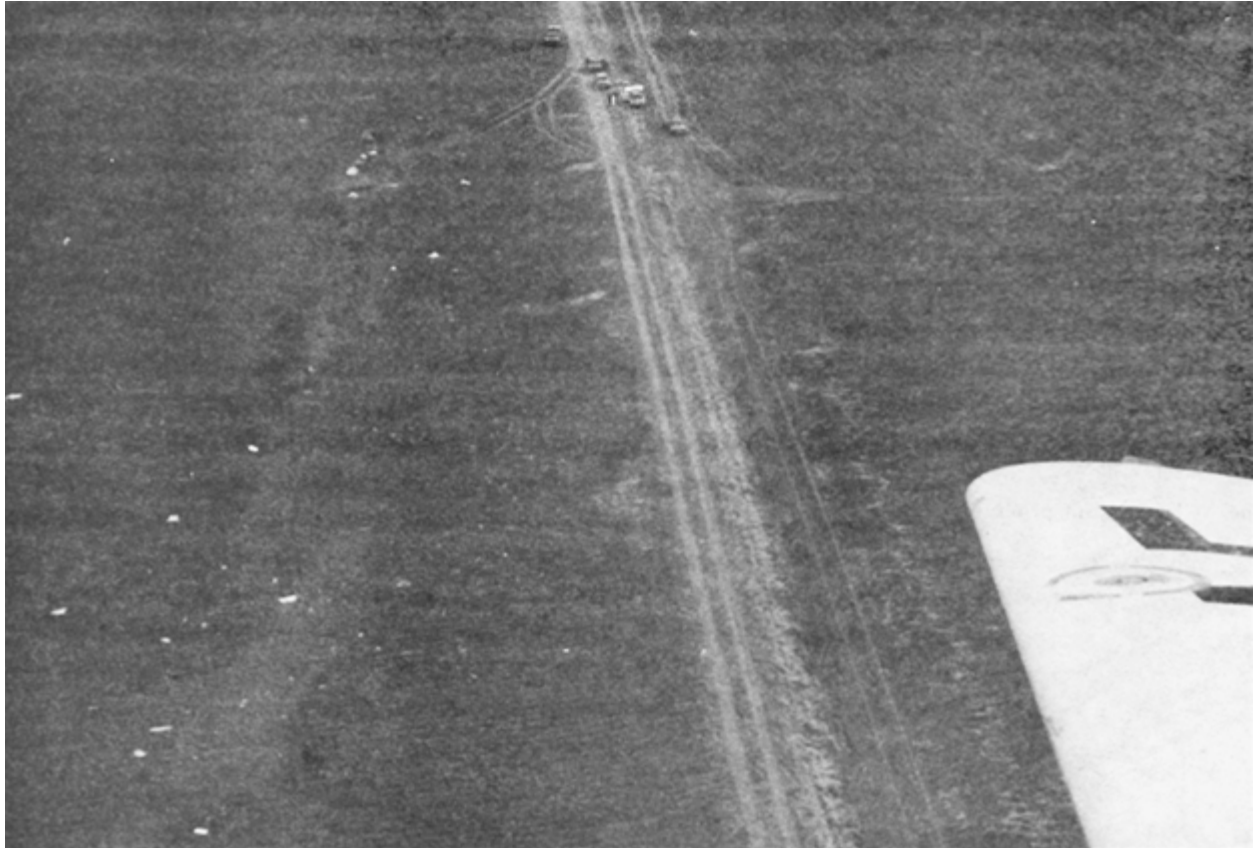
Figure 61. Stall – Final Turn.

57.1. **Mishap. Figure 61.** The SP was on his second solo contact sortie. Departure and area work were uneventful. The SP was on his third traffic pattern when he overshot final. The RSU controller advised the SP that there was no conflict with traffic on the center parallel runway. The SP acknowledged and indicated he was going around. He increased his bank to about 60 degrees and inadvertently developed a high sink rate. The RSU controller noted the descent and told the SP to use his afterburners. Just moments later, the aircraft impacted the ground and was totally destroyed. The student made no attempt to eject and was fatally injured.

57.2.1. Operator Factor. The SP configured the aircraft with landing gear, but failed to lower the flaps. He initiated his turn to final, using normal full-flap airspeeds. As he increased bank during the ensuing overshoot, the aircraft developed a high sink rate. The RSU controller directed the student to use afterburners, but the student had insufficient altitude to recover.

57.3.1. The SP probably failed to lower his flaps due to inattention and/or distraction. Habit patterns are fragile things, so plan for disruption or distraction. That is, develop habit patterns that can withstand interruption. The gear check has been mentioned before. Check its configuration at the perch, in the final turn, and rolling out on final. It is unlikely you will miss all three.

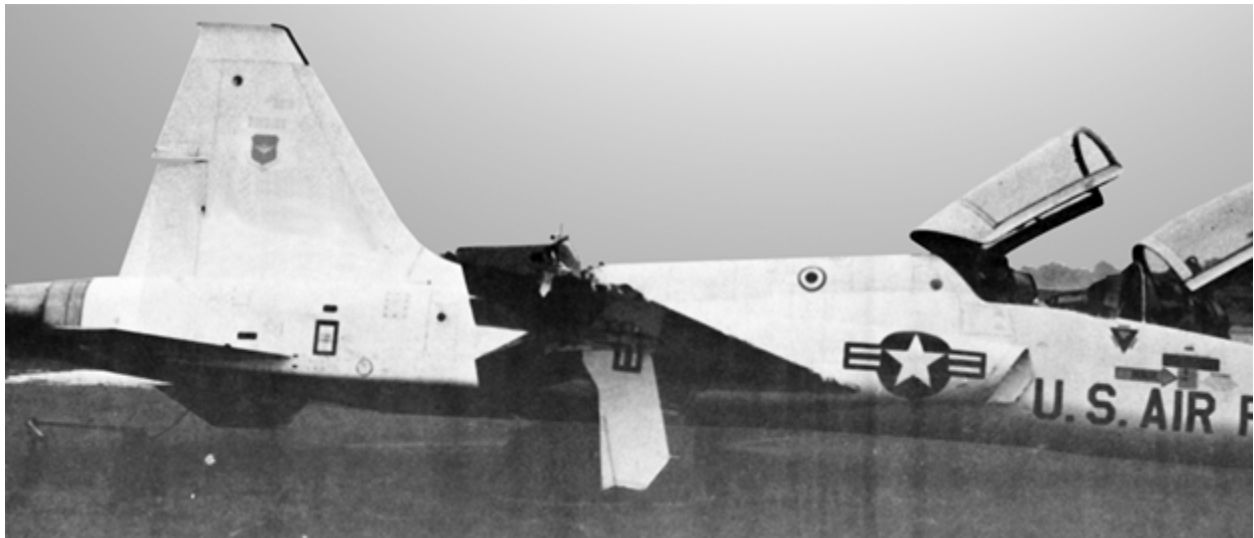
Figure 62. Circling Approach.

58.1. **Mishap. Figure 62.** The mission was a dual contact sortie with touch-and-go landings at an alternate base. The SP became confused by tower instructions on TACAN final and started a go-around at about 90 feet AGL. The IP took control and tried to salvage the approach. He got into a high sink rate, and the aircraft landed hard about 130 feet past the runway threshold. The aircraft sustained substantial damage from the impact and came to rest approximately 3,000 feet from the threshold and 160 feet right of the runway. The crew egressed after the aircraft came to a stop. The IP sustained major back injuries, but the student was uninjured.

58.2.1. **Supervisory Factor.** The IP assumed aircraft control in the overrun to salvage the approach. He lowered the nose to establish a visual glide path and developed an excessive rate of descent. He did not recognize the developing hazard and continued the approach to impact.

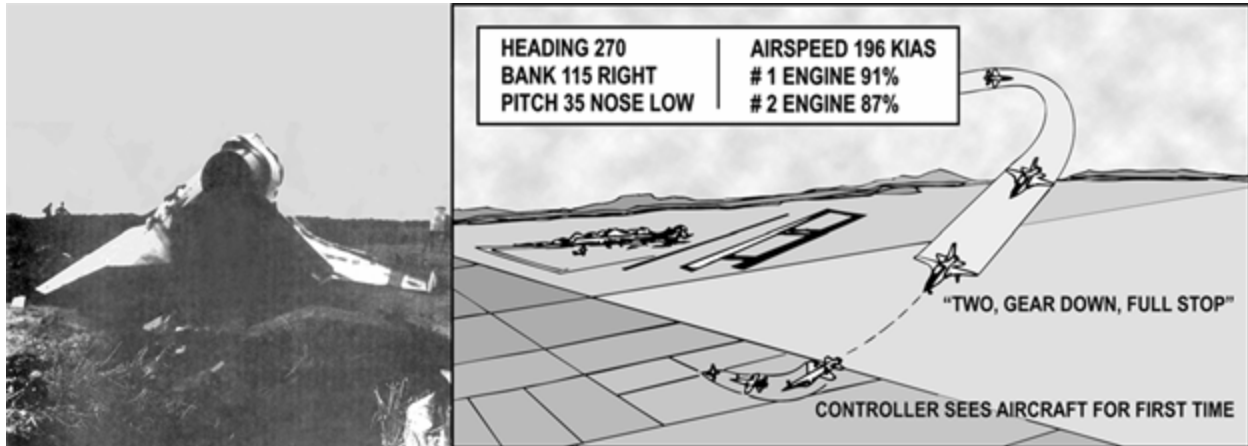
Figure 63. Stall – Final Turn.

59.1. **Mishap. Figure 63.** The mishap aircraft was on a solo two-ship training mission. Departure and area work were uneventful, and the flight was back in the pattern for landing. The SP pitched out normally and called, “gear down, full stop.” The aircraft impacted the

ground approximately three-quarters through the final turn. The SP did not eject and was fatally injured.

59.2.1. **Operator Factor.** The SP approached a stall or developed a sink rate shortly after beginning the final turn. He failed to recognize the impending stall or sink and did not initiate a stall recovery. He may have been slow to react due to fatigue. The investigation revealed a lack of sleep and high activity in the 3 days prior to the mishap, compounded by hot weather.

59.4.1. Added guidance on the effects of fatigue, stress, and improper nutrition.

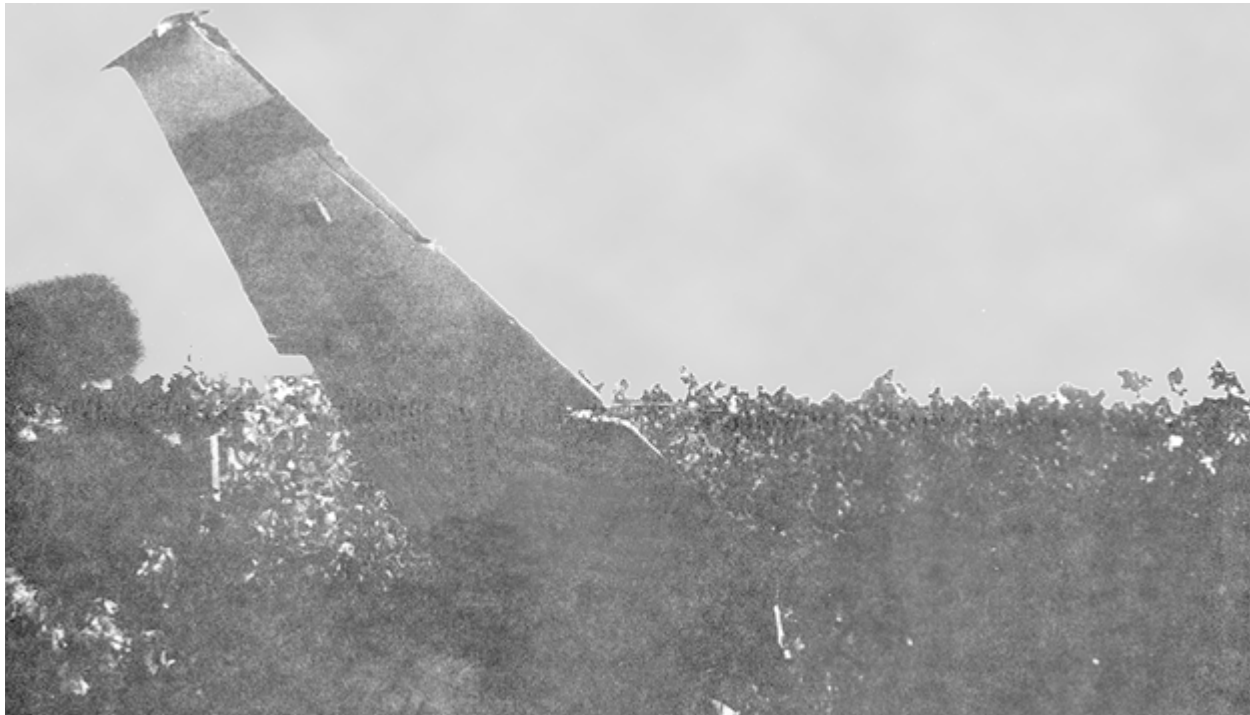
Figure 64. Stall – Final Turn.

60.1. **Mishap.** [Figure 64](#). The mishap aircraft was lead in a two-ship formation sortie. The mission was uneventful until returning to the traffic pattern. The aircraft impacted the ground during the final turn and was destroyed. Both crewmembers were fatally injured.

60.2.1. **Operator Factor.** The SP performed the pitchout and angled about 10 to 20 degrees into the runway, flying to an extremely tight inside downwind position. It is possible he mistook the center runway for the landing runway. At any rate, he was too close to fly a normal final turn and used excessive bank and back stick pressure to prevent an overshoot. He failed to recognize the hazards associated with a high sink rate and impending stall and continued the turn until the IP took the aircraft.

60.2.2. **Supervisory Factor.** The IP was likely complacent or not paying attention and allowed the SP to begin the final turn. (The SP had over 4,000 flight hours.) The IP failed to recognize the excessive sink rate and impending stall until it was too late. When the IP finally took control of the aircraft, he executed a go-around instead of a traffic pattern stall recovery. The aircraft entered a full stall with insufficient altitude to recover. Both pilots ejected out of the safe ejection envelope and were fatally injured.

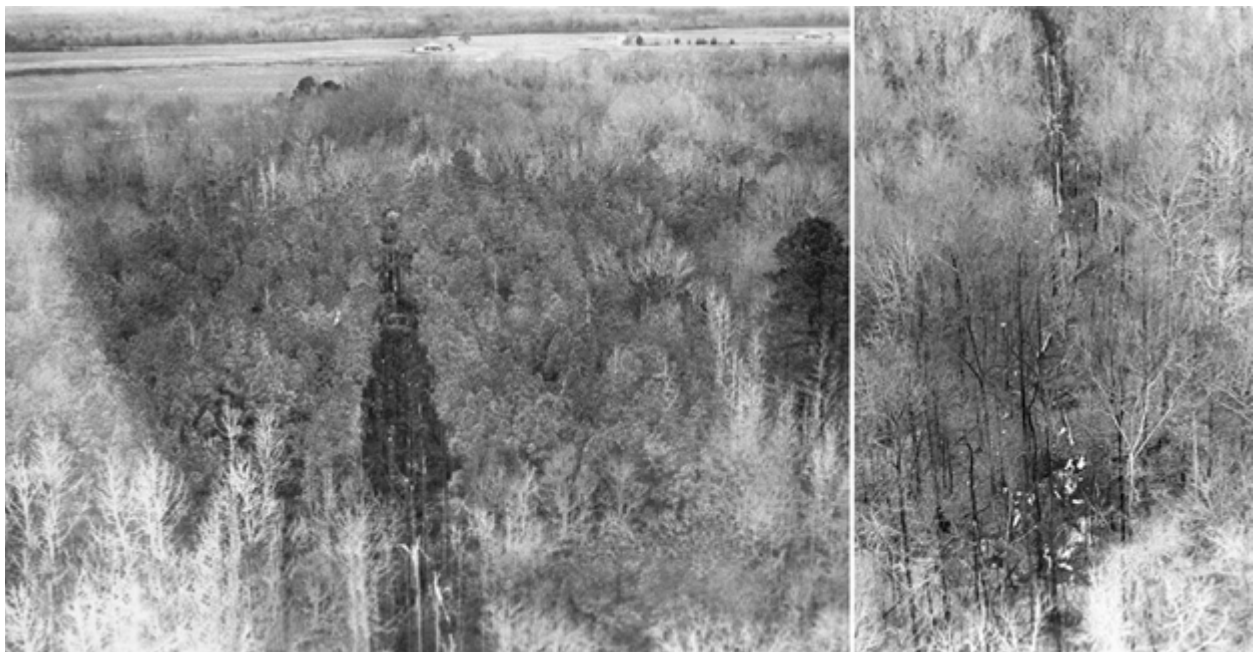
Figure 66. Stall – Final Turn.

62.1. **Mishap. Figure 66.** The mission was a solo contact training sortie. The mishap aircraft reported initial, pitched out, and reported gear down uneventfully. The RSU noticed a problem approximately 12 seconds later and transmitted, “Final turn, monitor altitude, (pause) final turn, go around, use burners.” The mishap aircraft went below the tree line seconds later and impacted the ground. The SP was fatally injured

62.2.1. **Operator Factor.** The SP allowed the aircraft to enter a high sink rate during the final turn.

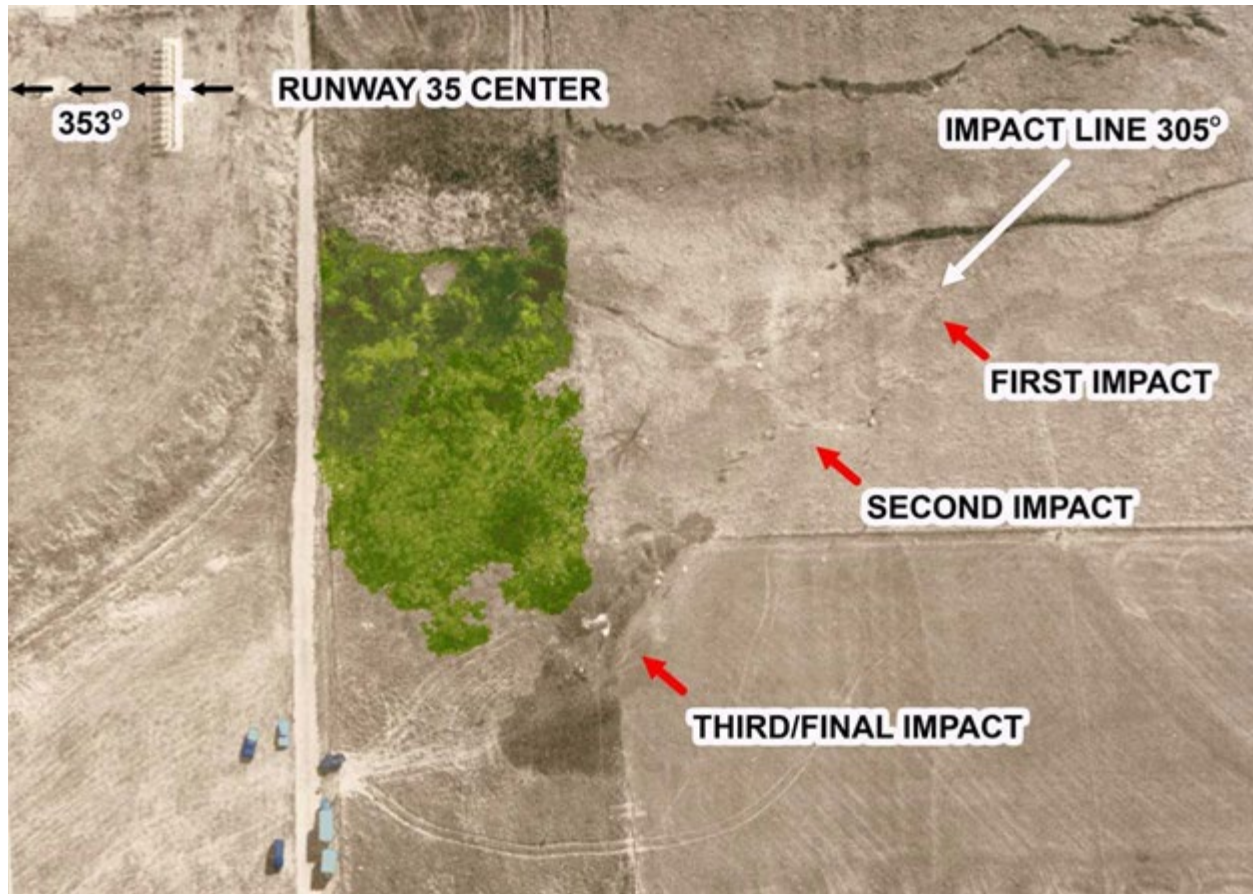
Figure 67. Circling Approach.

63.1. **Mishap. Figure 67.** The mishap occurred on the final leg of a 3-day cross country. This sortie was the second of the day (the sixth overall) and was uneventful from takeoff to arrival at the home airfield. The SP was in the RCP for syllabus-directed instrument training. The SP flew two ILS approaches before the IP executed a closed pattern. The IP ended up on downwind between the circling MDA and the normal overhead pattern altitude. The IP configured the aircraft, using circling procedures and planning to full stop. The IP overshot final and was correcting to the runway when the aircraft impacted the ground. The aircraft was one-third of a mile short of the approach end on a 45-degree intercept heading. Both pilots were fatally injured, and the aircraft was destroyed.

63.2.1. **Operator Factor.** The IP had not performed a circling approach for approximately 5 months. He misjudged the base turn and overshot so far that he could not get back on runway centerline until he was inside one half mile to the threshold.

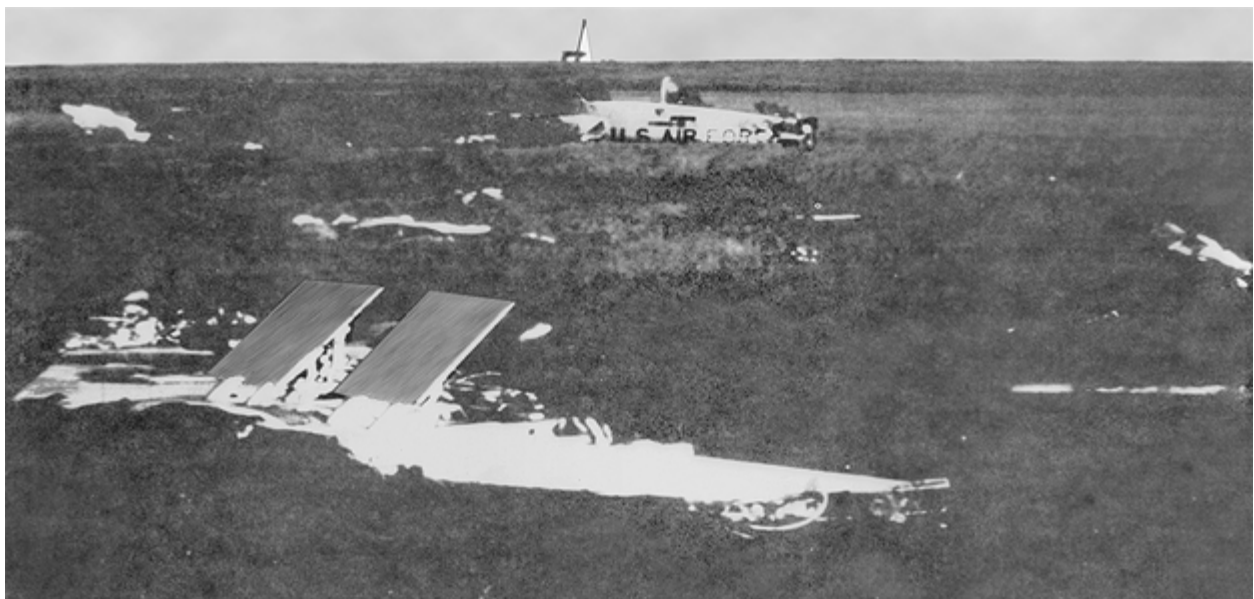
Figure 68. Stall – Touch and Go.

64.1. **Mishap. Figure 68.** The flight was a pre-solo contact review sortie. The crew returned to the overhead pattern after completing the area work. The SP flared high and pulled the throttles to idle on the first no-flap landing. The IP directed the student to add power, and the RSU controller transmitted “flare go-around” on the radio. The SP failed to add power as directed by the IP, and the aircraft started to wing rock. Just after the left wingtip contacted the runway, the RSU controller transmitted “go around, use burners,” and the IP assumed aircraft control. The aircraft departed the left side of the runway and went abruptly airborne in a very nose-high attitude. The SP perceived the aircraft would impact the ground and pulled both throttles to idle. The IP initiated ejection, but was fatally injured during the attempt. The SP did not eject and sustained major injuries that were not life-threatening.

64.2.1. **Operator Factor.** The SP flared high and pulled both throttles to idle during an attempted no-flap landing, placing the aircraft in a hazardous position. The SP was task saturated with the resultant wing rock and failed to respond to IP and RSU controller inputs.

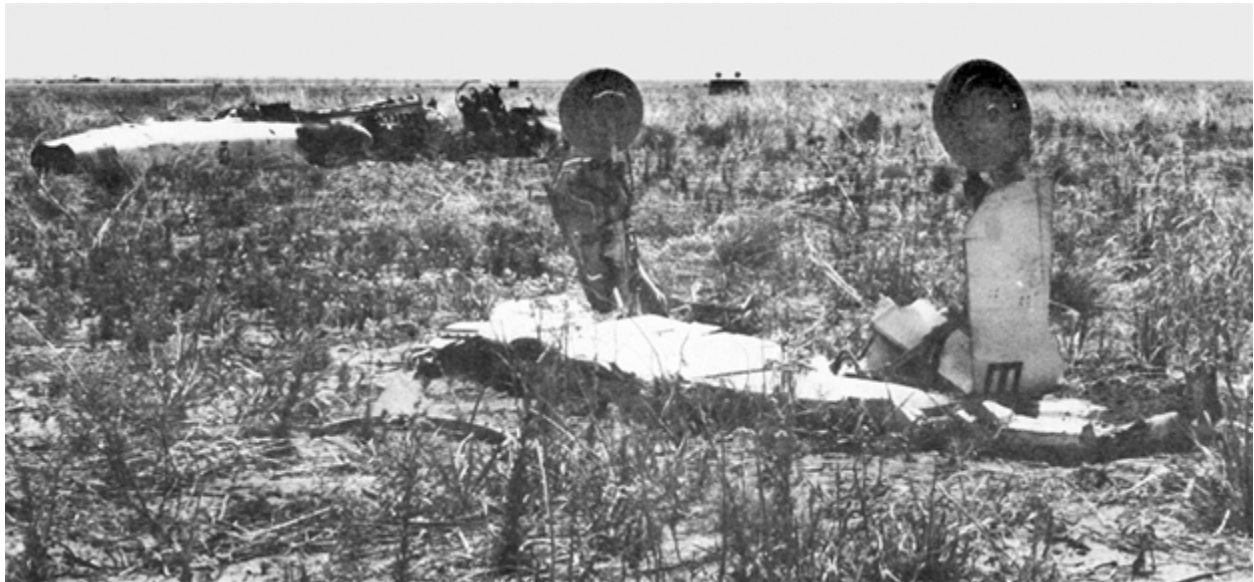
Figure 69. Final Approach Crash.

65.1. **Mishap. Figure 69.** The mission was an instrument qualification training sortie at a nearby out base for the pre-PIT SP in the back seat. This was the SP's second instrument sortie in the aircraft. The IP and SP were interrupted during their mission briefing due to a schedule change and departed the building without a complete briefing. The crew conducted several nonstandard procedures throughout the flight. At some point in the mission, the IP filled out the AFTO Form 781 with final landing and mission times. In addition, all of the IP's flight publications were found stored in the map case. Evidence implies the crew did not work jointly to accomplish the mission. The first penetration approach to an ILS final with missed approach was uneventful. There was some confusion on the second approach over whether the SP would fly an ILS or localizer approach. He began his descent to the MDA passing the FAF, but kept descending and crashed 2.2 NM short of the runway. The SP attempted to recover the aircraft before impact, but he was too low and slow to be successful. He ejected from the RCP as the aircraft rolled across the ground and began to break up, but was fatally injured in the attempt. The IP stayed with the aircraft and egressed after it came to rest.

65.2.1. **Operator Factor.** The IP was complacent and overestimated his abilities due to his extensive familiarity with the training environment. His inflated self-image also led to a disregard for established procedures.

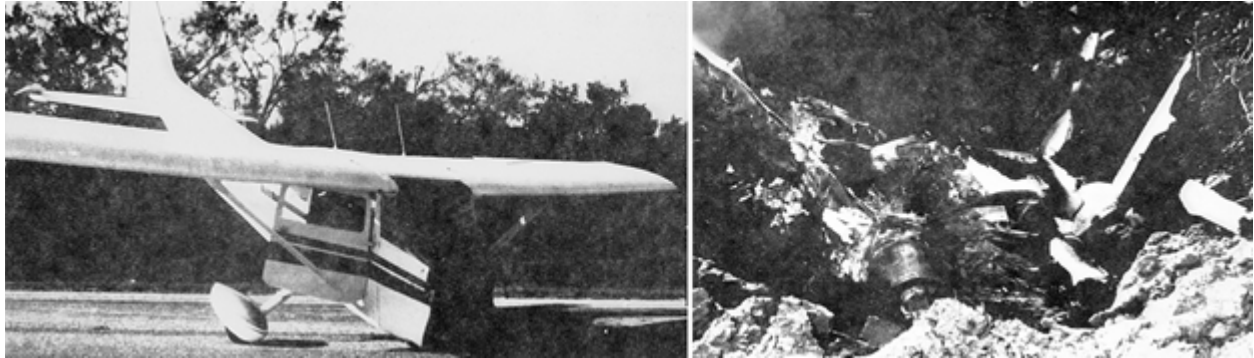
Figure 70. Instrument Approach.

66.1. **Mishap. Figure 70.** The mission was a navigation sortie on the last leg of a weekend cross country. The mishap crew departed from an out base and planned to drop in at a nearby field for an instrument approach. The SP was flying from the front seat to fulfill syllabus requirements. Air traffic control was providing radar vectors for the drop-in approach and initially directed the SP to climb to 5,000 feet. After handoff, the next controller directed a descent to 3,000 feet. Immediately after the SP leveled off and made his approach request, he collided with a civilian Cessna™ 172. (The SP had been airborne for about 6 minutes.) The Cessna™ had a civilian flight instructor and SP on board and had taken off approximately 18

minutes prior to the collision. The civilian crew had taken off from a local airfield and flown south to a practice area. Once they were outside the 20 NM outer limit of the airport radar service area (ARSA), the controller had terminated radar service and cleared the Cessna™ VFR. The Cessna™ crew had performed a series of stalls and was making a turn to the northwest when it collided with the T-38. The Cessna's™ engine was sheared off at the firewall, and the aircrew performed an emergency landing on a nearby highway. The T-38 aircrew ejected with minor injuries, but the T-38 was destroyed upon ground impact.

66.2.1. **Operator Factor.** The T-38 IP had limited visibility in the RCP. The SP in the FCP had better visibility, but was focused in the cockpit while setting up his navigational aids (NAVAID) for an ILS approach. The SP saw the Cessna™ prior to impact, but did not have enough time to avoid colliding with it.

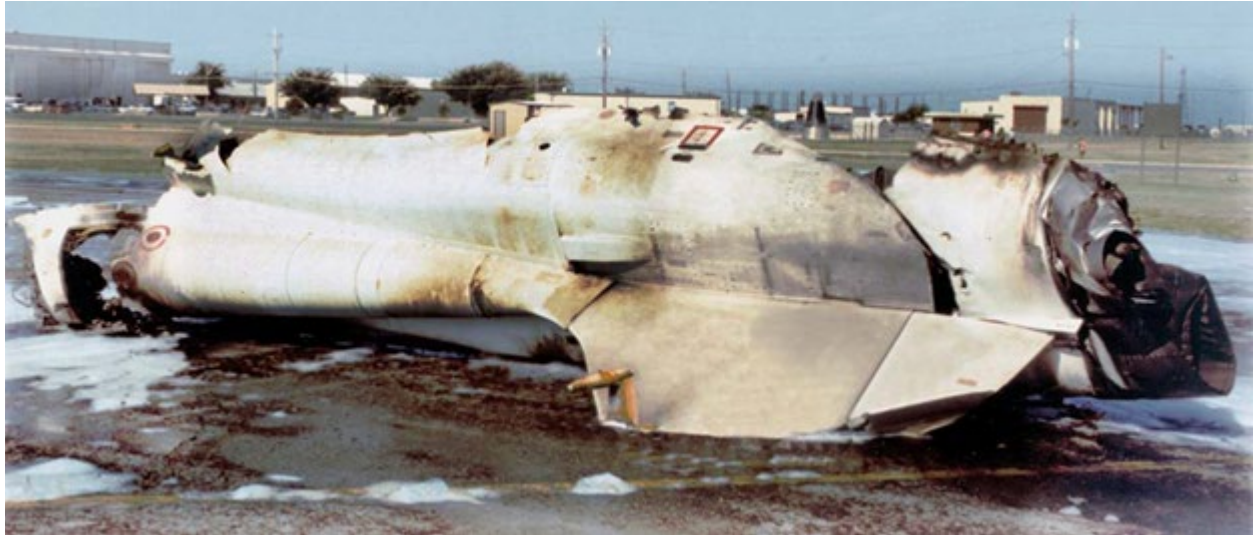
Figure 71. Stall – Touch and Go.

67.1. **Mishap. Figure 71.** This was the SP's first sortie in the T-38. The mishap crew completed area work and then returned to the home field to practice patterns and landings. During the second pattern, the SP flared high while attempting to land. The RSU controller directed the mishap crew to go around. The aircraft continued in the high flare until the left wing stalled and dropped, rolling the aircraft into approximately 90 degrees of left bank. The RSU directed the mishap crew to "use burners"! The aircraft entered a heavy wing rock and

began oscillating in yaw, all with a nose high attitude. The RSU transmitted, “lower your nose.” The aircraft nose came down and the oscillations dampened as the aircraft veered off from the runway at less than 80 feet AGL. It appears that the IP raised the flaps from full down to 60 percent some time during this sequence. The aircraft seemed to gain altitude, but the nose pitched up again after just a few seconds. The aircraft rolled abruptly to nearly 135 degrees of right bank and the nose dropped rapidly. The aircraft impacted the ground and was destroyed. Neither crewmember attempted to eject and both were fatally injured.

67.2.1. **Supervisory Factor.** The IP failed to recognize an impending stall and did not execute a proper stall recovery in a timely manner.

67.2.2. **Operator Factor.** The IP failed to ensure the engines were operating in full afterburner during the initial wing rock. It is possible he focused his attention on raising the flaps to reduce induced drag.

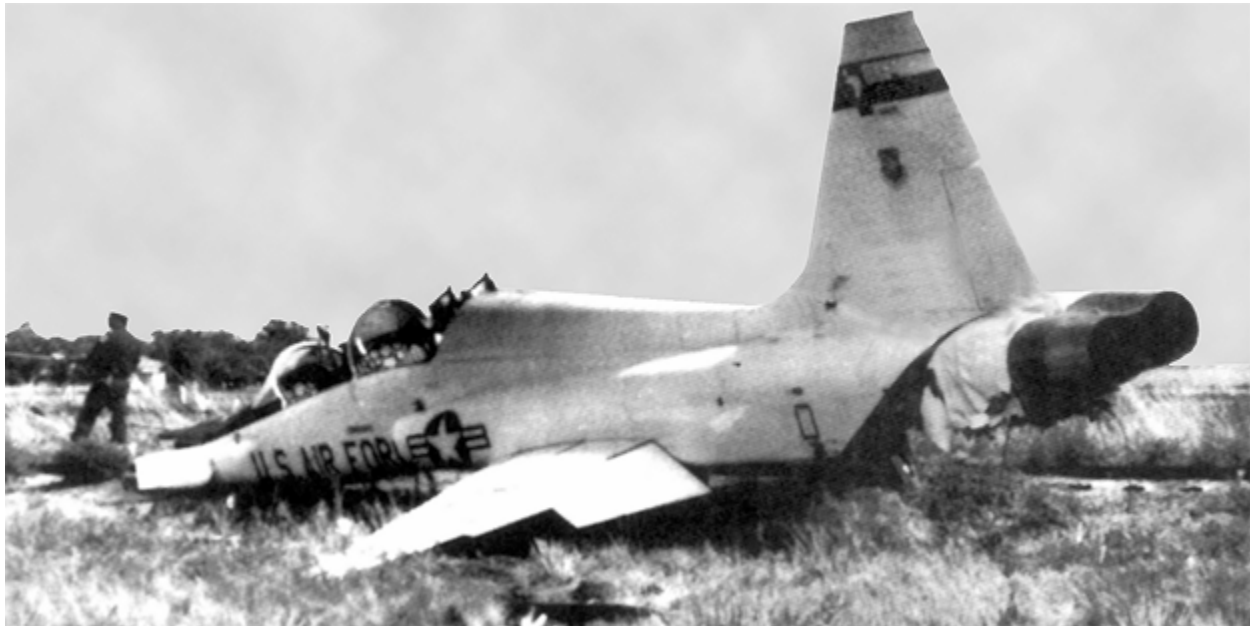
Figure 72. Bird Strike, Engine Failure – Touch and Go.

68.1. **Mishap. Figure 72.** The mishap crew was on a dual pre-solo formation sortie flown in the local area. After completing area work, the mishap crew returned to the home field for a formation approach and pattern work. The SP saw a brown flash on the left side of the aircraft on departure from the first touch and go. The flash turned out to be a bird, which went down the left intake. The aircraft was at 165 knots and 30 to 50 feet AGL with 6,000 to 7,000 feet of runway remaining. Both crewmembers heard a loud crunch or bang as the left engine failed catastrophically. The master caution, left hydraulic, and left generator lights illuminated. The aircraft yawed and rolled left. The SP applied rudder to straighten out the aircraft. The IP assumed control of the aircraft and placed the right throttle in afterburner. He directed the SP to open the throttle gate. The IP checked the airspeed (now 145 knots) and set the flaps at 60 percent. The mishap aircraft would not accelerate above 145 knots and remained at or below 50 feet AGL as it continued down the runway. With only 1,500 feet of runway remaining, the IP told the SP "Prepare to eject." The aircraft began to descend, and the IP commanded ejection. He saw the flash from SP's ejection and simultaneously noticed the barrier passing under the nose of the aircraft. The main landing gear contacted the barrier webbing, pulling the barrier cable to the bottom of the mishap aircraft. The cable became lodged in the hinge point of the left stab and tore the stab from the aircraft, causing the aircraft to pitch down. The IP initiated his ejection, leaving the aircraft as the nose impacted the ground. Although the IP's ejection and initial parachute deployment were normal, the parachute collapsed and did not inflate prior to ground impact. The IP sustained serious injuries on landing. Once on the ground, his parachute dragged him until the SP released him. The aircraft continued to skid another 1,500 feet across a highway embankment and onto a railroad track, sustaining major damage.

68.2.1. **Operations Factor.** The left engine ingested a horned lark on the departure leg of a touch and go, causing a compressor stall and engine failure.

68.2.2. **Logistics Factor.** The right engine failed to achieve maximum afterburner due to a binding cam in the T-5 motor.

68.2.4. **Operator Factor.** The IP failed to make a timely ejection decision.

68.4.1. Expanded command guidance for emergency procedures simulators to include compound and multiple emergency situations, scenarios requiring ejection, and thrust-deficient, single-engine go-arounds.

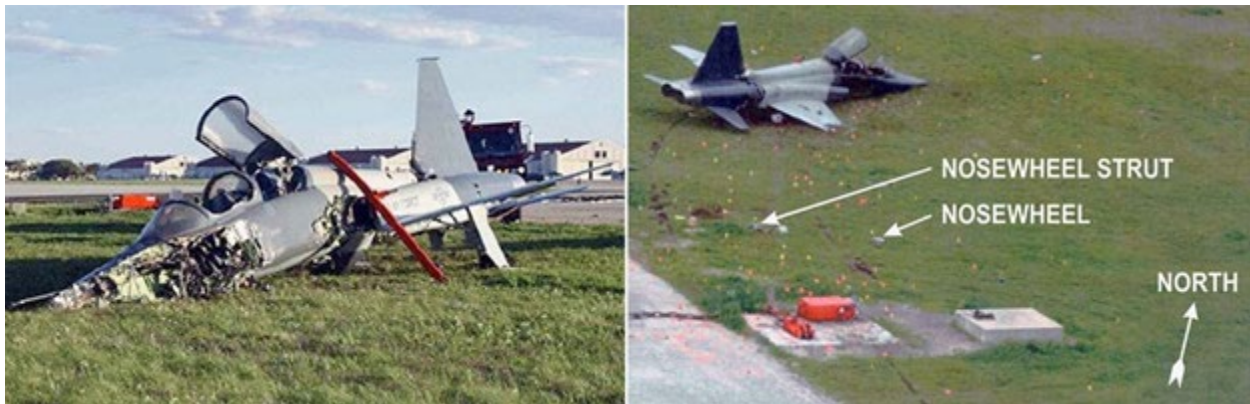
Figure 73. Blown Tire and Runway Departure.

69.1. **Mishap.** **Figure 73.** The mishap sortie was a CT mission for the IP in the RCP. The mishap crew was executing a no-flap touch and go with a left crosswind of 19 knots. The RCP IP heard a loud bang soon after touchdown and determined the left tire had blown. He initiated an abort by bringing the throttles to idle and directing tower to raise the BAK-15 barrier. The IP began to max aerobrake with approximately 5,200 feet of runway remaining without lowering flaps. At 4,000 feet remaining, the aircraft drifted right, causing the right tire to blow as well. The RCP IP used a combination of braking, rudder, and nose-wheel steering in an effort to maintain directional control. Despite these efforts, the aircraft departed the runway at 50 to 80 knots and struck a barrier stanchion (a 5.5 inch steel pole). The pole impacted the left side of the aircraft, causing substantial damage. The pole and nose gear sheared off, and the right main gear collapsed. Impact forces caused the FCP ejection seat to fire. The ejection was outside the envelope under high wind conditions, and the FCP IP was fatally injured. The RCP IP egressed without injury.

69.2.1. **Supervisory Factor.** Technical Order, Air Force Instructions, and courseware contained conflicting guidance regarding go/no-go decisions and guidance for no-flap touch and go and tire wear limits during crosswind landings was nonexistent.

69.3.2. Aggressive aerobraking can significantly degrade directional control during strong crosswinds. Due to too much aerobraking (trying to stop the aircraft), the RCP IP allowed the aircraft to drift off the runway. The priority should have been to properly

69.4.3. Recommended additional guidance regarding tire wear during crosswind landings. Maintenance directives were changed to include additional guidance on T-38 tire inspections.
