**AIR EDUCATION AND TRAINING
COMMAND HANDBOOK 11-210**

04 FEBRUARY 2020

Flying Operations

ROAD TO WINGS

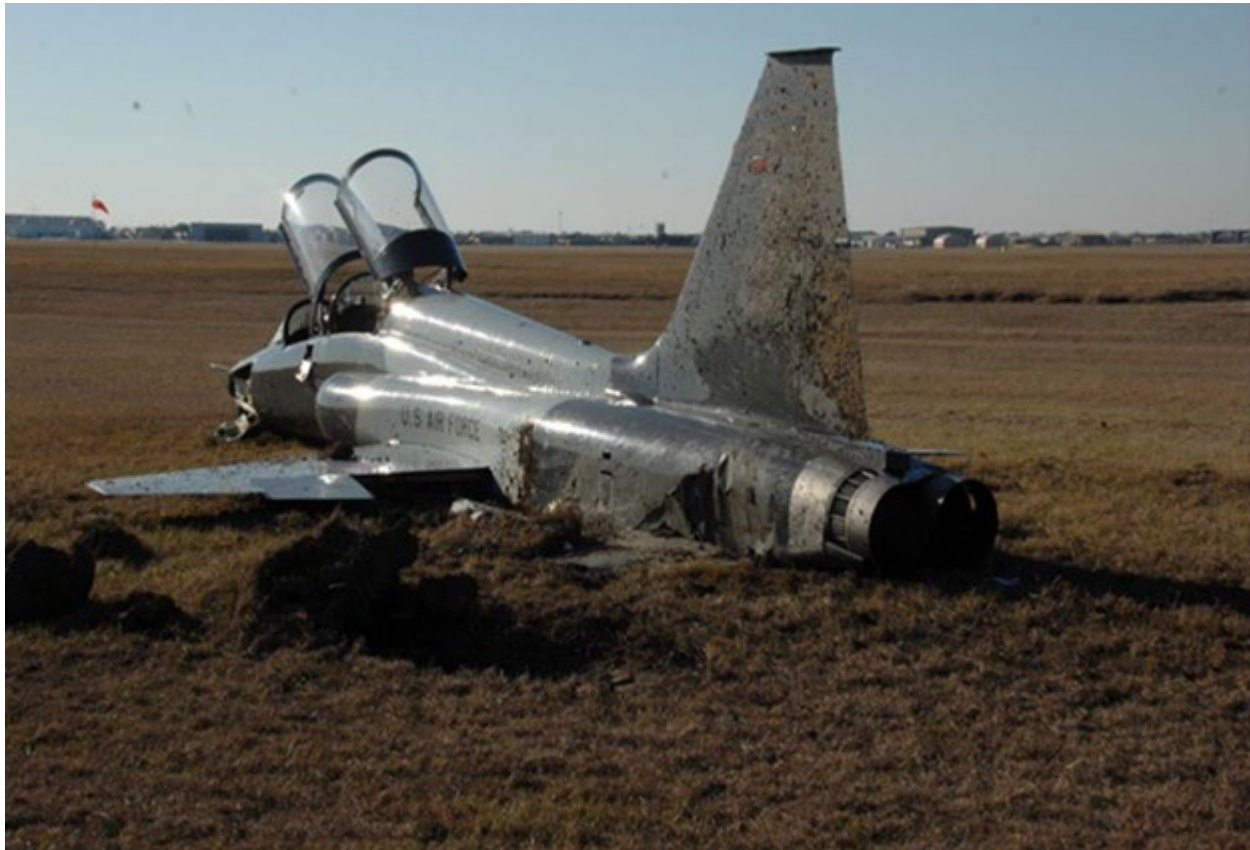
Figure 74. Excessive Sink Rate – Final Approach.

70.1. **Mishap. Figure 74.** The MP was flying his fourth sortie of the day as a night solo continuation training sortie into the civilian field on a cross-country mission. The MP requested a visual approach to a runway. The MP misidentified another runway as the landing runway and maneuvered to land on the misidentified runway. Due to the mismatch between what he was seeing outside and what his instruments indicated he allowed his airspeed to decrease well below a safe airspeed and descended at an insufficient rate, placing him well above a normal glide path. In an attempt to fix his glide path, he developed an excessive sink rate. The MP did not detect the slow airspeed nor excessive sink rate in time to prevent a hard landing and runway departure that caused damage to the MA's landing gear, engines, right wing, and tail section and minor damage to the runway. The MA came to rest 2,500 feet from the point of impact. The MP accomplished a safe ground egress and suffered minor injuries.

70.2.1. **Operator Factor.** The MP's originally approved cross-country plan was changed one week prior to the mishap due to direction from squadron leadership. In order to meet the squadron requirements and personal objectives, an aggressive high-risk plan was developed that included flying a fourth sortie solo, single-ship on the MP's first night arrival to civilian field. Risk Management (RM) was inadequate on three fronts: inadequate risk analysis of the overall cross-country weekend plan as well as the MP's individual plan, an inadequate risk assessment matrix, and a culture of risk tolerance in the squadron. Inappropriate supervisory policy, combined with inadequate RM, led to the MP flying a high-risk mission profile relative to the real benefits.

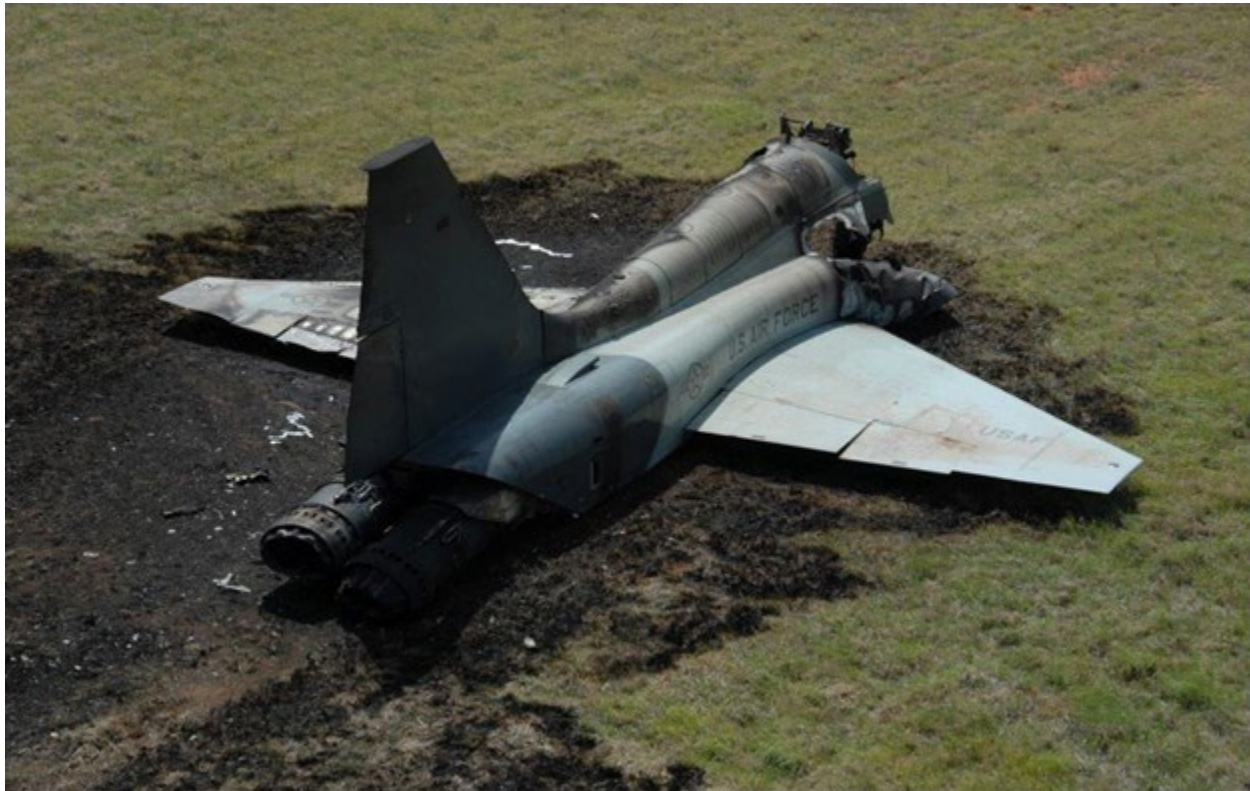
Figure 75. Engine Failure on Touch and Go.

71.1. **Mishap. Figure 75.** On a dual sortie, the mishap student pilot (MSP) flew a simulated single engine heavyweight (full fuel load) approach with an alternate gear extension without the heads-up display (HUD) for a planned touch and go. At or near the time the mishap aircraft (MA) touched down, the mishap instructor pilot (MIP) took control of the aircraft because the aircraft was outside the parameters for a successful landing on the main runway surface. The MA made a hard landing in the overrun throwing debris from the overrun surface into the number 2 (right) engine intake resulting in compressor stall two seconds after touchdown and complete engine seizure four seconds after touchdown. Eight seconds after the right engine failed while climbing away from the ground, the MIP retracted the landing gear and flaps. Eleven seconds after the engine failed the MIP selected maximum power (MAX) on the left engine. The mishap crew (MC) ejected 24 seconds after engine failure. At the time of ejection, the aircraft was 5-10 degrees nose low, 25-40 feet above the ground and in a fully developed stall. The near simultaneous ejection of the MC caused contact between the two ejection seats, disrupted their trajectories, and resulted in an unsuccessful ejection sequence. Both pilots were fatally injured upon impacting the ground. The aircraft came to rest approximately 6800 feet down the runway and was damaged beyond repair.

71.2.1. **Operator Factor.** The proper procedure following an engine failure during either the takeoff or landing phase is to immediately select MAX power, set flaps to 60 percent and attain a safe flying airspeed. The lack of power and airspeed, and the MIP's failure to leave the flaps positioned at 60 percent, resulted in a high angle of attack and subsequent stall.

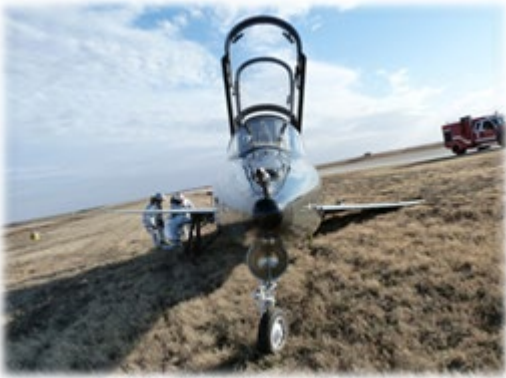
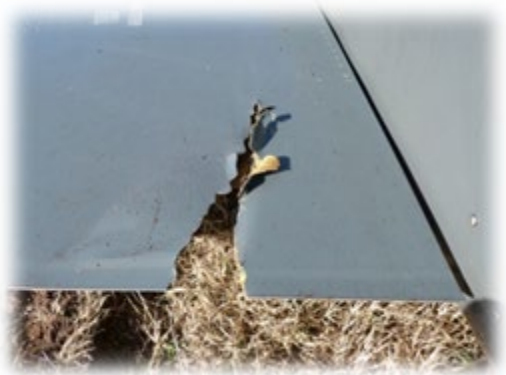
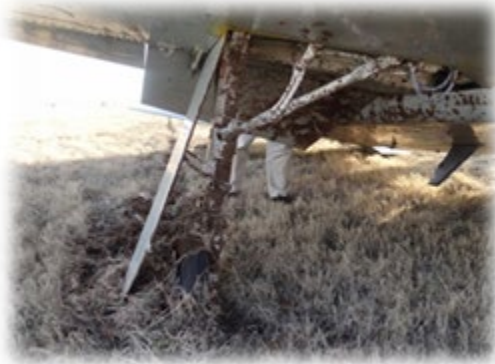
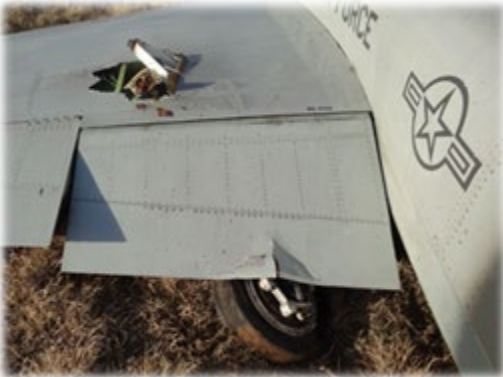
72.1. **Mishap.** [Figure 76](#), [Figure 77](#), [Figure 78](#) and [Figure 79](#). The mishap aircraft (MA) landed in a very strong crosswind near the limits of the aircraft and the downwind tire blew

during rollout leading to directional control problems. The mishap crew (MC) was unable to keep the aircraft on the paved landing surface. The aircraft departed the runway at 71 KCAS/62 GS approximately 5,551 feet down the runway. The left main landing gear (MLG) impacted a buried concrete block used for runway edge lighting approximately six feet from the runway edge at 59 KCAS/50 GS. This resulted in the left strut being driven through the top of the wing and catastrophic failure of the left MLG. The left MLG door separated from the aircraft and was partially buried into the ground. As the aircraft continued its track, the left horizontal stab suffered damage when it impacted the left MLG door. The aircraft came to rest 5,842 feet down the runway and 52 feet right of the paved runway surface with engines running in idle. The mishap instructor pilot (MIP) shutdown the engines and both pilots safely egressed the aircraft.

72.2.1. **Supervisory Factor.** At the time of the mishap, T-38s were operating near the maximum crosswind limit. Multiple T-38s had already blown tires prior to the mishap sortie. Wing leadership accepted risk under the assumption that aircraft and tire wear limitations provided a sufficient margin of safety for recovery.

72.2.3. **Operator Factor.** The mishap occurred because the MIP lowered the nose to the runway immediately following MLG touchdown, increasing compression on the downwind strut. This compression created right drift that, combined with an imperceptible left crab, increased tire wear. Upon brake application at approximately 108-117 KCAS, the right MLG tire failed. This failure at relatively high speed, in conjunction with maximum recommended crosswinds, made the aircraft uncontrollable and led to a runway departure.

72.2.4. **Operations Factor.** The majority of damage occurred when the left MLG struck a concrete pad housing a runway edge light. Current criteria requires the runway edge

72.2.5. **Logistics Factor.** No deliberate testing had been conducted on the main tires to determine how many takeoffs and landing can be accomplished prior to failure in maximum crosswind conditions. Leadership and pilots assumed the T.O. limits would provide a sufficient safety margin to operate at or below the crosswind limit.

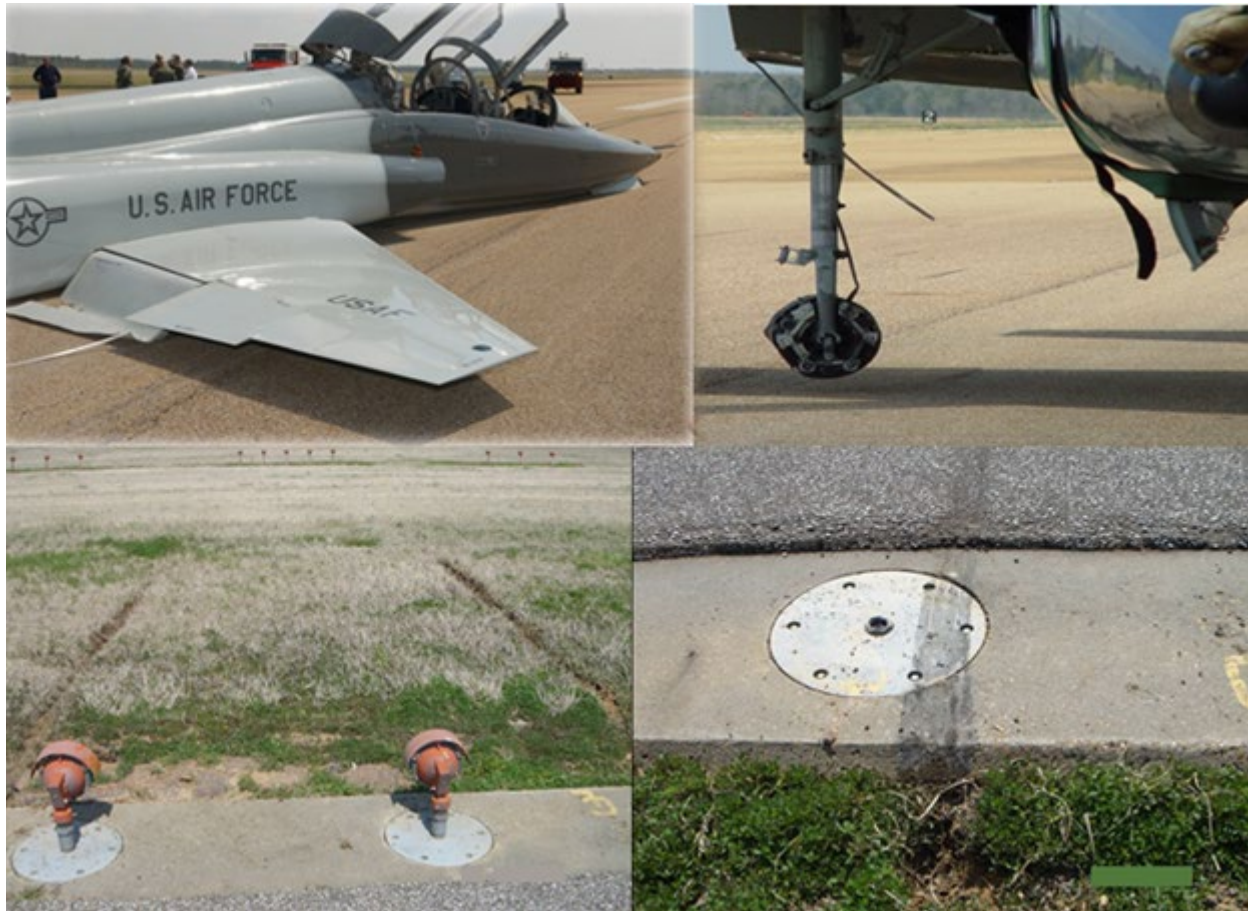
Figure 80. Landed Short of the Runway.

73.1. **Mishap. Figure 80.** The mishap sortie was planned and briefed as an instrument profile continuation training (CT) sortie with an instrument approach at an out base then return to home station for another instrument approach and visual flight rule (VFR) patterns. The front cockpit was occupied by the Mishap Upgrade Pilot (MUP), a T-37 First Assignment Instructor Pilot (FAIP), and the rear cockpit was occupied by the mishap instructor pilot (MIP). The MIP flew an uneventful ILS approach, breaking out of the weather at approximately 600 feet above ground level (AGL) and 2 NM from the runway threshold. The MIP transitioned to a visual approach lowering his aim point to the runway threshold. The MIP maintained a steady 3 degree glide path until he began the transition to land. The mishap aircraft (MA) landed approximately 25' short of the runway threshold in the unprepared overrun. The MA continued to roll through the grass and impacted a 2-3 inch lip at the threshold of the runway. The left tire suffered a gouge and deflated. The right wheel assembly disintegrated upon impact with the pavement and the right tire departed the MA. The left main landing gear strut door destroyed a raised threshold light and the right brake assembly rotated 90 degrees and gouged the runway surface for approximately 320'. The right main landing gear strut door departed the MA at an undetermined time after the impact. The MIP executed a go-around with no apparent directional control difficulties. The MIP requested a return to home base and a climb above the weather in order to troubleshoot their problem. After coordination with supervision, the MIP decided to execute an intentional gear up landing. The MIP flew an uneventful visual approach with the MA touching down approximately 800' down the runway and came to a stop 3,800' from the approach end on runway centerline. The pilots ground egressed uneventfully. The MA sustained damage to

the speed brakes, flaps, both horizontal stabilizers, both inboard main gear doors, the nose gear door and numerous antennas/lights on the underside of the fuselage.

73.2.1. **Supervisory Factor.** The MIP had just returned from SOS with only 2 sorties in the previous 40 days and had accomplished the required re-currency sortie to fly with students with no issues at the home field. The MUP was in the Introduction to Fighter Fundamentals spin-up program with limited proficiency and currency of experience in the T-38.

73.2.3. **Operator Factor.** Enroute, the MIP suspected a gear sequencing problem and referred to the "Landing Gear Retraction Failure" checklist. During this time, the MIP over-spiced the gear door limit of 240 knots calibrated airspeed (KCAS) by 26 KCAS. Not IAW checklist procedures, the MIP cycled the landing gear in an attempt to reset the gear door indication.

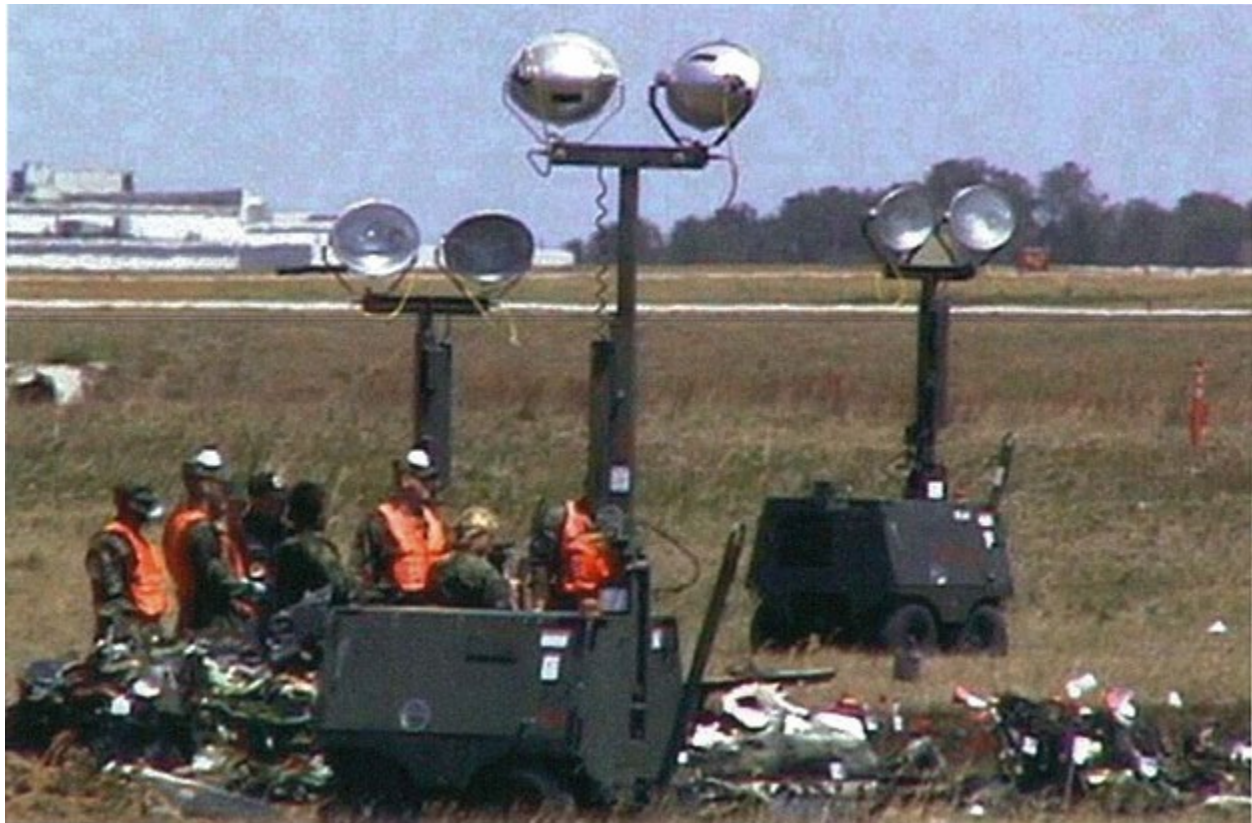
Figure 81. The Last Closed Pattern.

74.1. **Mishap. Figure 81.** The crew consisted of two instructor pilots. They planned the first leg of their cross-country mission to depart their home station and land at a civilian airfield where they would stay the night. The crew departed home station under Visual Flight Rules (VFR) and performed several airshow style maneuvers on their way to their destination. Four airshow-style events were recorded with high speeds passes (313 kts max), aggressive banks (max of 130 degrees), and high pitch angles (max of 80 degrees) accomplished as low as 50 feet above the ground. The crew continued to their destination where they accomplished five aggressive closed patterns. After completing their post-flight inspections, the IPs met several friends and went out to a local bar, alcohol was consumed by both IP's. The crew paid the bar tab around 2300 hrs and departed for crew rest. At 0700 one of the IPs got up and called the other IP requesting an early departure. They left the hotel at 0800 and performed a quick preflight around 0850 hrs, taxied a short distance for takeoff, and requested one pattern before departing to the west. No evidence of a filed flight plan was found, and the crew brushed off a friend's question of whether they needed to file and get weather. When the IPs began their takeoff roll, only ten and a half hours had elapsed since their last drink of alcohol. They had slept for less than seven hours and had had minimal food or water on this tragic day. The IPs rotated normally and cleaned up the aircraft, but kept the aircraft in ground effect for 21 seconds accelerating to 170 kts before pulling closed. The IP flying then

snapped an aggressive left turn with high G similar to the maneuvers flown on the previous day. The IP began the closed pull-up with full left aileron and nearly full aft stick. The IP then slowly moved the stick to full right aileron, but the aircraft continued to roll left. The front IP recognized the aircraft was out of control and ejected; the ejection occurred with the aircraft nearly inverted and at low altitude, the parachute did not have time to fully deploy. Normally, this would initiate the ejection sequence for both seats; however, the IPs failed to complete their normal checklist items prior to departure. While the ejection occurred, the rear seat IP brought the PCL to idle and neutralized the controls. The aircraft impacted the ground nearly inverted and 40 degrees nose low. Both IPs were fatally injured.

74.2.3. **Operator Factor.** Due to channelized attention and habit interference, rear seat IP misapplied flight control inputs while attempting to rollout.

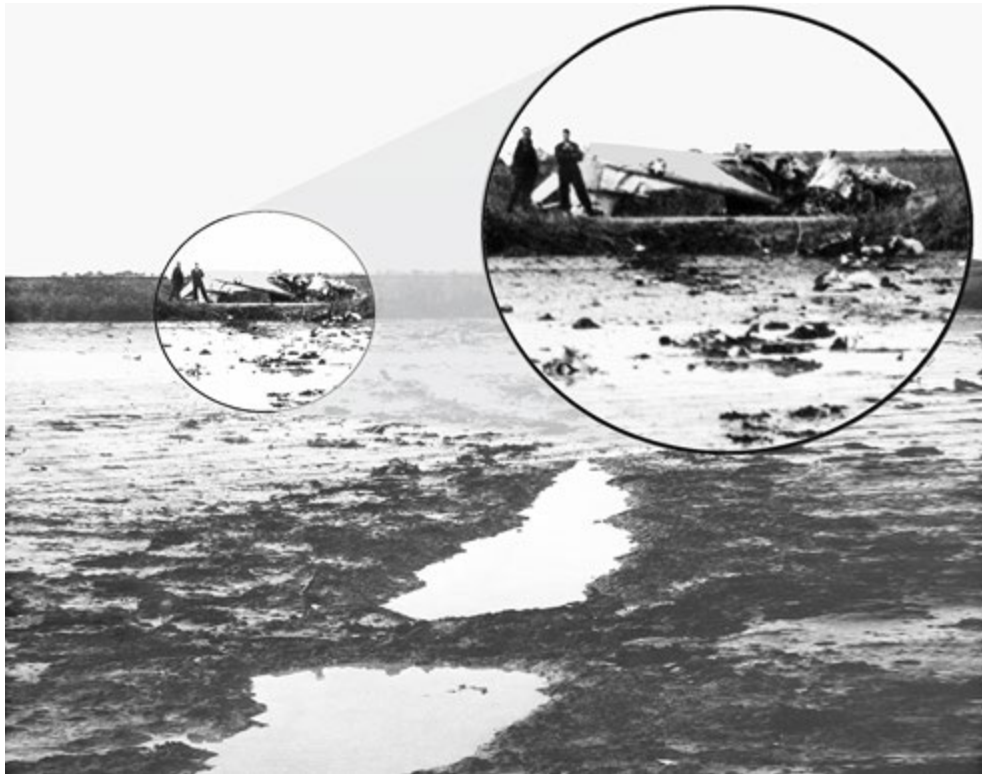
Figure 82. Departure Crash.

75.1. **Mishap. Figure 82.** This accident occurred after takeoff from an auxiliary airfield. The crew had performed runway supervisory unit (RSU) duties at the auxiliary field and were returning to home base. A right turn out of traffic was started early, using a steeper bank than normal. The copilot, bending forward to retrieve a pencil from the cockpit floor, inadvertently applied pressure against the control stick, causing the aircraft to continue to roll to the right to an inverted position. The pilot attempted recovery by continuing to roll to an upright attitude. During the recovery attempt, the left wing brushed the ground 3,700 feet from the departure end of the runway. The aircraft then struck a telephone pole and came to rest inverted on a farm road. The aircraft configuration was gear up, flaps up, and thrust attenuators and speed brake in. Neither crewmember attempted to eject. The pilot received minor injuries; the copilot received major injuries.

75.2.1. **Operator Factor.** The pilot initiated an unexpected, abrupt turn out of traffic while the copilot was bending forward to retrieve a pencil from the cockpit floor. The copilot inadvertently interfered with control of the aircraft during the turnout of traffic, causing the aircraft to enter an unusual attitude. The unusual attitude disoriented the pilot, causing a delay in initiating proper corrective action until recovery was highly improbable.

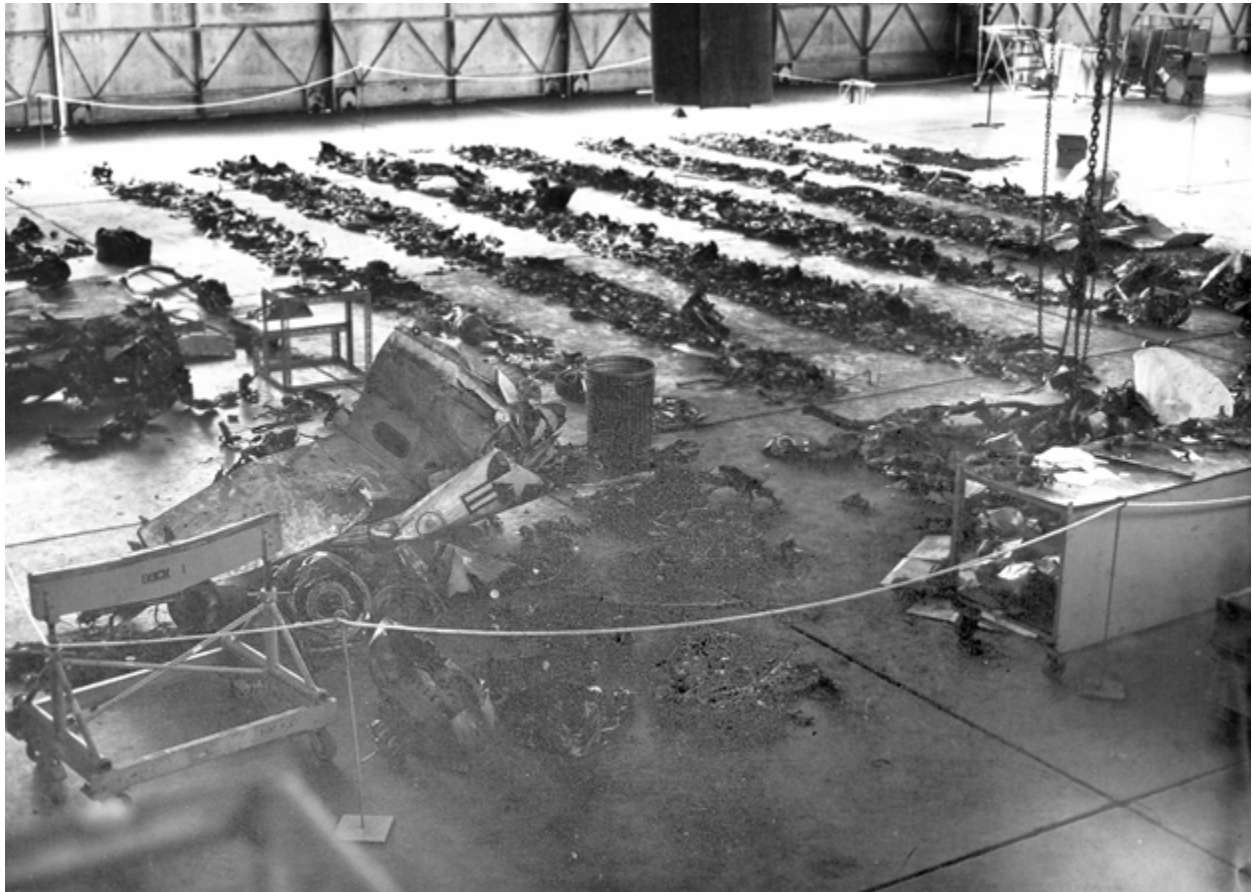
Figure 83. Departure Crash/MOA.

76.1. **Mishap. Figure 83.** The mission was a solo pattern-only profile to the auxiliary airfield. Two overhead low approaches were accomplished (runway construction limited the pattern to a 300 foot AGL low approach). The student pilot departed the auxiliary field enroute to home base when the aircraft impacted the ground. The aircraft was destroyed and the pilot was fatally injured upon impact with the ground.

76.2.1. Supervisory Factor. Operational and medical guidance was not sufficiently coordinated to ensure supervisors understood the phenomenon of manifestation of apprehension. The mishap student exhibited symptoms of manifestation of apprehension as defined in the governing directive, and these symptoms degraded his performance. The symptoms were masked and difficult to detect; and because of the absence of coordinated guidance on manifestation of apprehension, the problem was not recognized and the student remained in training. Ten days before the mishap, the student's performance began to deteriorate markedly. Two days before the mishap he performed a mission poorly and became airsick. Unit supervisors failed to ensure that applicable training directives were complied with and the student was not placed on special monitoring status as required, thereby depriving the student of the special attention he needed. On the day before the mishap, the student twice performed poorly on his emergency procedure examination, but the instructor pilot did not fail the student as required. Additionally, the flight commander failed to ensure the student was adequately briefed for the solo flight.

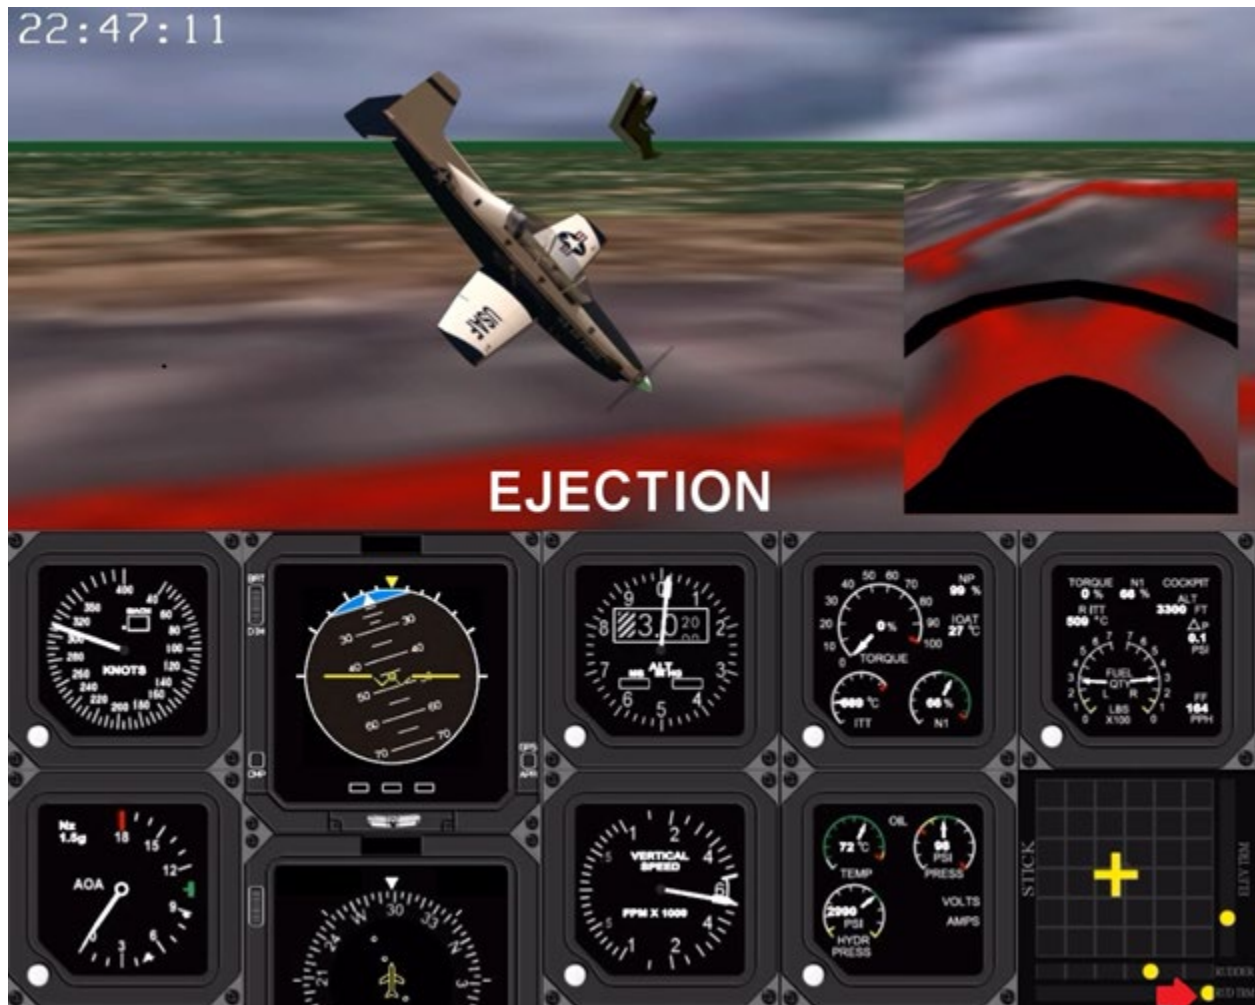
Figure 84. Lost Control – Area/ Disorientation.

77.1. **Mishap. Figure 84.** This student pilot was scheduled for an area solo sortie. He would take the aircraft, without an instructor pilot in the back seat, fly out to the MOA, and practice basic and advanced aerobatics. The student began the sortie according to plan. He departed the airfield, flew the departure, and completed normal checks in his assigned MOA. After completing some basic maneuvers, the student then performed some advanced aerobatic maneuvers: two leaves of a cloverleaf followed by a loop. The student then attempted a second loop, beginning with an inadequate 2.6 G pull-up at 240 knots. The student continued the insufficient pull, bleeding airspeed until the aircraft was 90 degrees nose high. At this point, the student became disoriented and stopped the pull. Due to the nose high attitude, the aircraft's airspeed quickly decreased and the aircraft momentarily departed controlled flight. This caused the aircraft to pitch down and tumble back towards the ground. The rapid change in aircraft attitude caused the student pilot to believe the aircraft was in a spin, and he brought the PCL to idle. As he retarded the PCL, he inadvertently mashed down on the rudder trim button and ran the trim to the full right position. The aircraft stabilized in a nose low attitude and regained flying airspeed. However, the unknown change in rudder trim caused the aircraft to remain in a right turn. The student perceived the turn as a spin and

77.4.1. A runaway trim demonstration has been added to the syllabus as a special syllabus requirement (SSR).

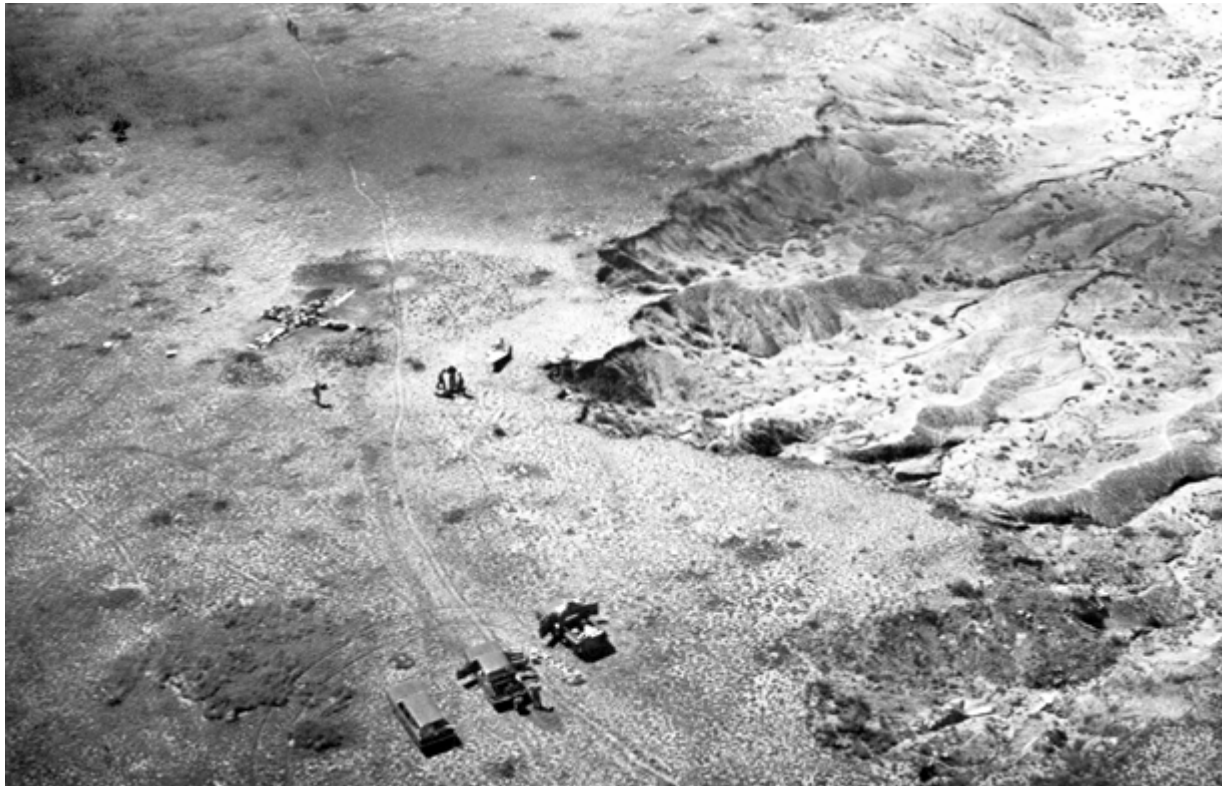
Figure 85. Lost Control – Area/Unintentional Spin.

78.1. **Mishap.** **Figure 85.** The student pilot performed the takeoff and flight to the training area. The student practiced traffic pattern stalls. The instructor pilot then assumed control to demonstrate control effectiveness and steep turns in the slow-flight regime. Following the demonstration, the instructor rolled the aircraft into a steep right turn to demonstrate a rapid loss of altitude associated with steep bank turns in slow flight. As the aircraft approached 45 degrees of bank, the instructor attempted to roll it back to wing-level attitude. When left aileron was applied, the aircraft rolled abruptly right with the nose lowering. Spin prevention procedures were applied immediately, but the aircraft continued to rotate. Two single spin recoveries were attempted without apparent effect. When the altimeter was passing 9,000 feet MSL (6,500 feet AGL), the instructor ordered the student to eject. The student responded immediately and the instructor followed. They were not injured.

78.2.1. **Supervisory Factor.** The spin prevention description in the flight manual and governing directive at the time of this mishap may have encouraged premature abandonment of the spin prevention attempt. The instructor pilot had not been briefed or instructed on recovery procedures in connection with landing configuration spins. This led to a lack of confidence on the part of the instructor in the effectiveness of the “single spin recovery” in recovering control of a configured aircraft.

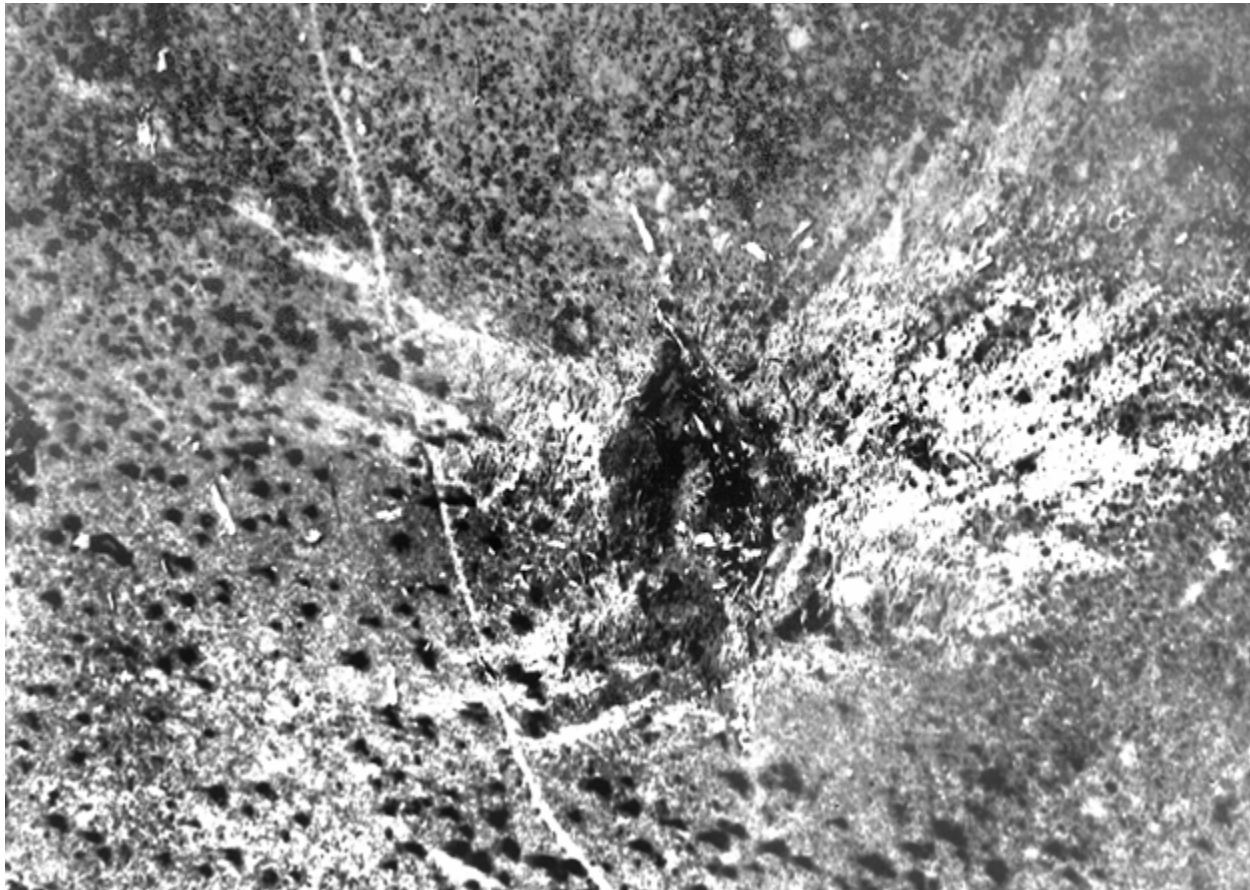
Figure 86. Disorientation/Night – Area.

79.1. **Mishap. Figure 86.** The aircraft was on a dual night orientation flight. The night orientation mission profile was part of a four-leg, round robin navigation route, during which night unusual attitude recoveries were to have been practiced. The aircraft was second in a sequence of four aircraft. The takeoff and initial route flown were uneventful. Although the aircraft were on a VFR clearance, radar approach control (RAPCON) provided radar monitoring and made one transmission to the number two aircraft, stating that the aircraft was going outside assigned route airspace. The pilot responded he was correcting back to course. On the third leg of the route, the mishap aircraft was observed north of course. The pilot then overshot the inbound course for the final leg. Approximately 2 minutes later, he reported encountering heavy rain and requested a turn to the south with vectors to the entry point. The pilot acknowledged instructions to fly a heading of 160degrees. This was the last transmission received from the aircraft. The aircraft crashed in an open field in a near vertical attitude with the left wing low. The student pilot ejected, but was too low for seat/man separation. The instructor pilot made no attempt to eject. Both pilots were fatally injured.

79.2.1. **Supervisory Factor.** The pilot training squadron did not have procedures established to ensure the SOF was promptly advised of all pertinent data that might affect the flying operation, including weather conditions. The instructor pilot allowed the aircraft to be flown past the depicted inbound course by approximately 7 NM. This allowed the aircraft to enter weather that may have contributed to the pilot's disorientation.

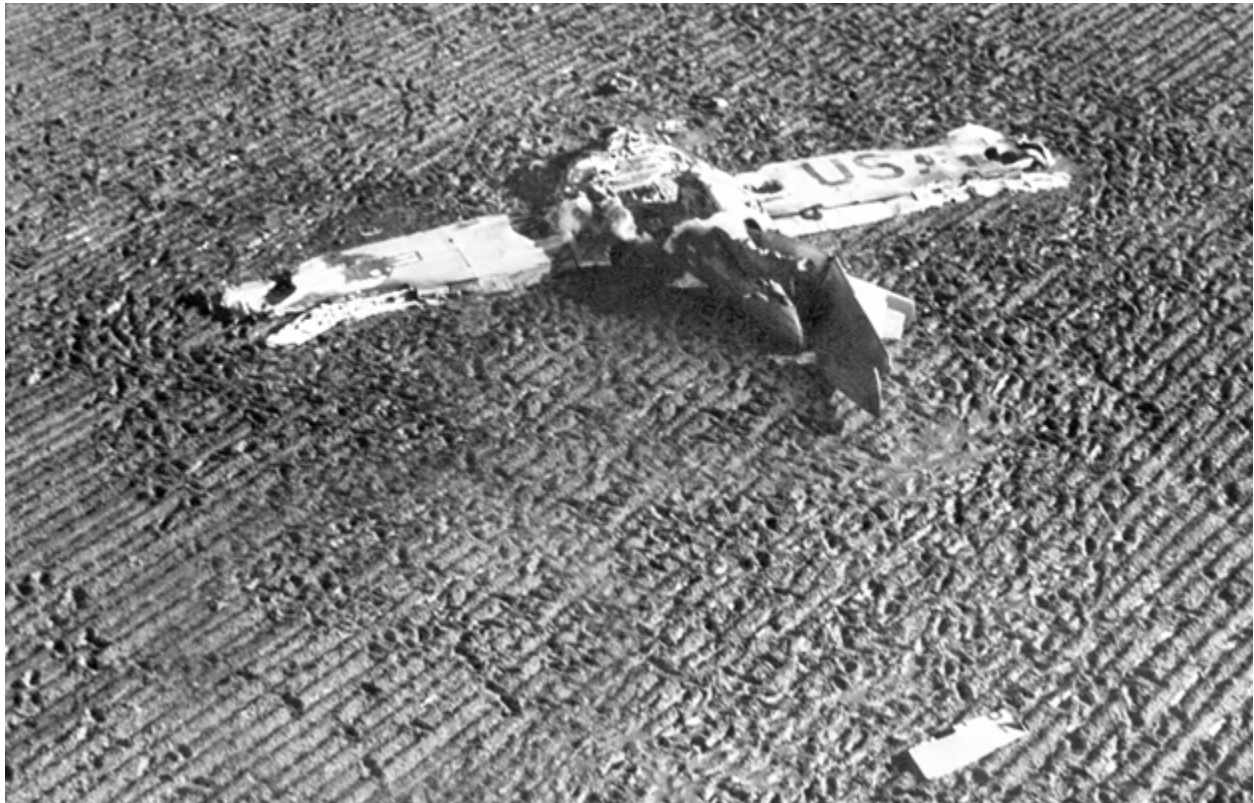
Figure 87. Spin – No Recovery.

80.1. **Mishap. Figure 87.** The mission was a dual contact review flight for the student pilot. It was flown as briefed until the instructor pilot assumed control following a spin prevention maneuver by the student. The instructor stated he would demonstrate a proper spin prevention maneuver. He initiated a left spin entry for a spin prevention. During the maneuver the aircraft went into an erect left spin. The instructor initiated the single spin recovery, but he released the forward stick pressure before he saw any pitch change. This procedure was aborted after two turns. The instructor then neutralized rudders, applied full aft stick for approximately three turns and reconfirmed left rotation. Right rudder was then applied and approximately one and one-half turns later, full forward stick was applied. The stick again was not held against the forward stop. When the nose did not pitch down, the instructor moved the stick full forward again. Almost simultaneously, the student informed the instructor the aircraft was passing through 14,000 feet MSL. The recovery attempt was aborted and another unsuccessful single spin recovery attempt was made. At 11,000 feet MSL the instructor ordered the student to eject. He had to repeat the command. The student and instructor pilot ejected successfully.

80.2.1. **Operator Factor.** The instructor pilot applied improper spin recovery techniques due to a lack of proficiency in the maneuver.

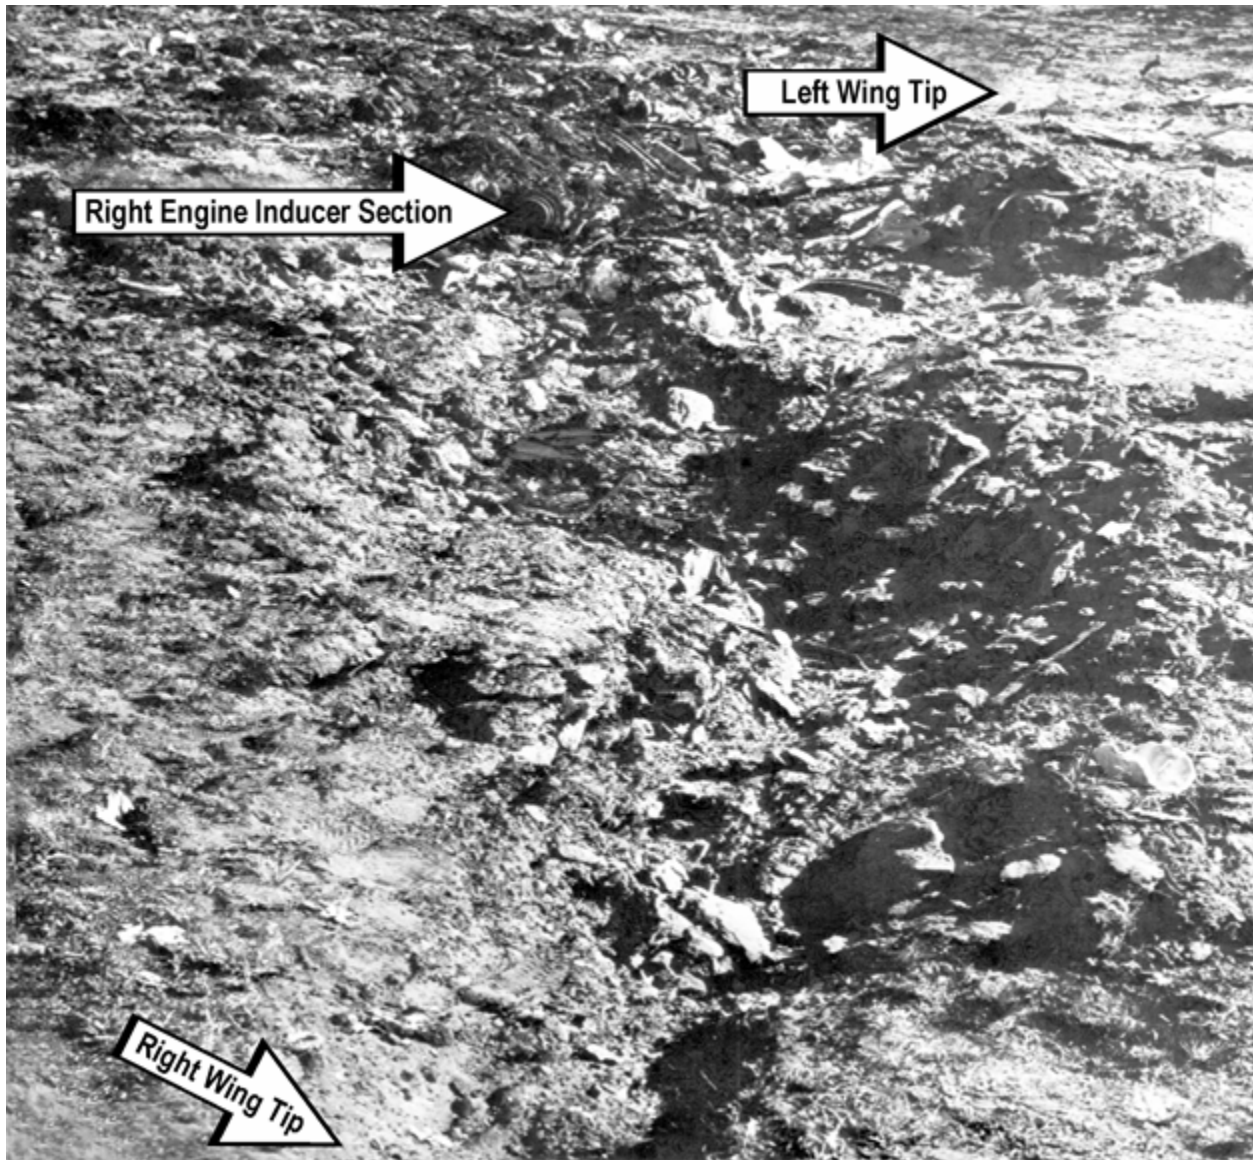
Figure 88. Lost Control – Area.

81.1. **Mishap. Figure 88.** This mishap occurred during a dual contact training sortie. Thirty-five minutes after the aircraft entered the working area, the radar controller lost both

radar and radio contact. The altitude readout 7 minutes prior to loss of contact was observed by the controller to be 16,700 feet MSL. The aircraft was later found to have impacted the ground in a near vertical attitude with a 100-degree-per-second roll rate to the left. Aircraft configuration was gear and flaps up, speed brake down, and the power at approximately 90 % RPM on both engines. The aileron trim was full left wing down upon impact. The instructor pilot had initiated ejection and cleared the aircraft just before impact. The student pilot did not eject. Both crewmembers were fatally injured.

81.2.1. No direct cause could be determined due to the lack of survivors, witnesses, evidence of aircraft malfunction and/or indications of pilot incapacitation.

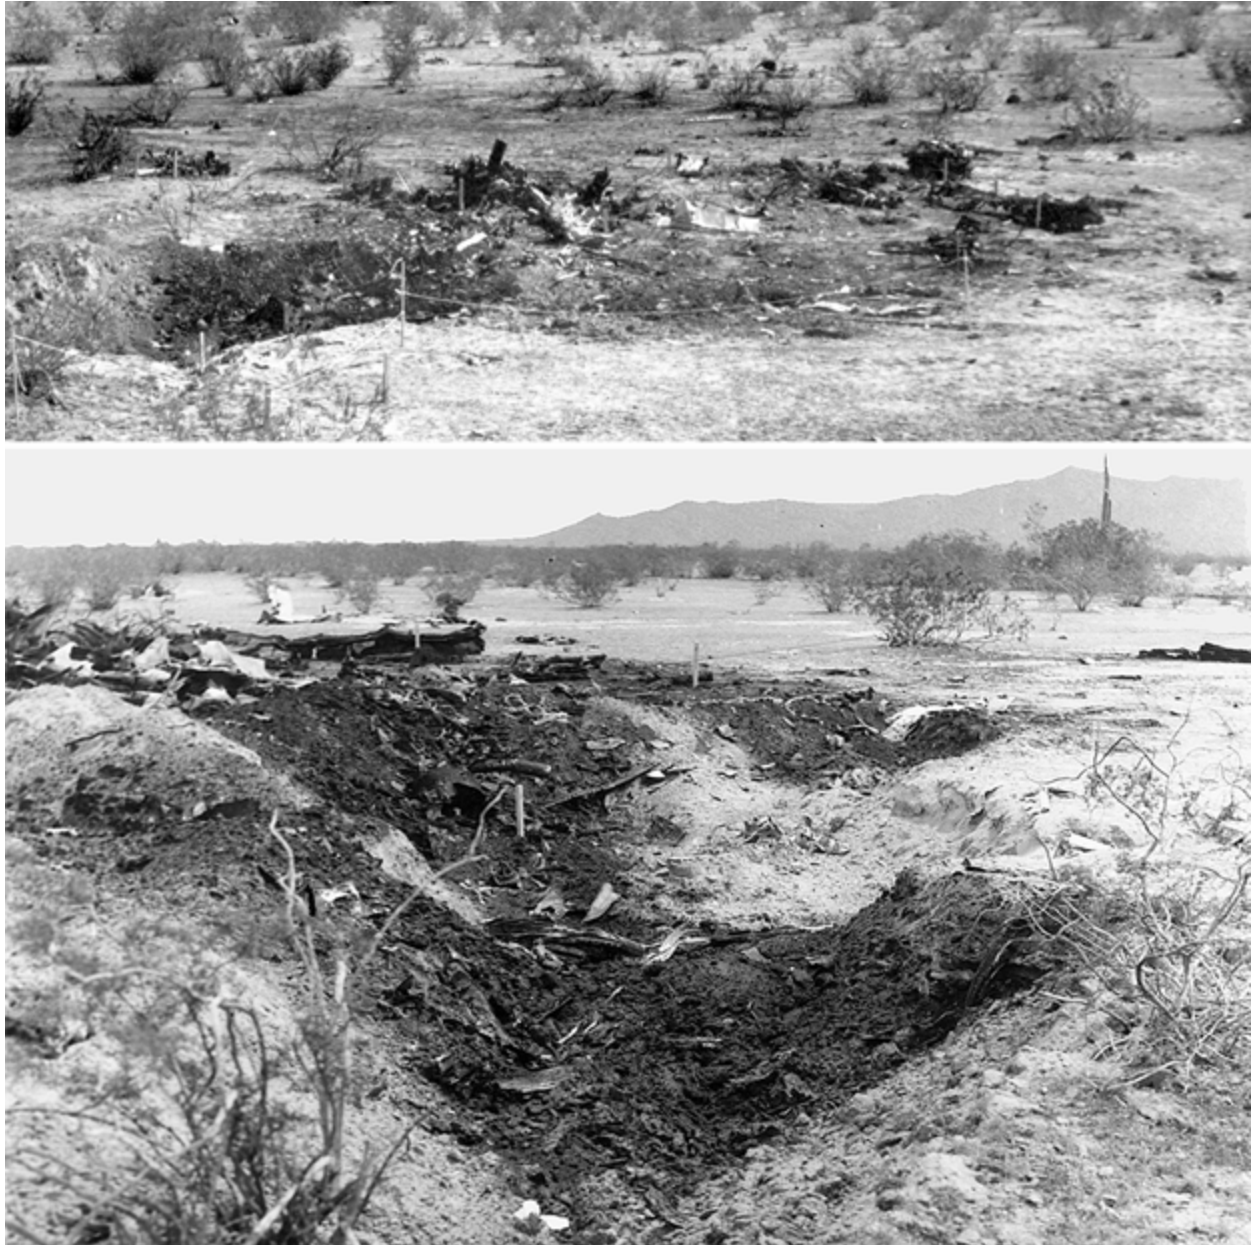
Figure 89. Lost Control – Area/High Speed Dive.

82.1. **Mishap. Figure 89.** The mission was a pre-solo contact training sortie. After entering the assigned training area, the instructor pilot pointed out ground references and demonstrated traffic pattern stalls, slow flight, and straight-ahead power-on stalls. Following these demonstrations, the student pilot attempted power-on stalls. On the student's second attempt, the instructor (who had been giving maximum assistance) assumed full control of the aircraft just before or at the stall. The aircraft entered into a series of nose-low unusual attitudes during which the instructor ordered the student to eject. The student ejected successfully and was recovered with only minor injuries. The instructor pilot did not (or could not) recover the aircraft from the ensuing high-speed dive. Although he initiated ejection, the sequence was terminated by ground impact resulting in fatal injuries. The aircraft was destroyed upon ground impact.

82.4.1. Technical data was reviewed and changed to reflect the requirements to inspect the elevator trim tab systems on a continuing basis.

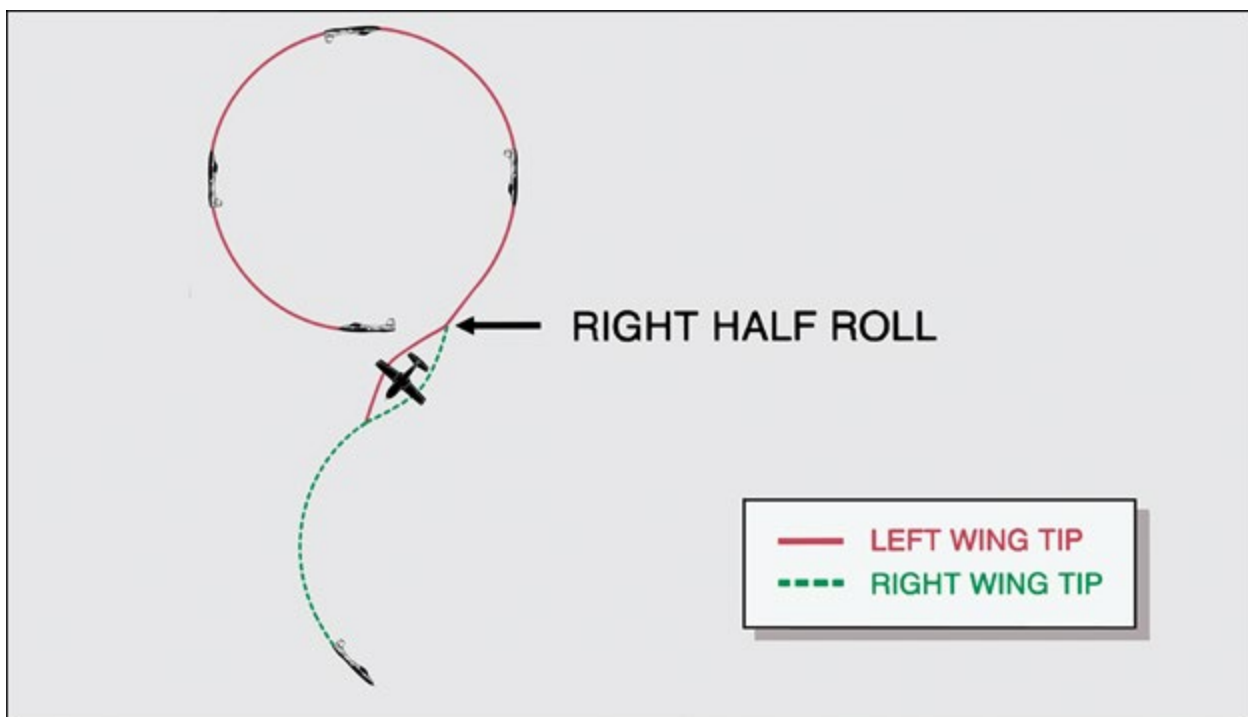
Figure 90. Lost Control – Area/High Speed Dive.

83.1. **Mishap. Figure 90.** The mission was a solo contact sortie to the local MOA. While performing a Cuban Eight, the student pilot lost control of the aircraft in a high-speed dive. The student pilot successfully ejected sustaining minor injuries. The aircraft was destroyed on ground impact.

83.2.1. **Supervisory Factor.** The flight commander did not place the student pilot on the commander's awareness program (CAP) in a timely manner to ensure efficient training. The IP authorized the student pilot to perform advanced aerobatics solo, by grading him "good" in situational awareness, despite his demonstrated problems of maintaining awareness of position in space. Instructional guidance on abnormal flight recoveries did not ensure appropriate training in the termination of unsafe aerobatic maneuvers.
