**AIR EDUCATION AND TRAINING
COMMAND HANDBOOK 11-210**

04 FEBRUARY 2020

Flying Operations

ROAD TO WINGS

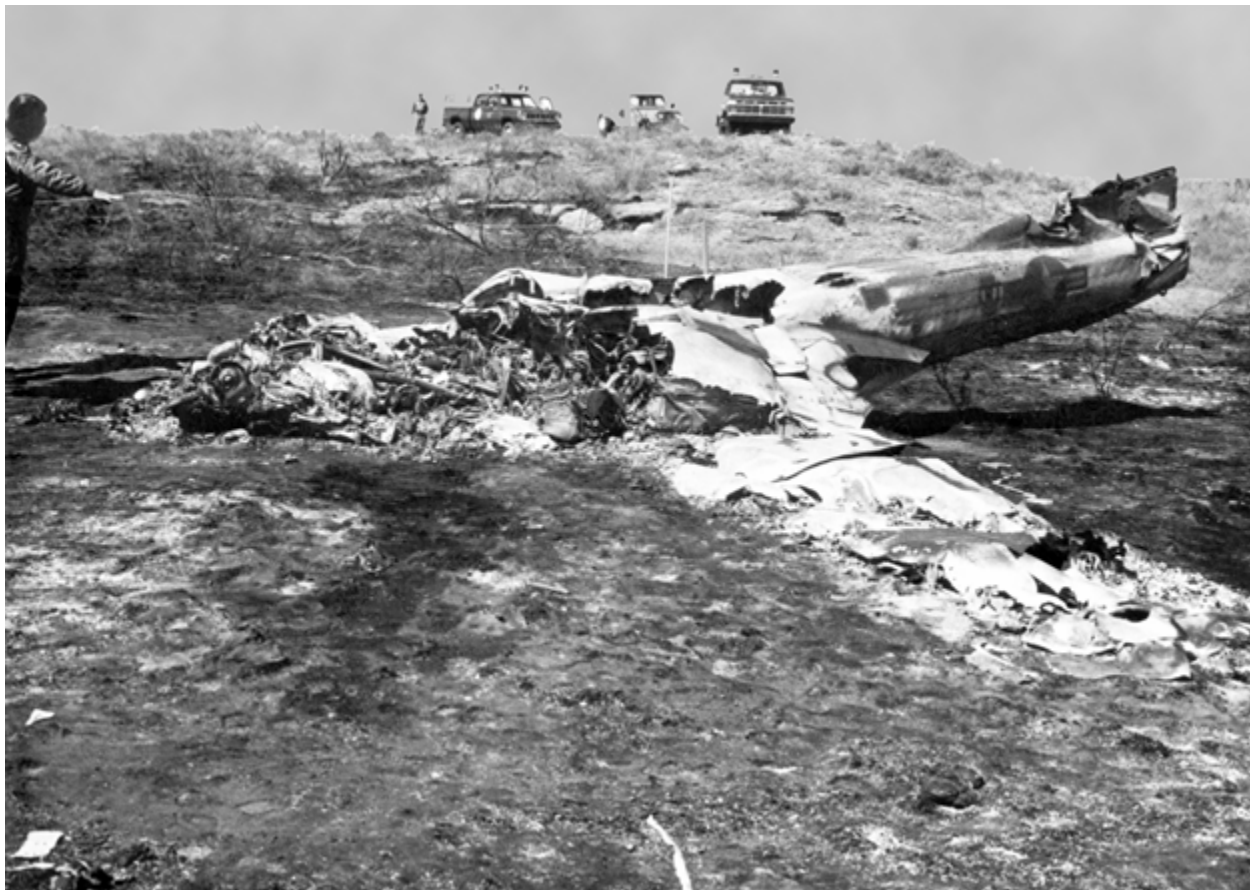
Figure 91. Lost Control – Area/Unintentional Spin.

84.1. **Mishap. Figure 91.** The accident occurred during a student solo contact training mission. The student pilot was briefed to go to a local training area, perform air work maneuvers, and return to the traffic pattern. During an attempted cloverleaf, the student experienced moderate aircraft buffeting, and entered a spin. The student attempted a spin prevention and a single spin recovery without success before ejecting at approximately 8,000 feet MSL. The student was recovered uninjured, but the aircraft was destroyed.

84.2.1. **Operator Factor.** The student stalled the aircraft during an attempted clover-leaf and failed to recover before the aircraft departed controlled flight. The student misinterpreted the stall as an incipient spin and performed the spin prevention procedure incorrectly. This aggravated the stall and resulted in a developed spin. The student attempted the single spin recovery procedure but prematurely abandoned the anti-spin controls, resulting in failure to recover from the spin. Due to low altitude, the student correctly ejected from the aircraft without attempting a second spin recovery.

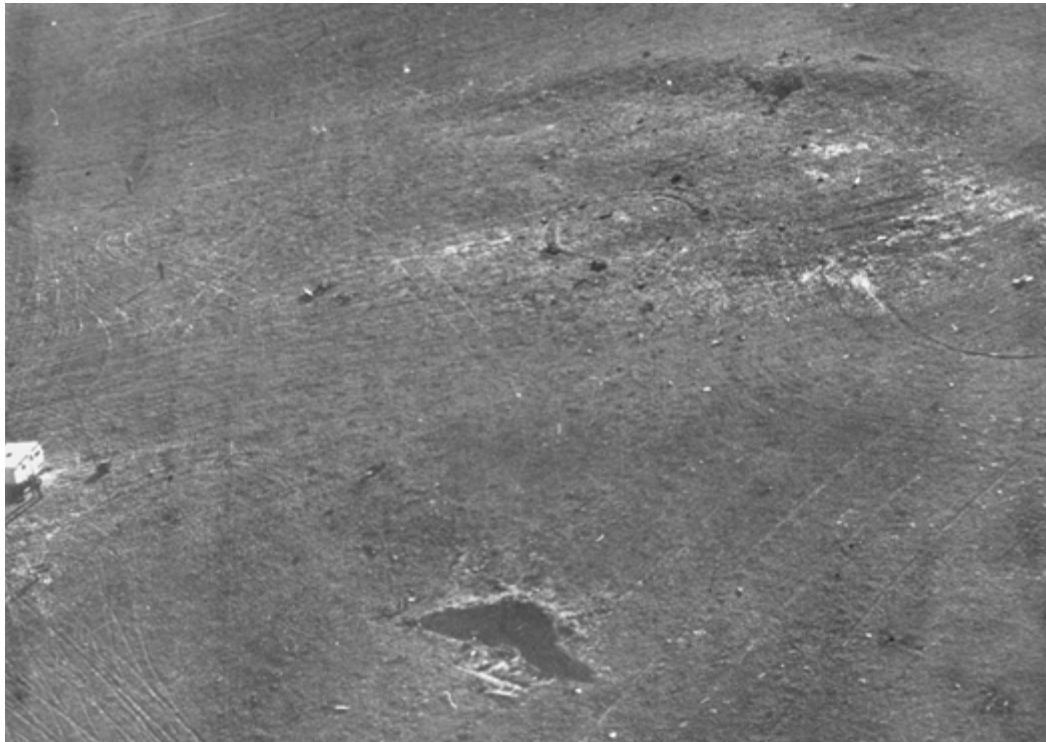
Figure 92. Lost Control – Area.

85.1. **Mishap. Figure 92.** The mission was a solo contact sortie, which was to include aerobatics. The student pilot made a radio call when established in the area and began performing aerobatic maneuvers. Radar and radio contact with the aircraft were lost 14 minutes later. Radar tapes showed the mishap maneuver was a barrel roll. The aircraft impacted the ground and was destroyed. The student did not eject and was fatally injured.

85.2.1. **Undetermined.** During a barrel roll, full nose-down trim was introduced for an undetermined reason. It is possible the student may have inadvertently applied trim or an unknown aircraft malfunction may have caused the trim to run full nose-down.

85.2.2. **Operator Factor.** The student failed to correct the nose-down trim condition. The student failed to abort a poorly performed barrel roll and recover after the first half of the maneuver did not go well. A high speed dive ensued in which the student did not recover or attempt to eject. The student's history revealed a strong motivation to succeed. Additionally, the student's training and medical records documented several cases of hyperventilation.

85.3.1. The human factors of spatial disorientation, excessive motivation to succeed, and hyperventilation may have had some bearing on the student's failure to eject. Disorientation may have distracted and confused the student to the degree that the seriousness of the situation was not realized. The sequence of events in this mishap may have resulted in the student pilot hyperventilating, resulting in partial incapacitation. Pilots must realize early recognition and recovery from poorly performed maneuvers is essential to prevent severely disorienting situations.

85.4.1. Manuals were amplified to stress the urgency of controlling airspeed in a dive situation and the ramifications of failing to do so. Additional guidance was provided regarding how to recognize an improperly performed maneuver, when to discontinue the maneuver, and how to recover.

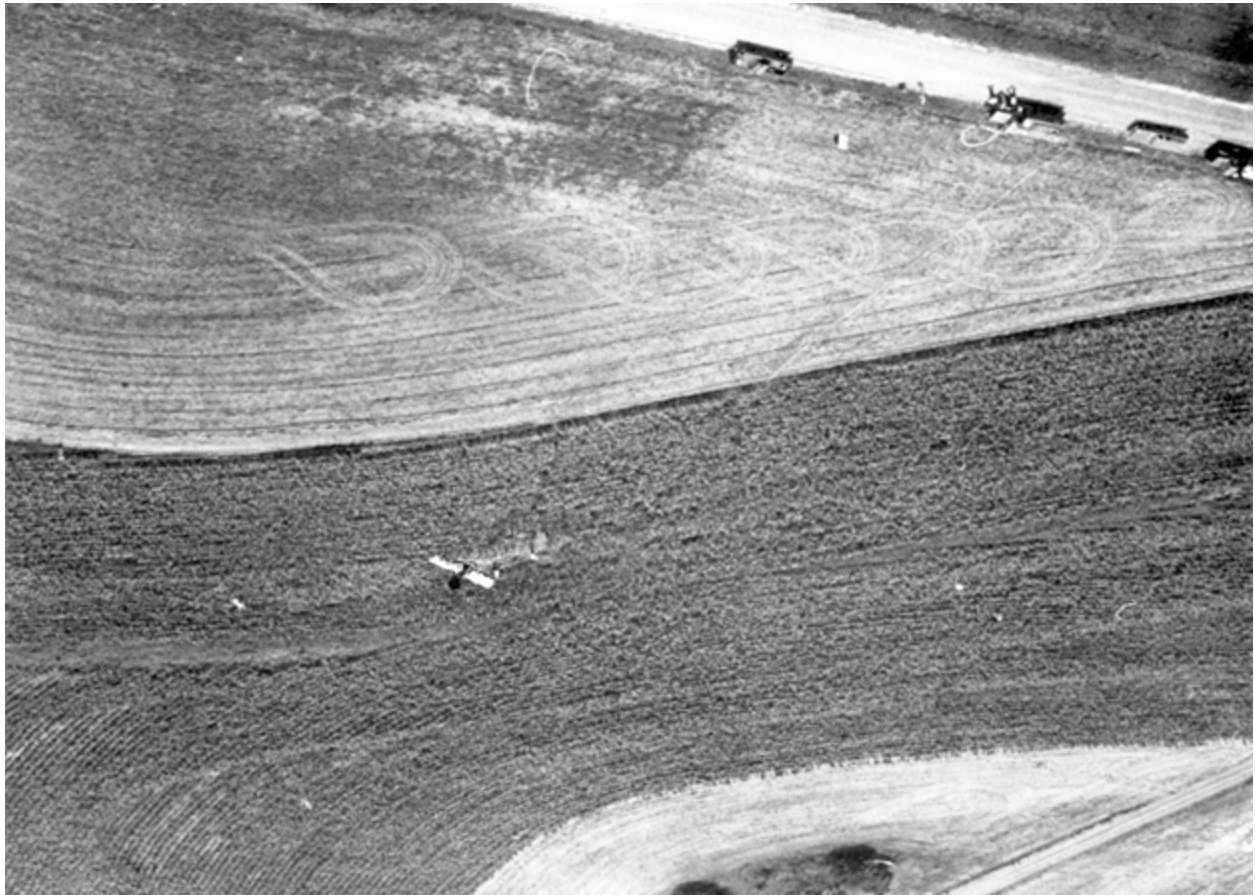
Figure 93. Disorientation/Instrument Approach.

86.1. **Mishap. Figure 93.** The student pilot and instructor pilot were on an instrument training mission. After basic instrument work, the aircraft was radar vectored for a ground control approach, full-stop landing. The instructor flew a right-hand box pattern with the downwind flown at 3,000 feet MSL in the clear. The instructor pilot was instructed to turn to a base leg heading of 230 degrees and descend to 2,000 feet MSL. Clouds were entered at 2,500 feet MSL. While in a descending right turn approximately 12 NM from the field, a “dogleg” heading of 290 degrees was given and acknowledged along with a final descent to 1,800 feet MSL. He rolled wings level on a heading of 290 degrees. He felt somewhat dizzy and selected 100 % oxygen. The instructor pilot then was instructed to turn to 315degrees, and he lowered gear and flaps at 10 NM remaining. The aircraft was left of course and radar control gave successive headings of 320, 325, and 330 degrees. The instructor was advised he was well left of course. At 8 NMs, he felt lightheaded and somewhat disoriented and was experiencing heavy breathing. The instructor asked the student to assist him on the controls. The student recognized a slight left bank, but could not move the stick against the instructor pilot’s control and released the stick. The instructor again asked the student to get on the controls. The student added power and leveled the aircraft. The instructor felt he was about to pass out and noted a 1,000 to 1,500 fpm rate of descent. He wisely ordered the student to eject and then ejected himself. The student ejected 4 seconds later. Both ejections were successful.

86.2.1. **Operator Factor.** The instructor pilot was unable to cope with a combination of spatial disorientation and hyperventilation after entering instrument meteorological conditions. A possible contributing factor was the location of the attitude indicator and other essential instruments, which required the instructor to look across the cockpit, thereby increasing both the difficulty of interpretation and the likelihood of spatial disorientation.

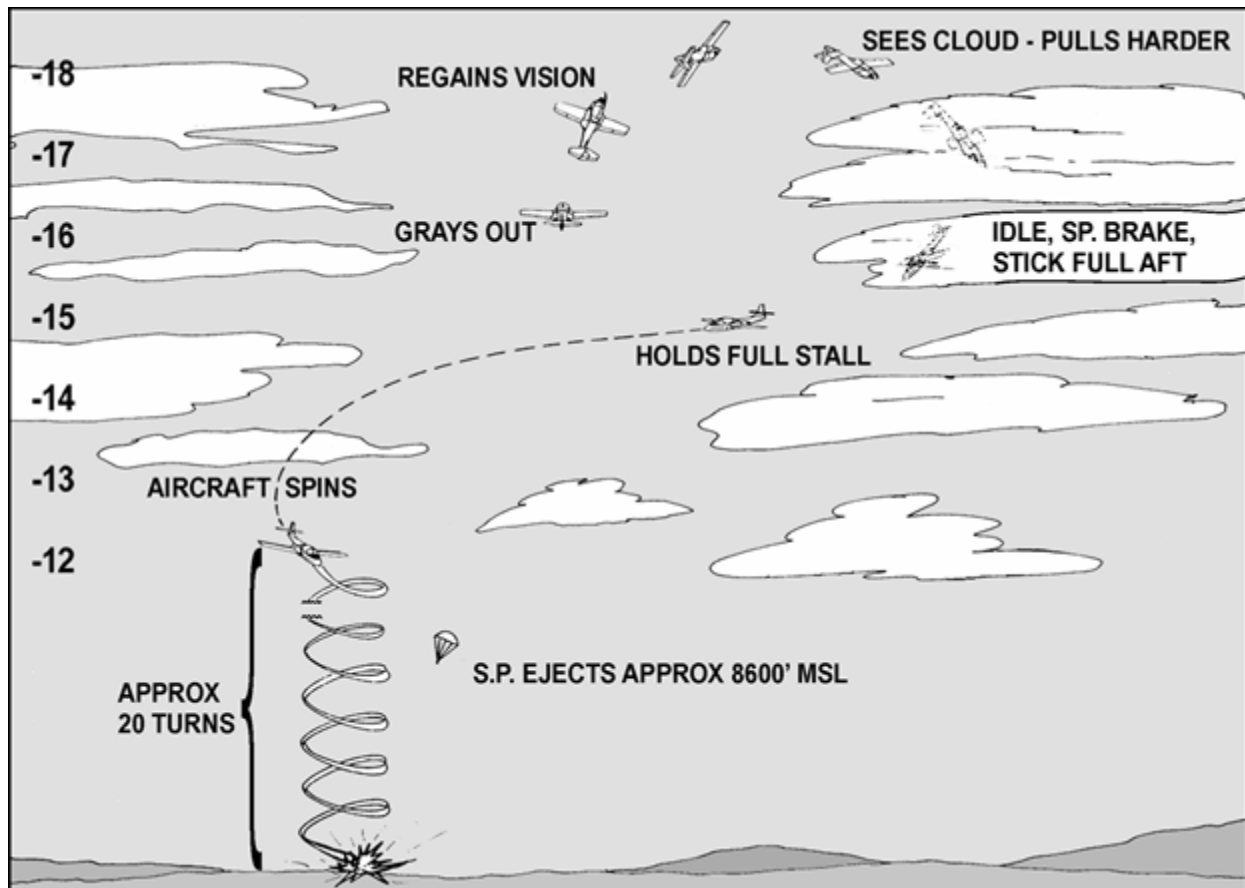
Figure 94. Disorientation – Area/Weather.

87.1. **Mishap.** **Figure 94.** The student pilot was briefed for a pattern-only sortie because weather conditions did not permit solo operations in the training areas. The SOF determined the weather had improved enough to warrant a flying status with solo students limited to the low sectors of the areas. The student proceeded to an auxiliary field for practice approaches and then to a training area for aerobatics. Subsequently, the student ejected sustaining no significant injuries. The aircraft impacted the ground and was destroyed.

87.2.1. **Supervisory Factor.** The SOF changed the flying status, but failed to ensure RAPCON was notified to keep solo students in the low sectors only.

87.2.2. **Operator Factor.** The student was notified the flying status had been changed and departed the auxiliary field for the training areas despite being briefed for a pattern-only sortie. RAPCON cleared the student to operate in both high and low sectors of a training area. The student began practicing aerobatic maneuvers in unsuitable weather conditions. While attempting a loop, the student inadvertently entered the clouds and became apprehensive, confused, and disoriented. He misapplied the controls and lost control of the aircraft. The student exited the clouds still suffering from apprehension, confusion, and disorientation causing him to hold a full aft stick stall until the aircraft entered a spin. He attempted a spin recovery, but misapplied the controls and failed to recover before minimum recommended ejection altitude for uncontrolled flight. The

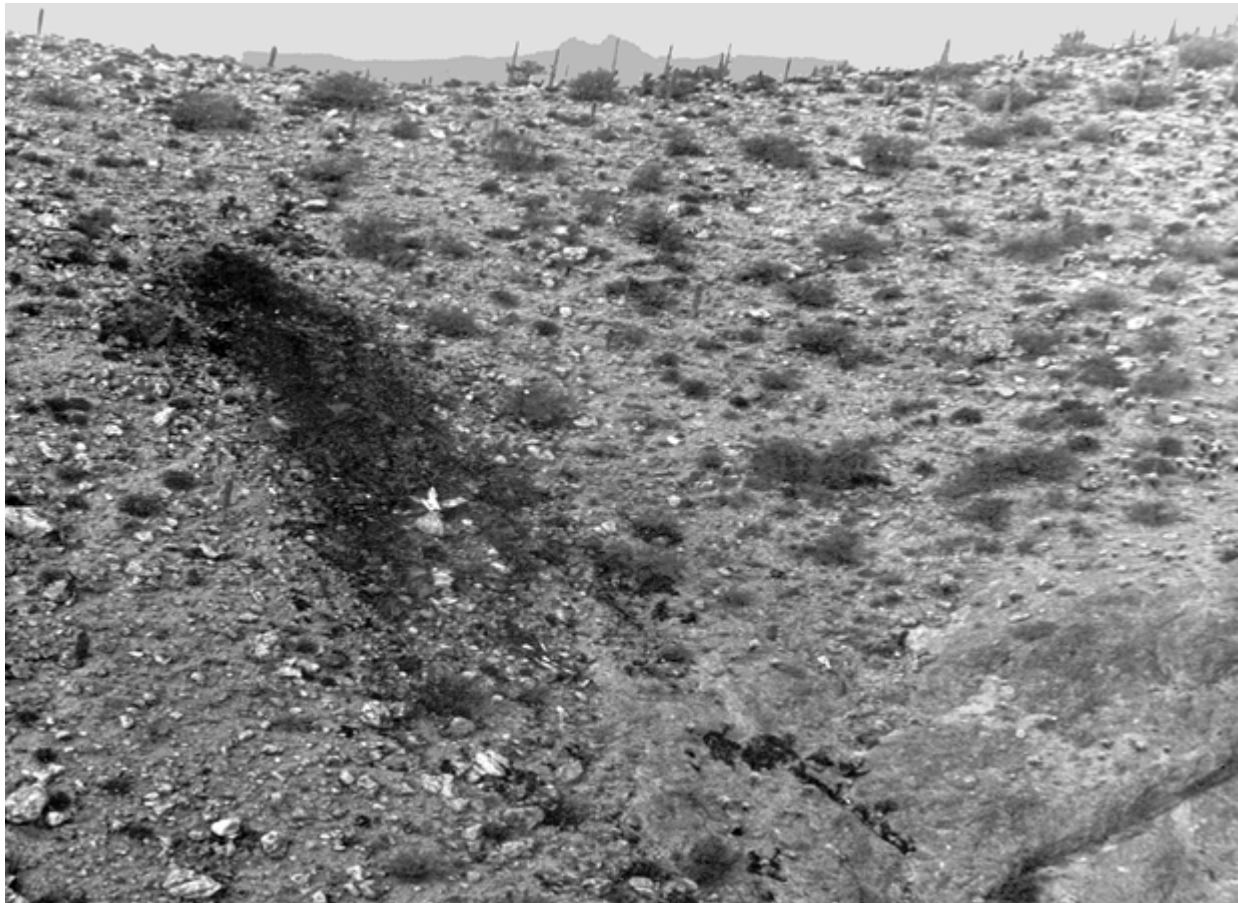
Figure 95. Lost Control – Area/Air Discipline.

88.1. **Mishap. Figure 95.** The mission was an advanced solo-contact sortie. After reaching the assigned training area, the aircraft impacted the ground and was destroyed. The pilot was fatally injured.

88.2.1. **Operator Factor.** For an undetermined reason, the student pilot lost control of the aircraft. The student may have intentionally descended below his assigned airspace to perform unauthorized low altitude flight and lost control of the aircraft, or he may have performed a maneuver in his assigned area and lost control of the aircraft.

88.3.1. There was substantial evidence the mishap pilot may have intentionally departed his assigned area. The student pilot's attitude during training, although unnoticed by instructors, reflected a tendency to observe only the regulations and rules he felt were important. This mishap indicates a need for increased awareness by instructors to detect and eliminate from training student pilots who display poor air discipline characteristics. Additionally, peers must not dismiss their responsibilities concerning air discipline by silently condoning such violations. Tolerance of poor air discipline breeds poor air discipline.

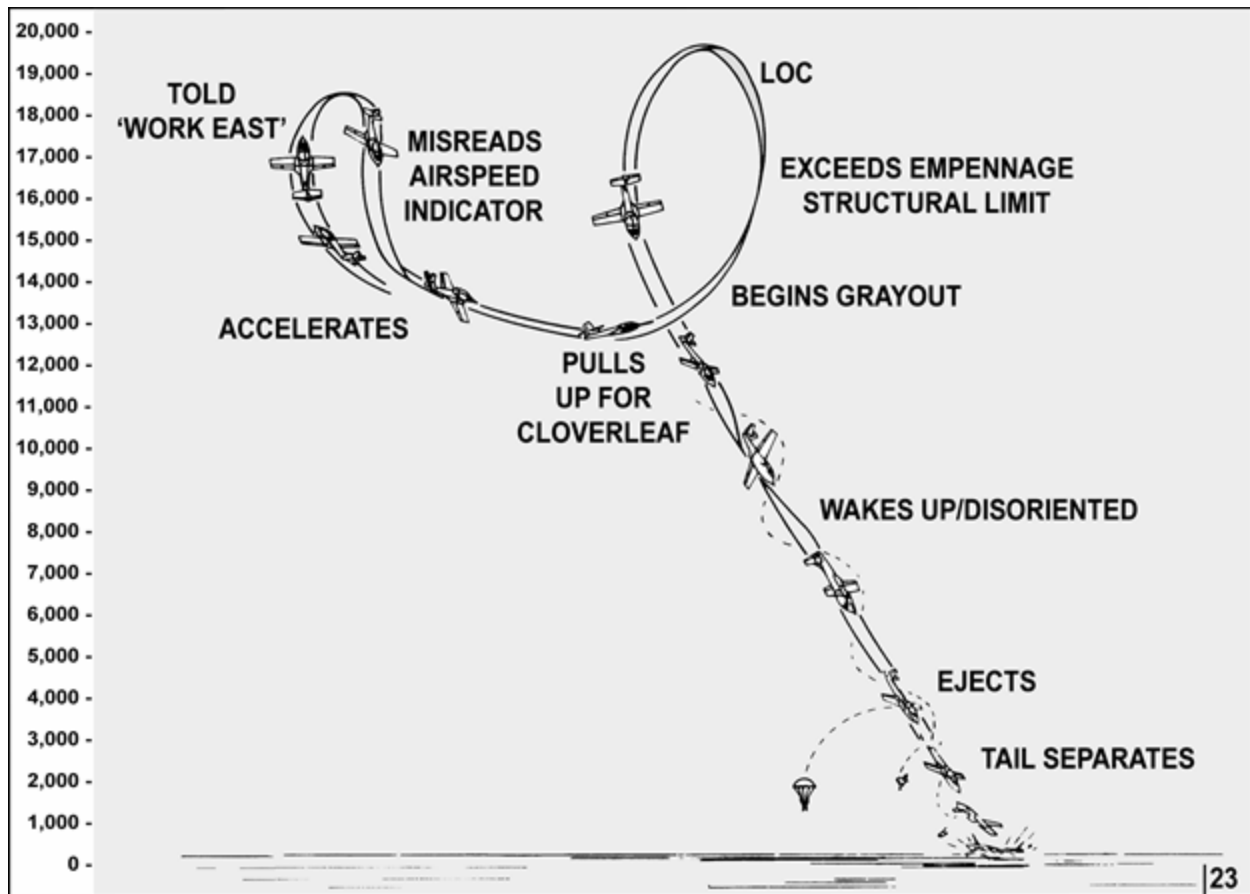
Figure 96. Lost Control – Area/Over G.

89.1. **Mishap. Figure 96.** The mission was a solo-contact mission. The student pilot flew to his assigned area and performed aerobatic maneuvers. During the initiation of a cloverleaf, structural failure occurred. The student ejected at an altitude of 2,850 feet AGL. The aircraft impacted the ground and was destroyed. The student sustained minor injuries during his ejection.

89.2.1. **Operator Factor.** While accelerating for a cloverleaf, the student misread the airspeed indicator. He accelerated the aircraft to an airspeed 100 knots greater than the airspeed specified in the governing directive. The student did not sufficiently trim the aircraft for the higher airspeed and initiated the cloverleaf, using a rapid elevator input. The improper trim, combined with the student's rapid control input, created a critical loading condition on the horizontal stabilizer, which resulted in deformation of the forward spar. The student lost consciousness due to the rapid, high G onset. The student regained consciousness, perceived he was out of control, and successfully ejected from the aircraft. The deformation of the forward spar culminated in the catastrophic failure of the empennage. The aircraft impacted the ground and was destroyed.

89.3.1. Abrupt stick movements can induce a failure load on the stabilizer. These loads can occur within the normal operational flight envelope depending on aircraft weight, center of gravity, roll rate, and rate of elevator deflection. Pilot technique determines the potential for overloading the stabilizer. Therefore, pilots must be aware of the danger in abrupt stick movement at high airspeeds, particularly in an untrimmed condition.

89.4.1. T.O. guidance was amended to inform pilots of the hazards of abrupt control movements at high airspeeds.

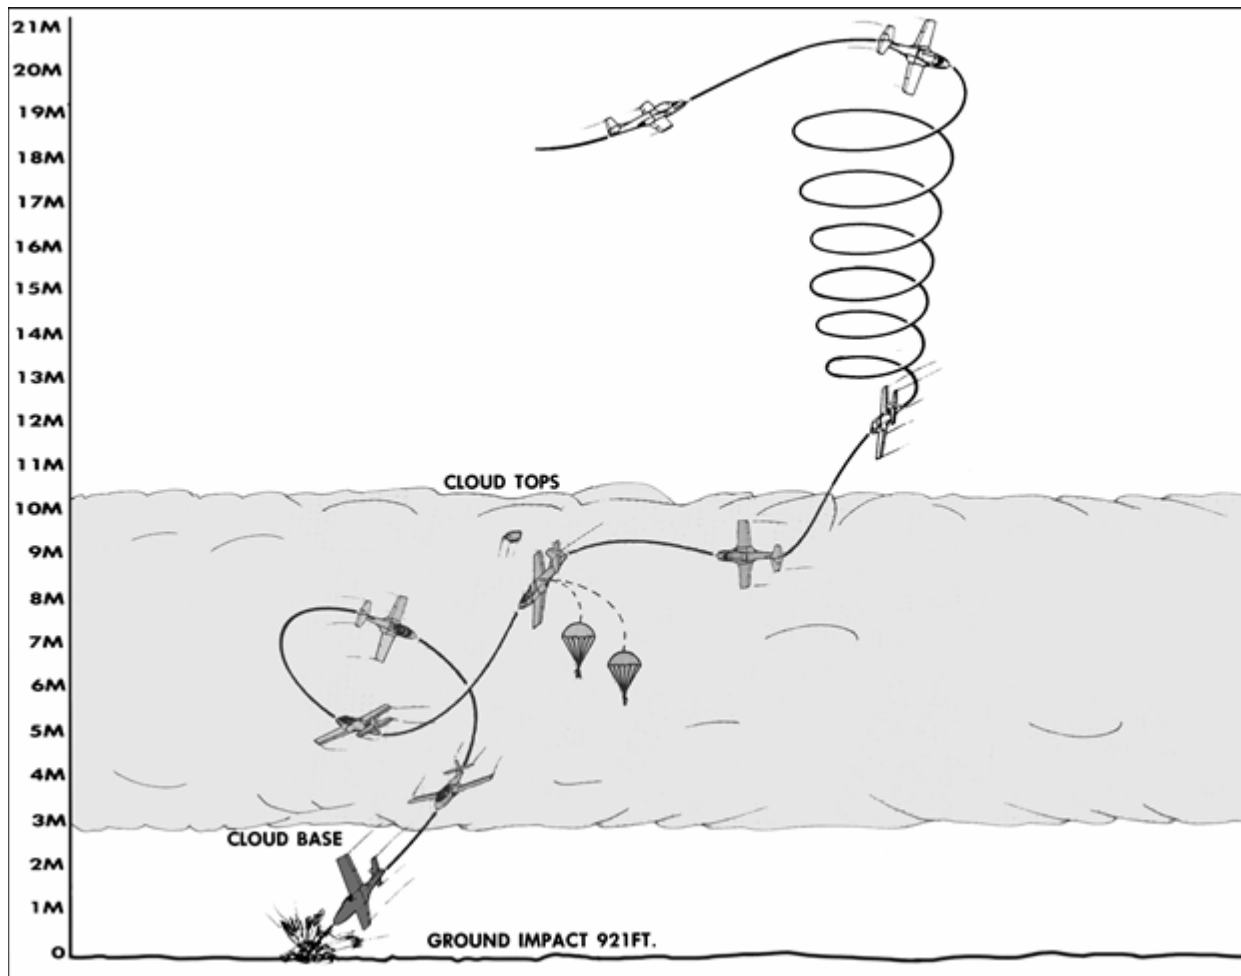
Figure 97. Disorientation/Spin Demonstration Flight.

90.1. **Mishap.** **Figure 97.** The sortie was planned and briefed as a Stan/Eval spin demonstration flight. The mission proceeded normally until the “slow prevention” demonstration. At that time, the spin pilot started the maneuver from a right entry at 20,300 feet MSL. He demonstrated the attempted slow spin prevention and, after reaching full control deflection, transferred aircraft control to the other pilot for the spin recovery. During the dive recovery portion of this maneuver, the aircraft entered a cloud deck at approximately 10,500 feet MSL. Both crewmembers were unsuccessful in recovering the aircraft, but ejected safely. The aircraft was destroyed upon ground impact.

90.2.1. **Supervisory Factor.** Based on available PIREPs, the spin pilot decided to launch the sortie with the intent to check the weather once airborne. On departure, the aircrew broke out of the clouds at 8,000 feet MSL and thought the cloud tops looked level. While proceeding at 13,000 feet MSL to the assigned working area, the mishap aircrew was unable to discern the cloud tops sloping up to 10,500 feet MSL. Without checking actual cloud tops, the spin pilot entered a spin to demonstrate the attempted slow prevention.

90.3.1. The spin pilot's failure to check the cloud tops caused this mishap. However, concern centers on the strong possibility that under similar circumstances this kind of misjudgment might occur again. During spin demonstration flights, always knowing exact cloud tops within a working area can be impractical. The mission requires at least six spins and each uses a significant amount of time to climb above the minimum entry altitude to begin the next demonstration. During the time between spins, cloud tops can rise significantly. The spin demonstration flight further compounds the problem due to the large variations in recovery altitudes associated with some of these maneuvers. A final concern is the severe disorientation problem associated with entering clouds during a spin or shortly after recovery. As demonstrated in this mishap, without sufficient time and altitude, recovery may be impossible.

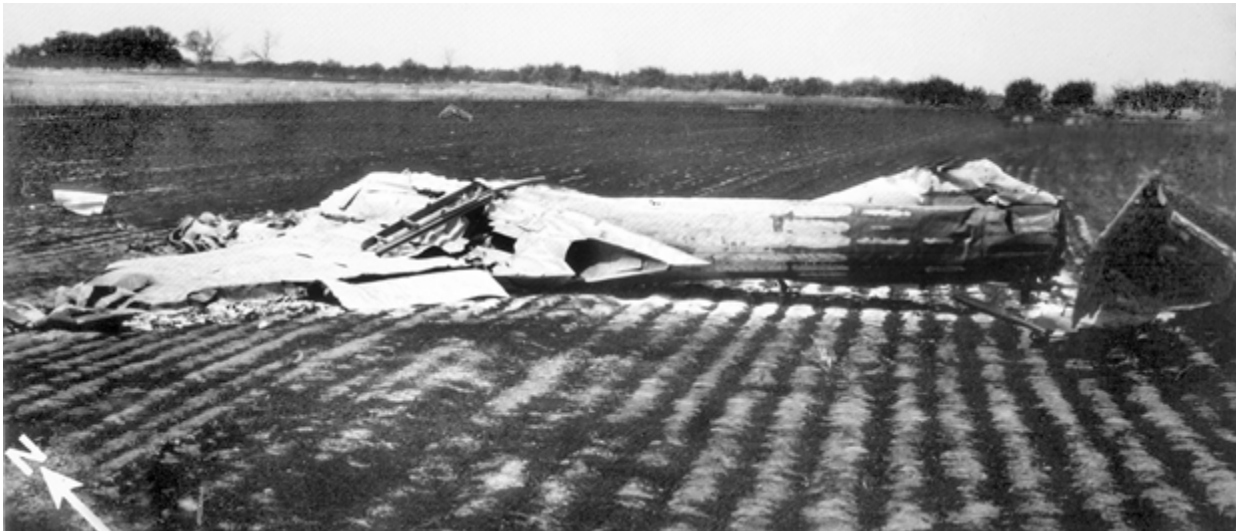
Figure 98. Lost Control – G-LOC (Solo-Contact Sortie).

91.1. **Mishap. Figure 98.** The mission was an area solo-contact sortie. After reaching the assigned area, the student pilot accomplished several low-G aerobatic maneuvers. As the student pilot was performing an Immelman, he noticed his vision begin to gray out. He then made a conscious effort to bear down on his anti-G straining maneuver (AGSM) and to continue the Immelman. The student pilot then experienced G-induced loss of consciousness (G-LOC), and the aircraft continued in a vertical attitude before entering a spin. The student pilot regained consciousness shortly afterward, and noticing his aircraft in an apparent spin decided it was unresponsive to his control inputs. As he passed the bottom of his area, he ejected. The aircraft impacted the ground in a left spin and was destroyed. The student pilot was not injured.

91.2.1. **Operator Factor.** During the pull-up for the Immelman, the student pilot failed to initiate the AGSM prior to the onset of G-forces. As a result, he experienced a disorienting grayout/blackout. He elected to continue the Immelman and, in an attempt to regain his vision, improperly altered his AGSM technique. Because of this, he experienced a G-LOC episode. The aircraft continued in a near vertical attitude. During his post-G-LOC state of relative incapacitation (where he was conscious, but had not yet regained control of his extremities), the student pilot made inadvertent control inputs as the aircraft approached its apex. This caused the aircraft to enter a left spin. While still disoriented and confused, the student pilot improperly applied spin prevention controls and the aircraft continued to spin. At the bottom of his altitude block, he ejected successfully.

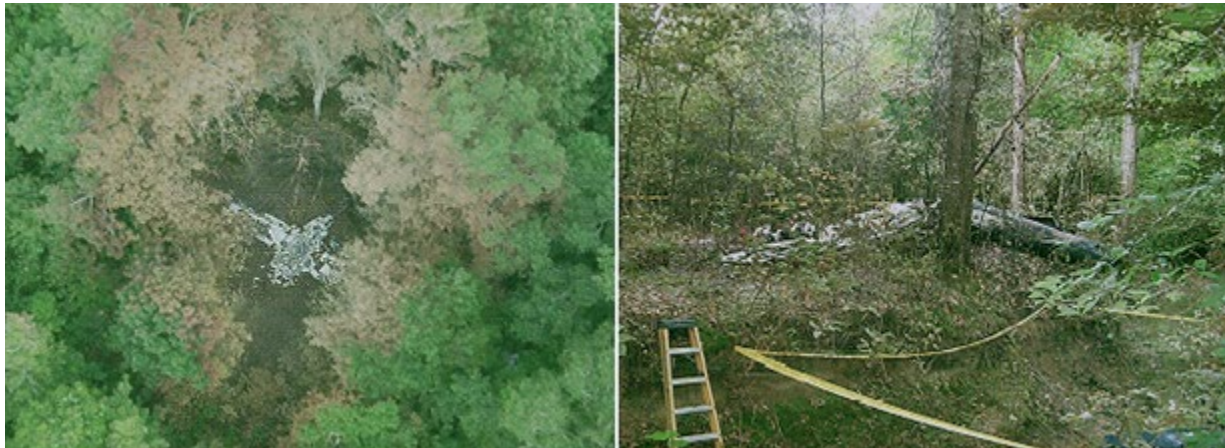
Figure 99. Lost Control/G-LOC.

92.1. **Mishap. Figure 99.** The mission was the student's fourth solo training mission and planned to practice basic aerobatic maneuvers. The student pilot entered the low MOA, completed required aircraft checks, and started a G-awareness exercise. Shortly into the turn, the student pilot noticed a low pitch attitude and airspeed nearing upper limits. While focusing on reducing airspeed, the student pilot experienced a G-LOC. When the student pilot regained consciousness, he was descending and the aircraft was in a spiral or spin. After initial control inputs did not recover the aircraft, the student pilot ejected safely. The aircraft impacted the ground and was destroyed.

92.2.1. **Operator Factor.** Due to channelized attention on the increasing airspeed, the student pilot failed to maintain an effective AGSM. As a result, the student pilot experienced gray-out and a subsequent G-LOC. During the post-GLOC reduced state of consciousness, the student pilot probably made bad control inputs resulting in a spin.

92.3.1. It is imperative that aircrew members remain ahead of the jet and anticipate possible problems that may occur. Implementing proper techniques in a timely manner can prevent an undesirable situation from becoming an unmanageable chain-of-events. In this mishap, the student pilot's channelized attention on the increasing airspeed caused him to neglect the AGSM, leading to a G-LOC, improper control inputs, a spin, and the loss of an aircraft. The decision to eject however is not in question.

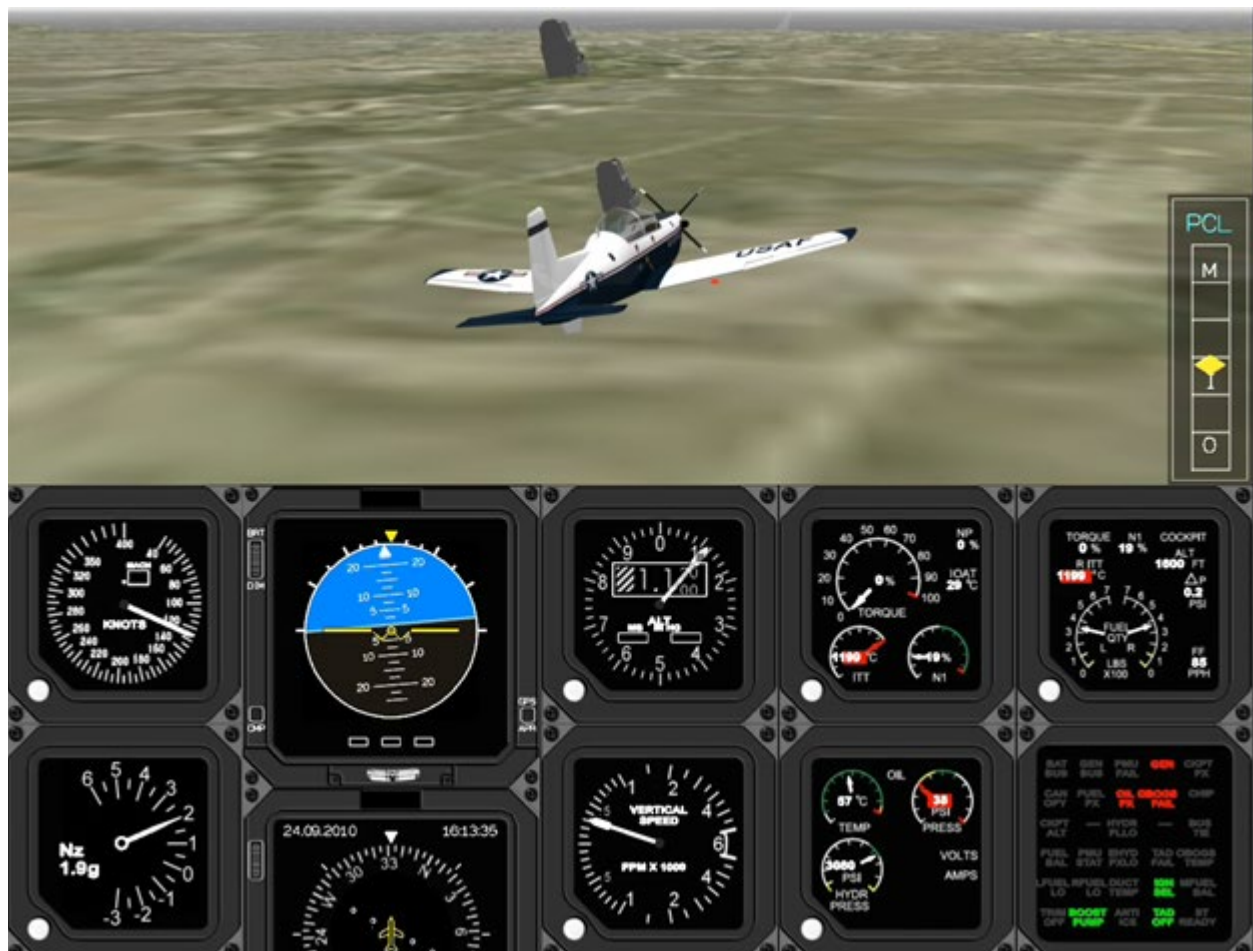
Figure 100. Second Inadvertent Engine Shutdown /Straight Ahead Rejoin.

93.1. **Mishap. Figure 100.** This mission was the second ride of the formation phase of pilot training. The formation departed the airfield and completed normal in-flight checks once established in their assigned MOA. The formation completed their maneuvers as planned and initiated recovery back to base. As the formation leveled at 6,000 feet, the Lead Aircraft directed Aircraft 2 to rejoin to the fingertip position. Aircraft 2 was in trail and set up for a straight-ahead rejoin. Following procedure, Lead maintained 200 knots and level flight while Aircraft 2 attempted the rejoin. Shortly thereafter, Lead inadvertently descended 200 feet and initiated a correction back to their assigned altitude. This correction caused the aircraft to

slow while climbing back to 6,000 feet. Lead returned to the proper altitude but was flying at 190 knots instead of 200. As Lead leveled off, Aircraft 2 attempted to rejoin the formation at 220 knots. The IP in Aircraft 2 recognized the excessive closure, took control of the aircraft from the student, and aggressively retarded the PCL to idle. Unfortunately, instead of grabbing the PCL, he unintentionally grabbed the PCL cutoff finger lift and moved the PCL to off which initiated the engine's shutdown sequence. The IP immediately recognized his error and instinctually brought the PCL forward towards max (62%). Data showed this action prevented the engine from completing the shutdown sequence, and the engine would have remained operational. However, the IP misanalysed the engine displays, perceived the engine was shutting down, and returned the PCL to the off position. This resulted in shutting down the aircraft's only engine. The operating manual directs that, in the event of an air start, the pilot should turn towards the nearest landing surface and zoom the aircraft to trade airspeed for altitude until reaching the desired glide speed of 125 knots. The IP accomplished neither of these steps, and instead focused on restarting the engine. If the IP had zoomed the aircraft properly, he would have gained nearly two minutes of flight time. The IP rushed through the emergency procedure checklist for 'IMMEDIATE AIRSTART' and misapplied the steps. The engine failed to relight due to his errors. Frustrated, the IP then brought the PCL back to the off position and reattempted the checklist. This time he correctly completed the first three steps of the checklist and the engine relit. The checklist states that following a successful airstart, the PCL must remain at idle until the engine completes the start and returns to normal operating parameters. The checklist notes that this will take approximately 40 seconds. The IP prematurely advanced the PCL out of idle creating high fuel flow, raising engine temperature, and causing catastrophic engine failure. At this point, the aircraft was below 5,000 feet at 125 knots without an emergency landing airfield within gliding range. As the engine began winding down following the PCL advance, the IP became exasperated and channelized his attention on restarting the engine. The IP attempted the airstart four more times before the student pilot suggested they eject. The crew bailed out at 580 feet above the ground and was safely recovered by local emergency responders. The aircraft impacted the ground and was destroyed 14 seconds after the crew ejected.

93.2.1. **Logistics Factor.** Due to the acquisition policies/design process, the USAF accepted the aircraft with a deficient Power Control Lever (PCL) cut-off gate handle design. This deficiency has been identified as causal in 11 mishaps over ten years, including two class A and one class B.

93.2.2. **Operator Factor.** Mishap Instructor Pilot (MIP) The MIP completed the BOLDFACE portion of the T.O. "IMMEDIATE AIRSTART (PMU NORM)" checklist. However, he did not properly apply the remainder of the checklist. The MIP prematurely advanced the PCL prior to engine stabilization at IDLE RPM due to inadequate technical/procedural knowledge.

93.3.1. Analyze the situation, take the appropriate action, and land as soon as conditions permit is drilled into every USAF aviator. Applying these measures have a common theme of slow the situation down as much as possible and be methodical in your actions and application of the proper procedures. Procedural trainers can help train proper procedures and practice especially boldface item in real time scenarios. However no simulator can instill the fear factors that will be present during an actual emergency but should develop

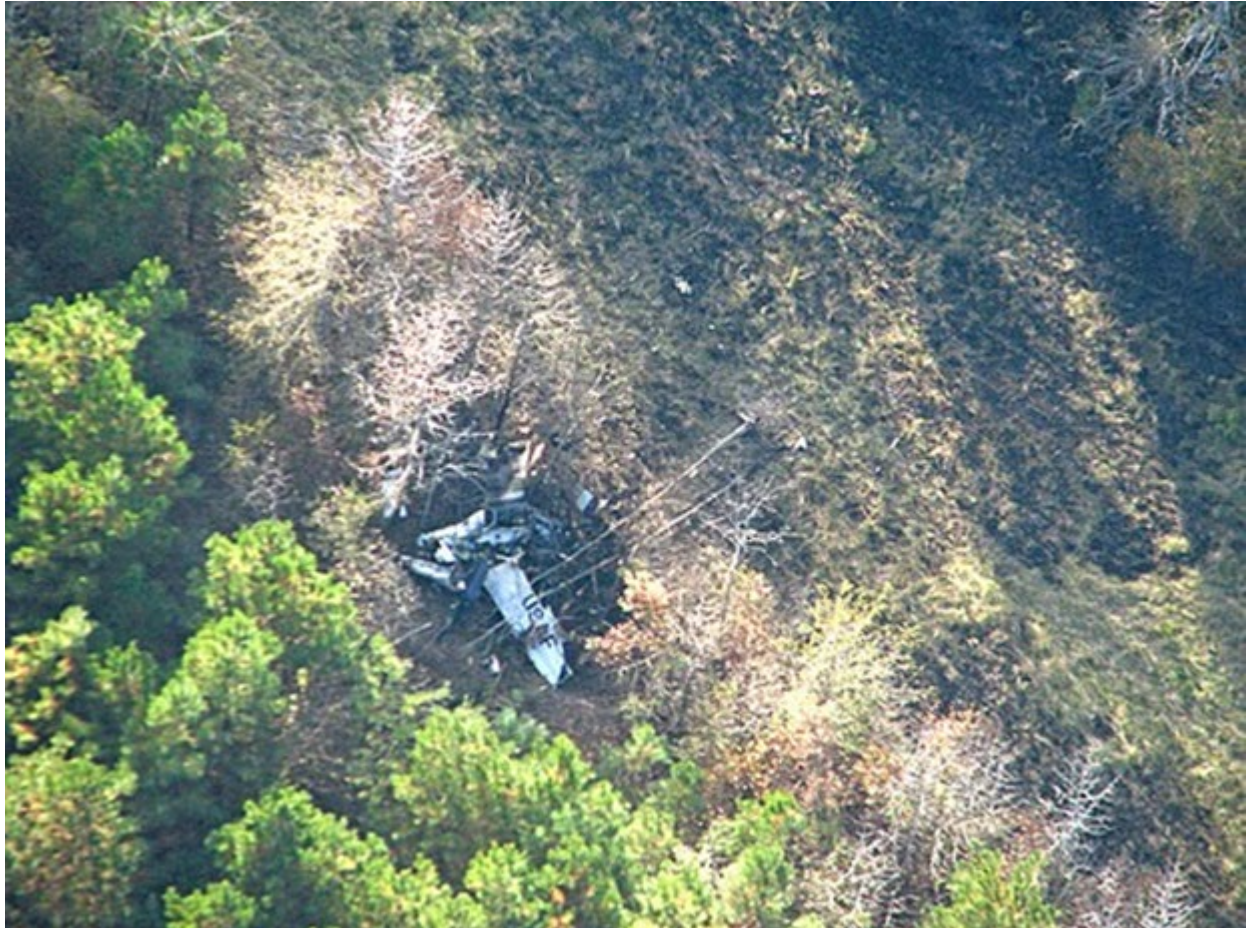
Figure 101. Midair Collision/Pattern Breakout.

94.1. **Mishap. Figure 101.** This mishap began like many pilot training sorties with a trip down to one of the auxiliary airfields. On this day, Texan 1 departed the local pattern for the auxiliary field, and Texan 2 followed seven minutes later. The auxiliary field pattern was set up similarly to the traffic pattern at home station; however, the VFR entry point was also the radar termination point. Aircraft that broke out of the pattern and aircraft that just arrived at the auxiliary field would use the same point to intercept the outside downwind ground track. For decades, aircraft had been operating at the auxiliary field under these procedures without incident. But procedures are not necessarily safe just because nothing tragic has happened yet. After a normal pattern, Texan 1 climbed above pattern altitude to 2,000 feet above the ground and turned towards the VFR entry point. Texan 1 complied with local guidance while executing this maneuver and made a radio call: "Texan 1, perch point, breaking out." Two seconds after that transmission, Texan 2 switched to the auxiliary field's frequency and announced that they would be entering the pattern through the same VFR entry point. According to local guidance, Texan 2 would maintain 1,000 feet above the ground while they entered the pattern. Texan 1 and Texan 2 were safely separated by 1,000 feet of altitude as they both converged towards the same entry point. The auxiliary field's control tower advised Texan 2 of the current winds and landing runway. Texan 2 heard this transmission but did not hear Texan 1's transmission and assumed they were the only aircraft in the pattern. As Texan 2 approach the entry point, the crew searched the sky for aircraft established in the pattern at their nine to ten o'clock position. Texan 1 was hidden at their high 1 o'clock position. Still assuming they were the only aircraft operating at the auxiliary field, Texan 2 initiated a climbing turn away from the pattern and back towards the entry point in order to practice the traffic pattern entry again. According to local guidance, this was the correct procedure to follow if there was another aircraft in the traffic pattern at 1,000 feet. Additionally, the guidance directs the aircraft to make a radio call "Texan 2, VFR entry, breaking out." Texan 2 never made the radio call, and as a result Texan 1 had no idea that Texan 2 was changing course. Texan 2 initiated this maneuver for training to practice the traffic pattern entry again. As Texan 2 climbed, their left wing sliced through the fuselage of Texan 1, missing the rear cockpit seat by inches. Texan 1 instantly plummeted and spiraled uncontrollably. The crew immediately recognized an impending impact and exited the aircraft. Texan 2 completely lost its left wing in the collision. The crew quickly elected to bail out of the aircraft and launched up the ejection rails, out of the aircraft. All four crew members found themselves safe under their parachutes, and three of them managed to land without harm in the densely wooded countryside. The fourth pilot's parachute caught a tree, which left him suspended 60 feet above the ground. After hanging in the harness for an hour,

he was brought down to safety by local firefighters. All four crew members survived this mishap with minor injuries.

94.2.1. **Supervisory Factor.** OG published guidance lead to non-standardized interpretations and ultimately fails to provide procedural deconfliction of aircraft at a fixed point where maneuvering aircraft are directed to converge.

94.2.2. **Operator Factor.** Mishap crews failed to successfully visually clear for conflicting aircraft. Flightpath geometry made visually acquiring either aircraft very difficult at the time of the event.

94.2.3. **Supervisory Factor.** Runway supervisory unit (RSU) failed to notify Texan 2 of the current pattern traffic advisory and Texan 1's location.

94.3.1. Pilot error, once again, caused the loss of over ten million dollars' worth of aircraft. The pilots, from both aircraft, failed to adequately clear their flight paths. This incident is a striking example where a series of small initial errors combine to a catastrophic result. The control tower failed to make an advisory call that there was

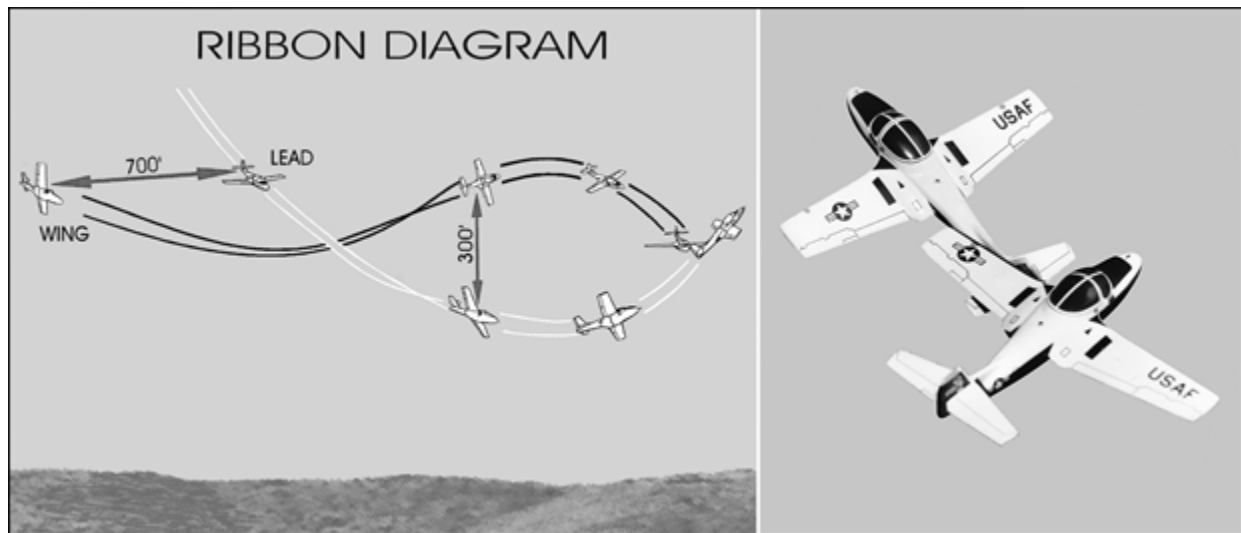
Figure 102. Midair Collision/Extended Trail Maneuvering.

95.1. **Mishap. Figure 102.** This mishap occurred during an instructor pilot formation continuation training mission. The flight was performing an extended trail, Cuban-8 maneuver. On completion of the Cuban-8, the wingman attempted to reposition to the inside of lead's left turn. Excessive angular cutoff resulted in the wingman departing the maneuvering cone to approximately line abreast with rapid closure on lead. The wingman attempted a late breakout. The wingman's left wing impacted the aft fuselage of lead, severing the tail section. Both aircraft were uncontrollable, but all four ejected successfully.

95.2.1. **Operator Factor.** The wingman inadvertently achieved excessive closure on lead and failed to execute proper evasive action in a timely manner.

95.2.2. **Supervisory Factor.** The instructor pilot not at the controls of the wing aircraft failed to intervene. The lead crew failed to adequately monitor the wingman.

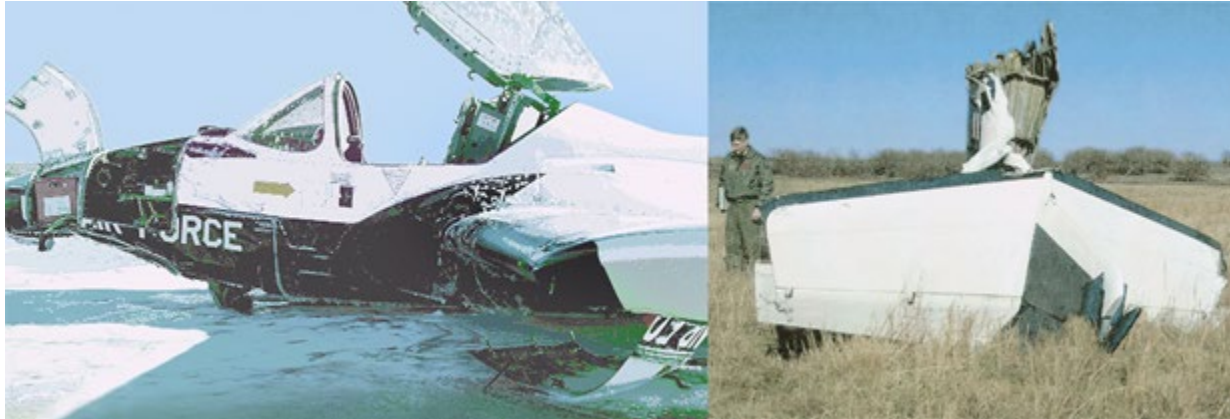
Figure 103. Midair Collision/Practice Breakout.

96.1. **Mishap. Figure 103.** The mission was a dual two-ship formation syllabus flight. It was the first flight of the day for all four pilots and the third formation flight for both students. Planned area work for the flight consisted of wingwork, echelon turns, pitchouts and crossunders. Lead began the second set of planned wingwork with the wingman positioned on the left. As lead began a climbing left turn, the wingman initiated a practice formation breakout. As the SP in the wing aircraft attempted a radio call, his IP's attention was momentarily diverted away from the maneuver. At this time, both the IP and SP in the lead aircraft lost sight of their wingman. The lead aircraft continued the maneuver and began the descending portion of the leaf in spite of not hearing an expected rollout call. The IP in the wing aircraft assumed separation was adequate and directed a rollout to look for lead. As the IP and SP in the wing aircraft were looking right, the lead crew was looking left and descended upon the wing aircraft. The left wing of the wingman's aircraft impacted the bottom of the nose of the lead aircraft. The wing aircraft pitched over and spiraled away from

the lead aircraft out of control. The crew successfully ejected. The lead aircraft coordinated with a chase ship and RTB for a gear-up landing. The crew egressed successfully.

96.2.1. **Operator Factor.** The SP in the lead aircraft failed to effectively use crew coordination when he lost sight of his wingman by not communicating such to his IP who was already blind due to the aircraft's cross-cockpit design. The crew in the lead aircraft did not hear and RAPCON did not record the wing SP's breakout radio call.

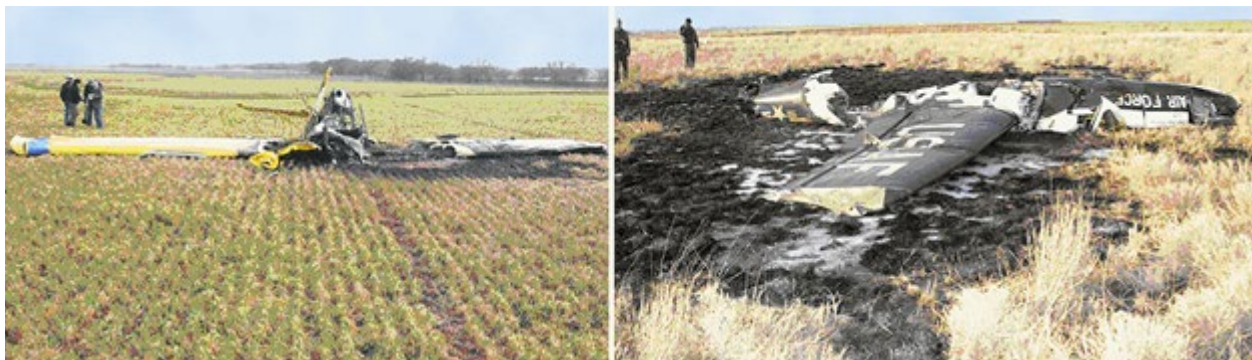
Figure 104. Midair Collision/Civilian Aircraft.

97.1. **Mishap. Figure 104.** The IP and SP were flying a syllabus contact sortie with planned area work followed by pattern work at the auxiliary field. The mission was uneventful up to the recovery to the home field. The SP contacted RAPCON and requested vectors. Radar contact was made and the crew was given radar vectors and an IFR clearance to 5000 feet MSL. The IP took control of the aircraft as they leveled at 5000 feet MSL. After several moments the SP asked the IP a question and the IP turned toward the student. When the IP turned back he saw an airplane out of the corner of his eye but did not have time to react. The two airplanes collided at an approximate 100-degree heading-crossing-angle. The aircraft's right wing was sheared off at the right wing root and sustained severe damage to the tail section. The civilian airplane received severe damage to the fuselage in front of and including the cockpit. The aircraft went into a tumbling inverted spin and the crew ejected successfully. It is unknown if the civilian pilot was killed during the midair or during ground impact and was found in the aircraft. The aircrew was transported to a medical facility where they were treated and released.

97.2.1. **Operator Factor.** Although not required, it was determined that the civilian pilot did not file a flight plan, have a transponder, or use his hand held radio to communicate with RAPCON. Additionally, the civilian pilot did not fly the appropriate VFR hemispheric altitude or properly use see and avoid or take advantage of the MIDAIR COLLISION AVOIDANCE (MACA) PROGRAM material available regarding military flying operations in the area. The IP and SP did not properly use see and avoid to prevent the midair collision with an aircraft that was not detected by RAPCON.
