**AIR EDUCATION AND TRAINING
COMMAND HANDBOOK 11-210**

04 FEBRUARY 2020

Flying Operations

ROAD TO WINGS

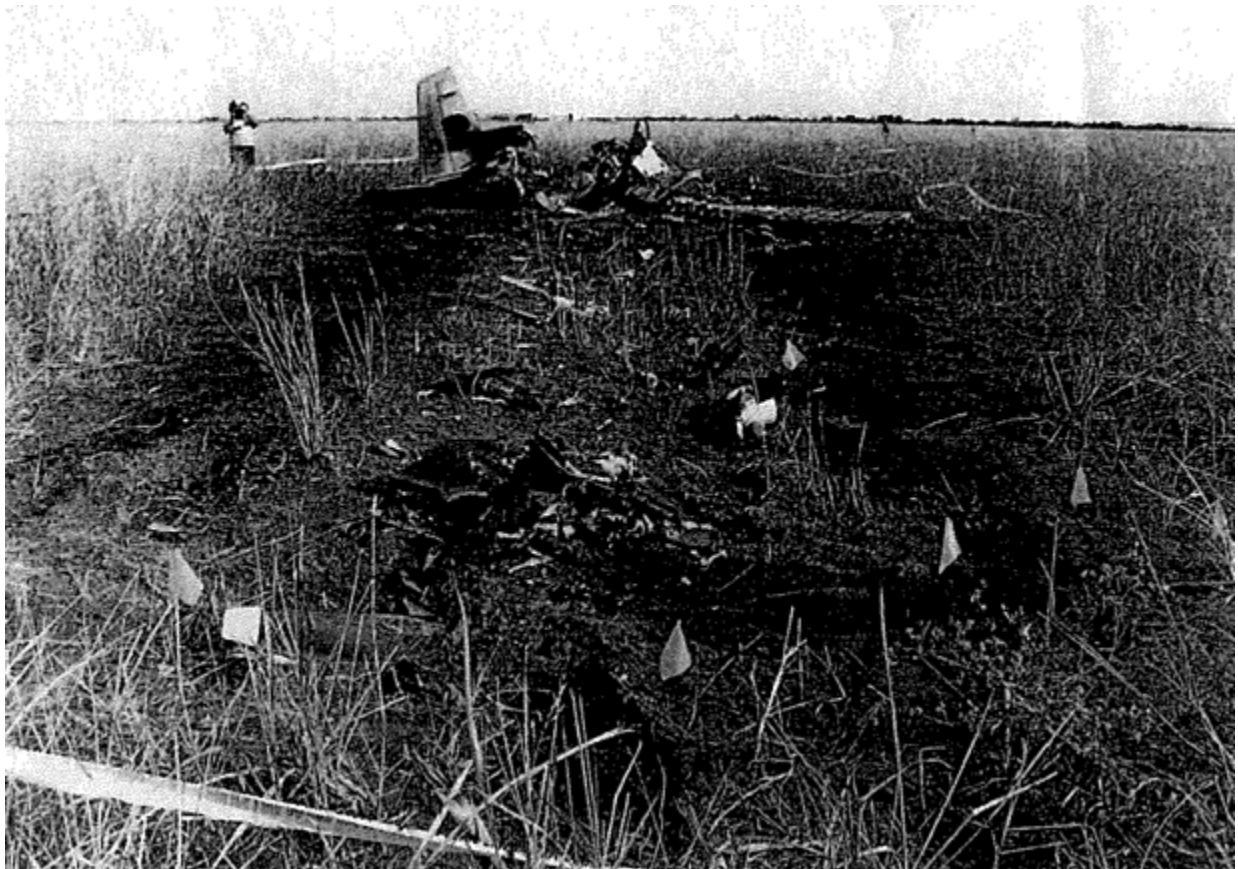
Figure 105. The First In-Flight Engine Shutdown

98.1. **Mishap. Figure 105.** The crew consisted of two IPs and they will be referred to as FCP and RCP. The sortie was part of the Instructor Enrichment Program that allows IPs to fly with IPs of different aircraft. One IP briefed the other IP on the egress procedures and cockpit familiarization, but failed to point out where the flap lever was located. As the rear cockpit pilot flew an instrument approach, he lowered the landing gear, but could not locate the flap lever. The front cockpit pilot attempted to describe how to find the lever, but the RCP still could not locate it. The RCP continued to search the side panel for the flaps. Finally, he located the label “FLAP” just in front of the Power Control Lever (PCL, similar to a throttle). The label was located in the middle of the panel equidistant from the PCL cutoff finger lift and the flap lever. The RCP IP saw the label, grabbed the PCL cutoff finger lift, lifted it, and moved it aft shutting off the engine. At the time of engine shutdown, the aircraft was flying 1,500 feet above the ground traveling at 120 knots. The aircraft’s oxygen system is driven by the engine. As soon as the engine lost power, the oxygen system shut down. This forced both pilots to drop their masks to breath. As the aircraft lost thrust, the FCP took control of the aircraft and attempted an air start. The engine failed to relight as it descended through 1,000 feet. Again, the FCP attempted another air start, and again the engine failed to relight. At this point the aircraft was just 500 feet above the ground. Both pilots recognized impact was inevitable and initiated ejection. The pilots ejected at 200 feet above the ground. Both pilots had their oxygen masks down, exposing their faces during the ejection sequence. Fortunately, their eyes were not injured, but their faces were permanently scarred as the canopy fracturing system fired during the ejection sequences. The FCP also broke his ankle during his parachute landing. The aircraft was destroyed.

98.4.1. Following this mishap, the Air Force added cockpit familiarization training prior to instructor enrichment sorties; installed anti-suffocation valves on the pilots' oxygen hoses, which allow breathing through a relief valve if the oxygen supply is cutoff; painted the PCL cutoff finger lifts red; and added the label "ENGINE CUTOFF." An emergency boldface procedure was written for immediate engine air-starts. After subsequent inadvertent in-flight engine shutdowns, a finger lift guard was also installed.

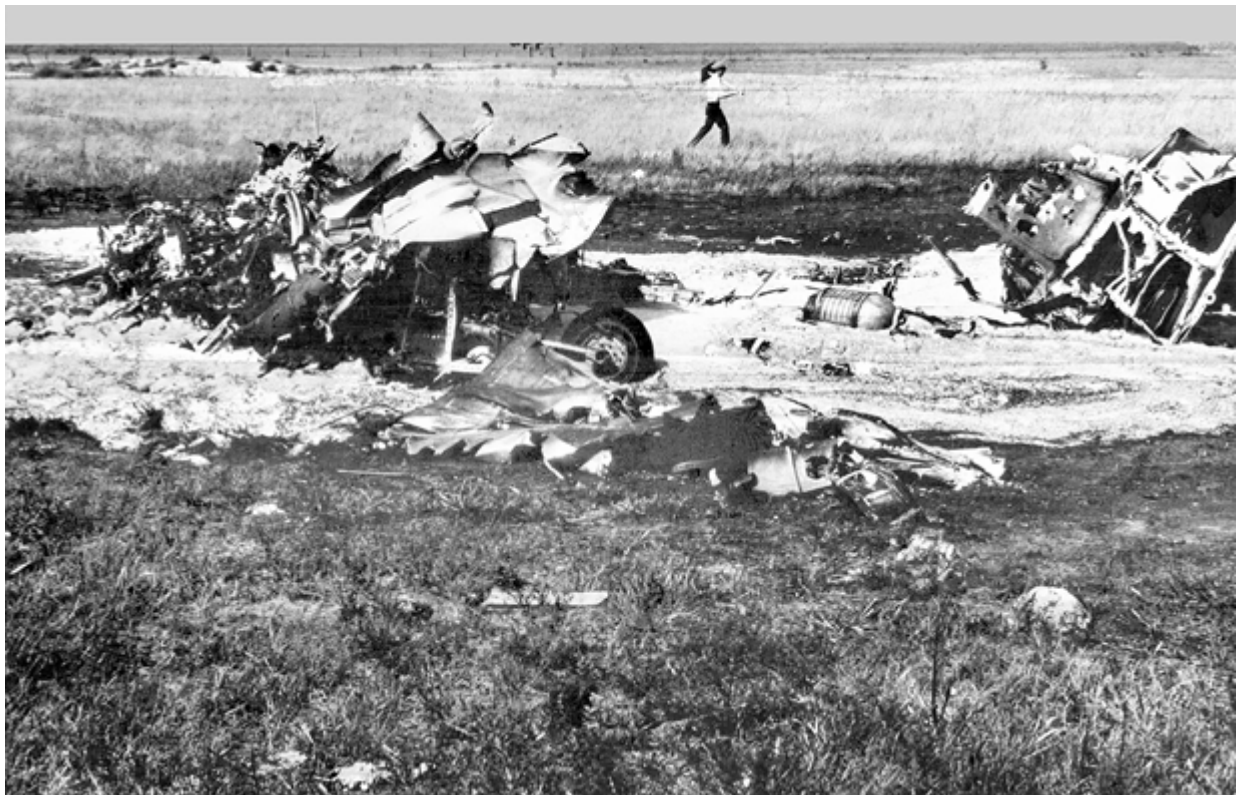
Figure 106. Traffic Pattern Stall.

99.1. **Mishap.** **Figure 106.** The mission was a solo traffic-pattern-only sortie. On the takeoff leg from the first touch-and-go landing, the student pilot requested an emergency

closed pattern. The closed pattern was approved, and the closed pullup was performed with the gear still extended. On downwind, the student angled toward the landing runway and the RSU directed a heading change to parallel the runway. The student made the appropriate heading change. The RSU crew noted the aircraft appeared slower than normal in a slightly nose-high attitude. The crew directed use of 100% power three times before the aircraft nose pitched down to approximately 40 degrees. The nose of the aircraft was observed to rise slightly and then drop near vertical with a rapid roll to the right. The aircraft impacted the ground in a nose low attitude and exploded on impact. The solo student received fatal injuries.

99.2.1. **Undetermined.** The temperature modulating valve was positioned fully open, either as a result of an unidentified malfunction or as a result of the student moving the temperature selector to the full HOT or near full HOT position.

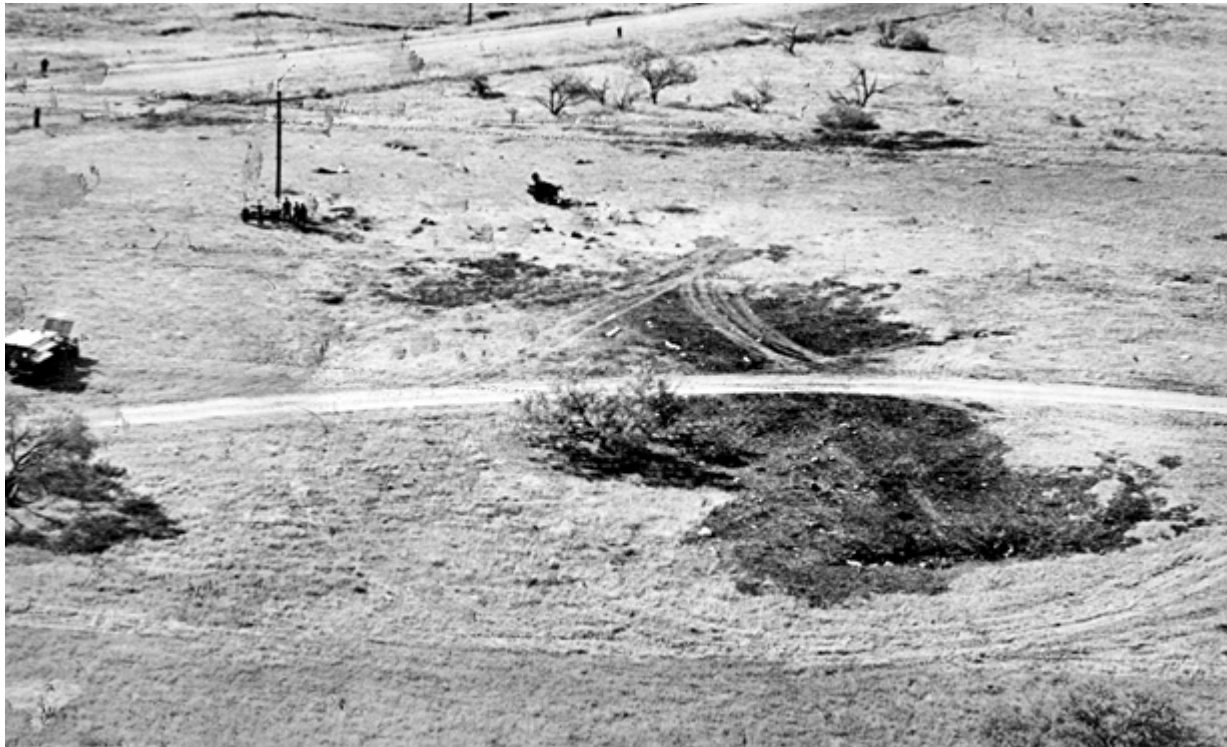
Figure 107. Engine Failure.

100.1. **Mishap. Figure 107.** The mission was a student pilot solo-pattern-only sortie. The student's first pattern was flown satisfactorily until final approach where he was sent around by the RSU controller because of a high flare. The student had to break out of the traffic pattern during the second pattern due to a potential traffic conflict. A normal pattern and touch-and-go landing followed this breakout. Just after a turn to the crosswind leg, the student alerted the controller to a problem. The student's next transmission concerned a loud noise in the cockpit. At this time, the RSU controller directed a turn toward the inside downwind. The student then transmitted he had smoke and fumes in the cockpit. The RSU controller requested the status of engine instruments. The student stated the left engine was at 80% RPM, which the RSU controller interpreted as both engines were at 80% RPM. The RSU controller next directed that the air-conditioner be placed in "vent." Shortly thereafter, the RSU controller noticed smoke trailing from the aircraft and saw the aircraft begin a descent. The RSU controller directed a bailout. The ejection was successful; the aircraft crashed and was destroyed.

100.2.1. **Logistics Factor.** A number one engine turbine blade was manufactured with surface discontinuities, which contributed to a fatigue crack. The manufacturer's quality control inspections did not detect the defects in the blade. Supervisors failed to ensure the turbine rotor blade inspection requirements were completed, resulting in the blade defects going undetected during maintenance inspections. During flight, a number one engine turbine blade failed.

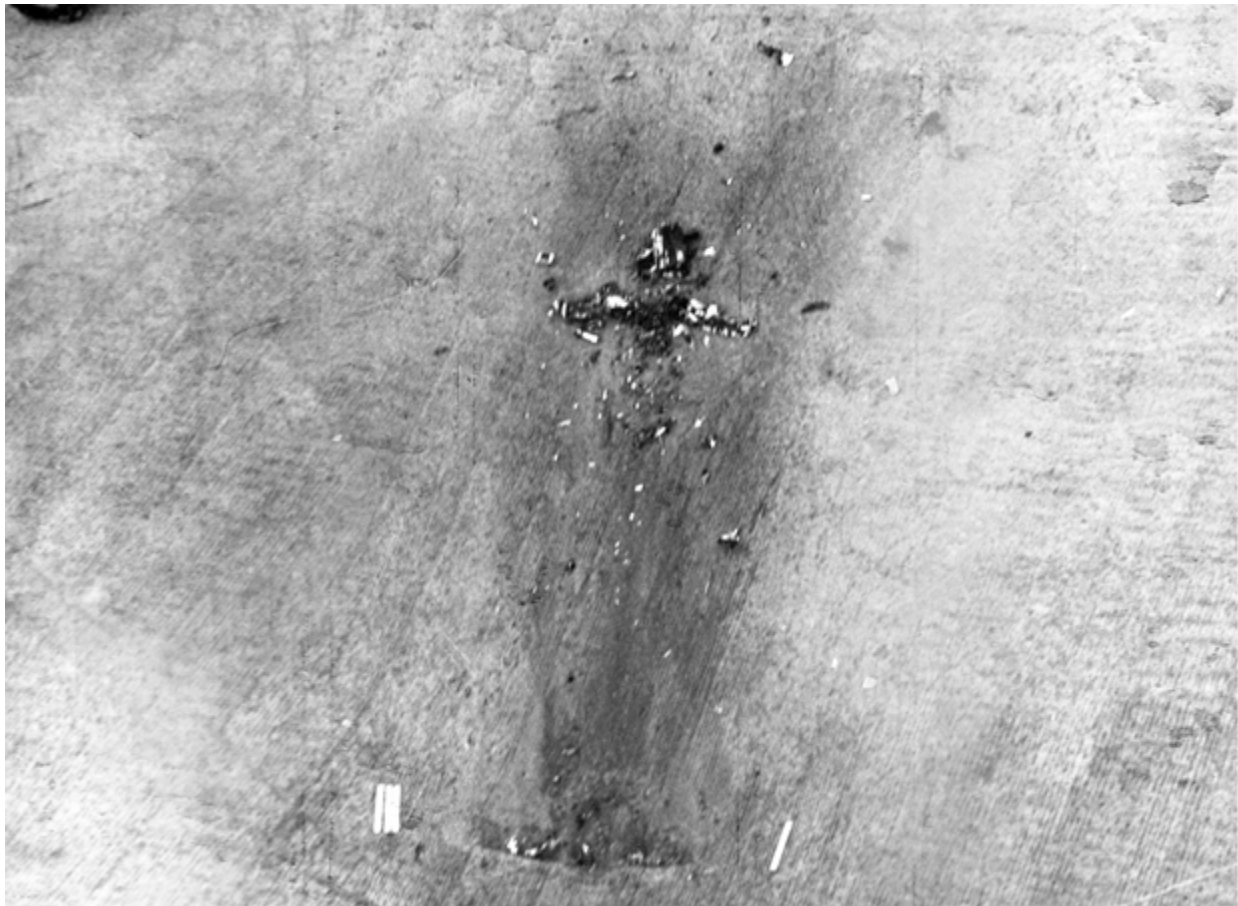
Figure 108. Dual Engine Failure.

101.1. **Mishap.** **Figure 108.** The mishap mission was a student pilot contact training sortie. The mission had progressed to the landing phase of the sortie. A touch-and-go landing had just been completed when the RSU asked the mishap crew to check the base of the clouds in the pattern. The instructor pilot assumed control of the aircraft, broke out of the pattern from the crosswind leg, checked the cloud bases, and passed the information to the RSU. The instructor pilot then descended to traffic pattern altitude and entered outside downwind at the entry point. Shortly thereafter, the crew transmitted they had experienced a dual-engine flameout and were ejecting. Both crewmembers ejected at about 800 feet AGL. The instructor pilot sustained major injuries during his parachute landing fall; the student sustained no significant injuries. The aircraft was destroyed upon ground impact.

101.2.1. **Maintenance Factor.** The flight before the mishap flight, a fuel transfer malfunction occurred, resulting in the premature illumination of the low-level and gravity-feed lights. Maintenance personnel did not adequately troubleshoot the system and failed to correct the fuel transfer malfunction by removing and replacing the float switch assembly. As a result, during the mishap flight, the lower float of the float switch assembly stuck at the midlevel switch position, preventing the transfer of fuel from the wing tanks to the fuselage tank.

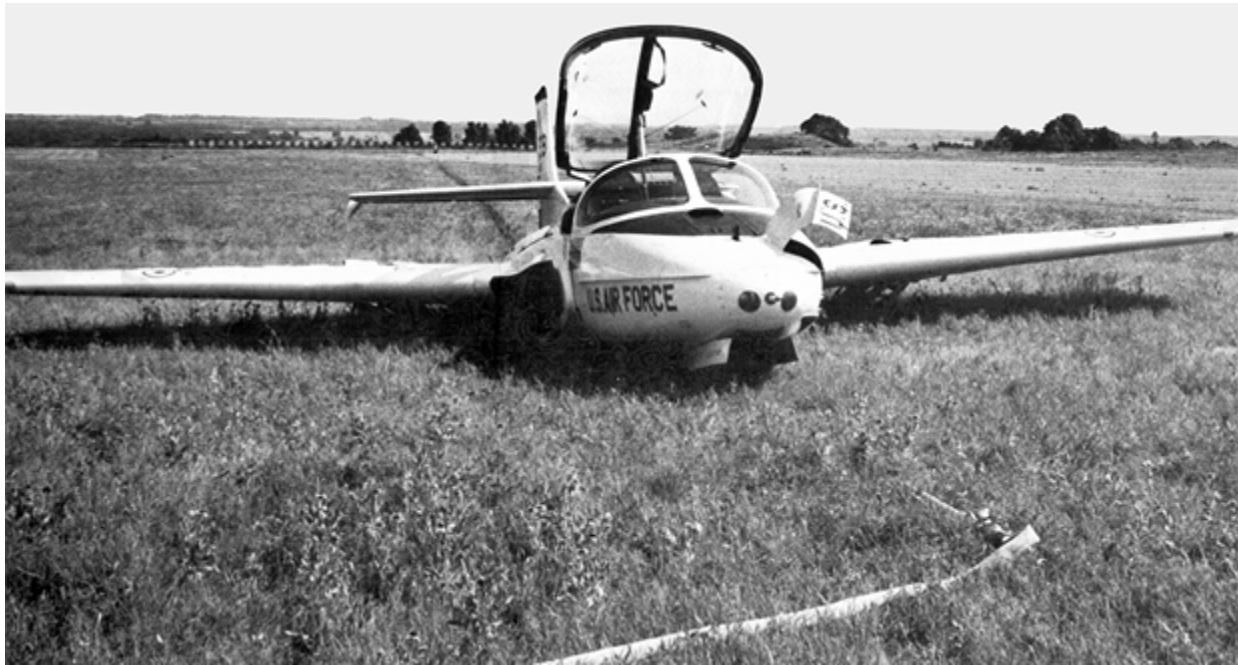
Figure 109. Short Landing.

102.1. **Mishap. Figure 109.** The aircraft was scheduled to transport the crew to an auxiliary airfield for the purpose of opening the RSU. Approaching the auxiliary airfield, the pilot began an idle power descent and then elected to fly a no-flap approach to landing. The aircraft touched down 19 feet short of the overrun, traveled 87 feet across a corner of the overrun, and continued 328 feet before coming to a stop 50 feet off the opposite edge of the overrun. The crew ground egressed with no significant injuries; the aircraft was destroyed.

102.2.1. **Supervisory Factor.** Squadron supervision was inadequate to ensure the aircrew flew a proper pattern upon arrival at the uncontrolled airfield.

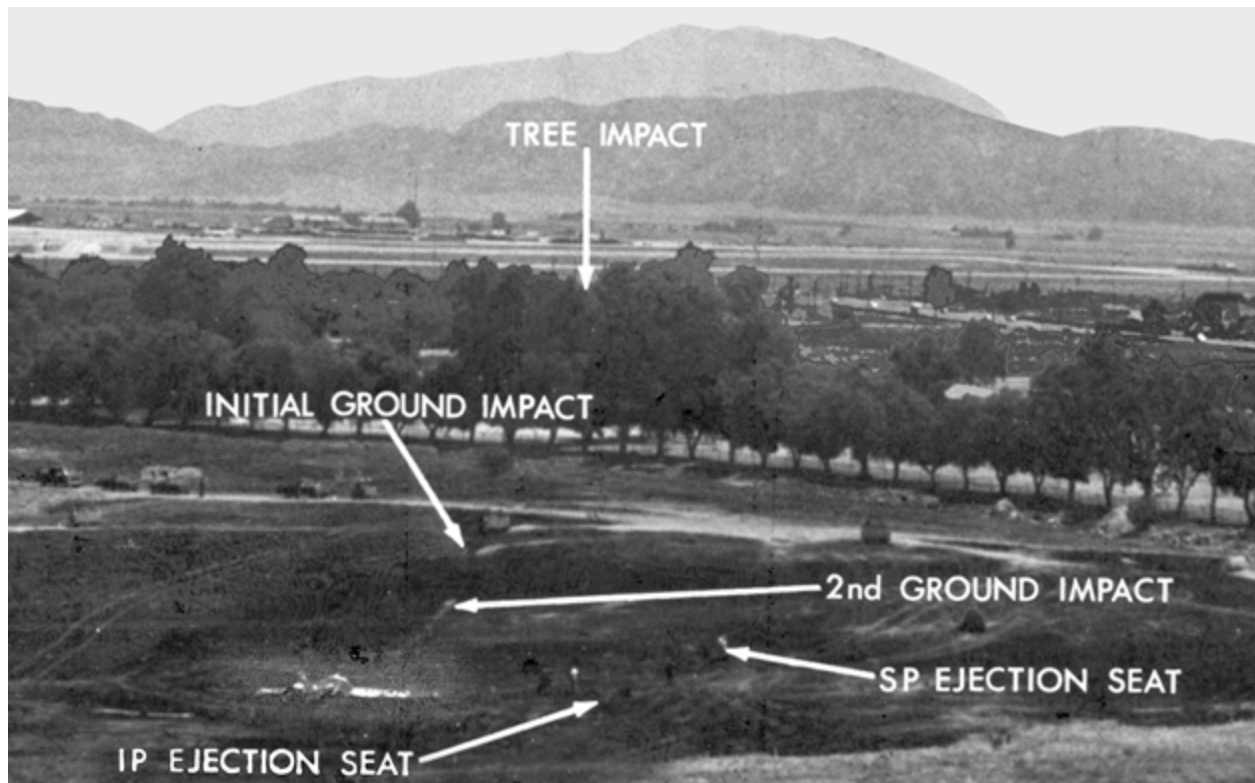
Figure 110. Single Engine Go-Around.

103.1. **Mishap. Figure 110.** The mission was a dual cross-country navigation sortie. On takeoff leg, the number one engine overheat warning light came on. The engine was shut down, and the instructor pilot maneuvered the aircraft to accomplish a single-engine overhead pattern and landing. Difficulties were encountered during the pattern resulting in a single-engine go-around attempt; the aircraft impacted a tree 1 NM from the runway. The instructor pilot and student pilot ejected out of the envelope and were fatally injured. The aircraft impacted the terrain and was destroyed.

103.2.1. **Logistics Factor.** Immediately after takeoff, the number one engine overheat light illuminated for an undetermined reason. No evidence of fire or overheat was found.

103.3.1. The mishap pilot disregarded accepted practices by attempting to salvage a landing after making a timely decision to go-around. When a second single-engine go-around was attempted at very low altitude, the mishap was certain. The decision to eject versus attempting a forced landing was a last-ditch attempt to survive. Although, pilots must reevaluate emergency situations on a moment-to-moment basis because of changing conditions, they must not fall subject to the hazards of indecision. Once an acceptable plan is put into action, stick with it, and make it work.

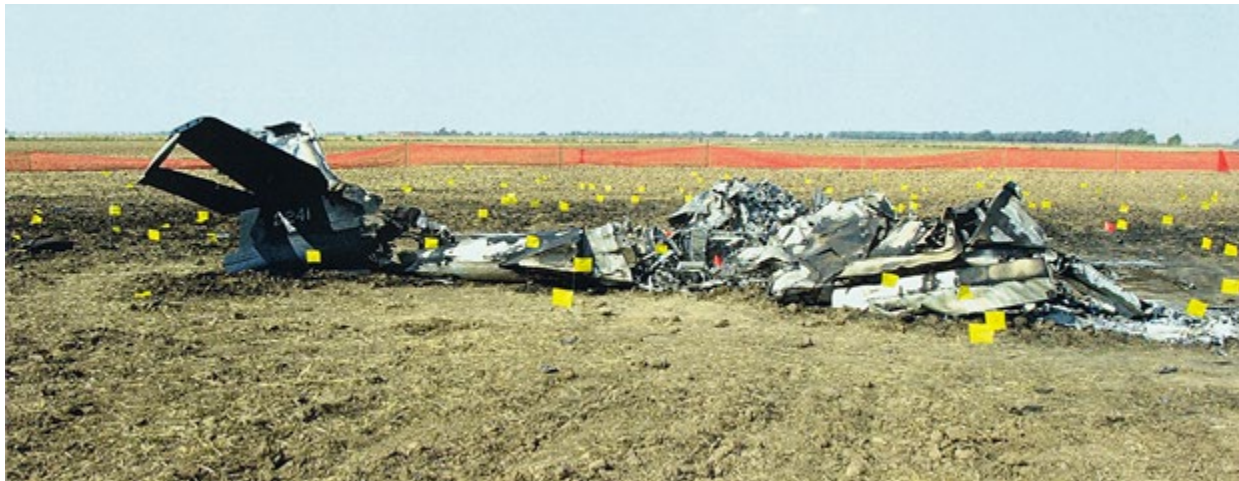
Figure 111. Stall – Final Turn/Loss of Control.

104.1. **Mishap. Figure 111.** The mishap sortie was the student pilot's second solo flight. Prior to the mishap the student pilot had been duties not including flying (DNIF) for 10 of the 12 previous days. After takeoff the student pilot entered the local pattern and reported initial for the first overhead pattern. The student pilot broke early and established a normal offset for downwind. The mishap aircraft was observed overshooting final at an altitude of approximately 400 feet AGL. When crossing the extended runway centerline, the aircraft's ground track was perpendicular to the runway with approximately 90 degrees of turn remaining. The student pilot abruptly rolled left to 80-90 degrees of bank. The aircraft's nose tracked aggressively toward the runway heading, then stalled and entered a steep nose-low altitude. The aircraft impacted 0.9 NM short of the runway threshold. The student pilot made no attempt to eject and was fatally injured. The aircraft was destroyed.

104.2.2. **Operator Factor.** Approaching the extended runway centerline, with approximately 90 degrees of turn remaining, the student pilot attempted to prevent an overshoot. The student pilot abruptly rolled into 90 degrees of bank causing the aircraft to rapidly track toward the runway. The abrupt control inputs caused the aircraft to go into an accelerated stall. The aircraft's nose then dropped and impacted the ground.

104.3.1. The recognition of deficiencies in training and the importance of recent experience are critical. In this mishap, supervisors did not adequately perform a risk assessment. The student pilot's poor academic and flying skills combined with his recent DNIF status (off and on for 10 days) should have been considered prior to allowing the student to fly a solo syllabus sortie.

104.3.3. It must also be noted that the SP had a history (known by his peers) of making abrupt control inputs without regard to personal safety.

104.3.2. Regarding pattern operations, it is important that RSU training stress the importance of early detection of the development of an unsafe situation as well as the importance of issuing instructions in a timely enough manner to allow proper crewmember reaction. Additional emphasis on the control of solo students in the pattern was identified.

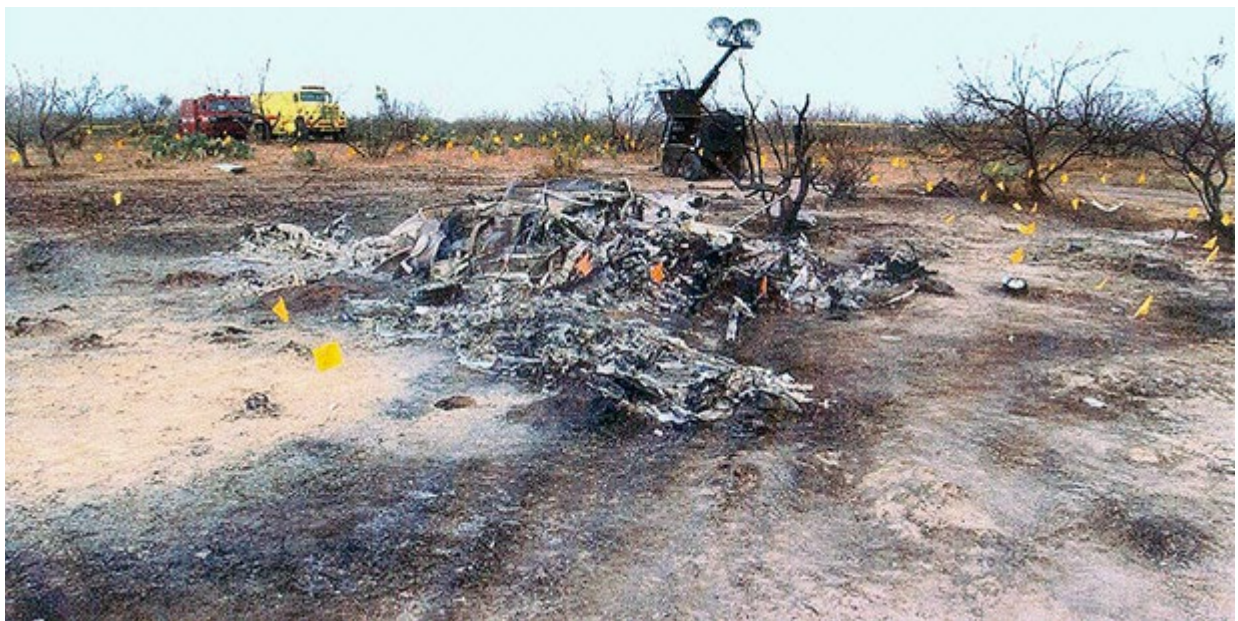
Figure 112. Stall – Final Turn/Go-Around.

105.1. **Mishap. Figure 112.** The mission was a dual contact sortie and was the student pilot's third sortie in the program. The winds were strong and gusty and the status was dual (no student solos) for winds. Upon arrival at the auxiliary airfield the student pilot flew a straight-in approach and performed a touch-and-go landing. Following a normal box pattern back to initial, the RSU controller noticed the aircraft's ground track was offset to the left of the runway. A break to the right resulted in rolling out on downwind well inside of the normal ground track with a higher than normal ground speed. In response, the RSU controller issued an advisory of "late turns to final, overshooting finals." Immediately after, the aircrew made an aggressive correction to normal downwind spacing followed by an early turn to final. Concerned about spacing, the controller asked the mishap crew if they had the straight in traffic in sight. The IP replied "negative" and began go-around procedures. After trying to locate the traffic, the IP rolled into 60-80 degrees of right bank to avoid a perceived conflict. The RSU controller observed the dangerous situation developing and directed a go-around. In an attempt to avoid a perceived collision the IP further increase bank to 90 degrees and increased backpressure. The aircraft departed controlled flight and was destroyed on ground impact. Neither pilot attempted to eject and were fatally injured.

105.2.1. **Operator Factor.** Inattention led the mishap crew to fly the overhead traffic pattern unaware of straight-in traffic (mishap crew missed at least 6 radio calls pertaining to traffic location). Fearing a collision, the instructor pilot over controlled the aircraft by using excessive bank (90 degrees) and backpressure, entered an accelerated stall, departed controlled flight, and crashed.

105.3.2. Regarding RSU operations, the possible creation of additional radio terminology for final turn directives was evaluated. Specifically addressed was the governing instruction, 19 AFI 11-204, Runway Supervisory Unit (RSU) Operations, statement: "This phraseology is not intended to cover every situation or restrict use of additional terms." It was decided that additional phraseology would only reinforce the misconception among RSU controllers that only standard phraseology may be used. This statement is not found in the current AETCI 11-204.

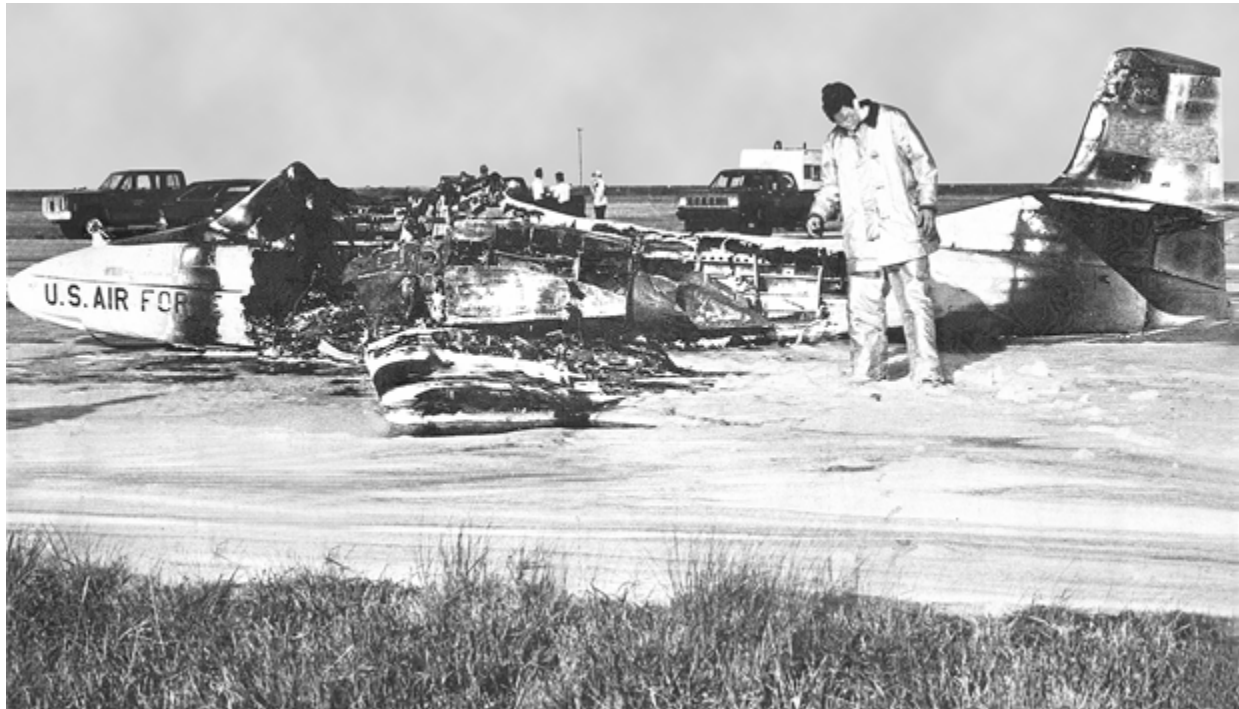
Figure 113. Short Landing.

106.1. **Mishap. Figure 113.** The aircraft was on a dual contact training sortie. Shortly after takeoff, the aircrew attempted to fly a heavyweight, no-flap, straight-in to a planned low approach. During the transition to the low approach, the aircraft impacted a drainage ditch 228 feet short of the overrun and came to rest 22 feet past the threshold. The crew ejected without injury. The aircraft was destroyed.

106.2.1. Supervisor Factor. Following a previous mishap, MAJCOM supervisors failed to provide a timely change to directives concerning minimum RPM on final approach. MAJCOM supervisors also failed to ensure instructor pilots and students received adequate instruction on performance and flight characteristics during heavy-weight, no-flap approaches. Unit supervisors failed to discontinue use of the auxiliary field when the crash response capability was below that required by directive. Due to inadequate training, the student flew a steeper than normal no-flap glide path with a heavyweight aircraft and the power at idle. The instructor pilot failed to direct timely discontinuation of the poor approach and failed to take control of the aircraft in time to make a safe recovery. While attempting to shallow out the steep final approach, the student did not use enough power, and the airspeed bled off 10 knots below the required minimum speed. The instructor pilot failed to prevent the bleed-off of airspeed, but took control of the aircraft and attempted a go-around. However, the steep descent and slow speed prevented a safe recovery. The aircraft impacted the ground short of the overrun and was destroyed.

106.3.1. The mishap was caused by numerous instances of supervisory errors. Investigation of a similar mishap 14 months before had identified the need for additional command directives concerning minimum power settings during approaches. At the time of this mishap, necessary guidance was still not available to aircrews. Supervisors must realize that timely dissemination of critical guidance is essential to mishap prevention.

106.4.2. T.O. guidance was revised to include, “in a thrust deficient situation when time is critical, rapid throttle movement is the most effective procedure to achieve maximum engine acceleration.”

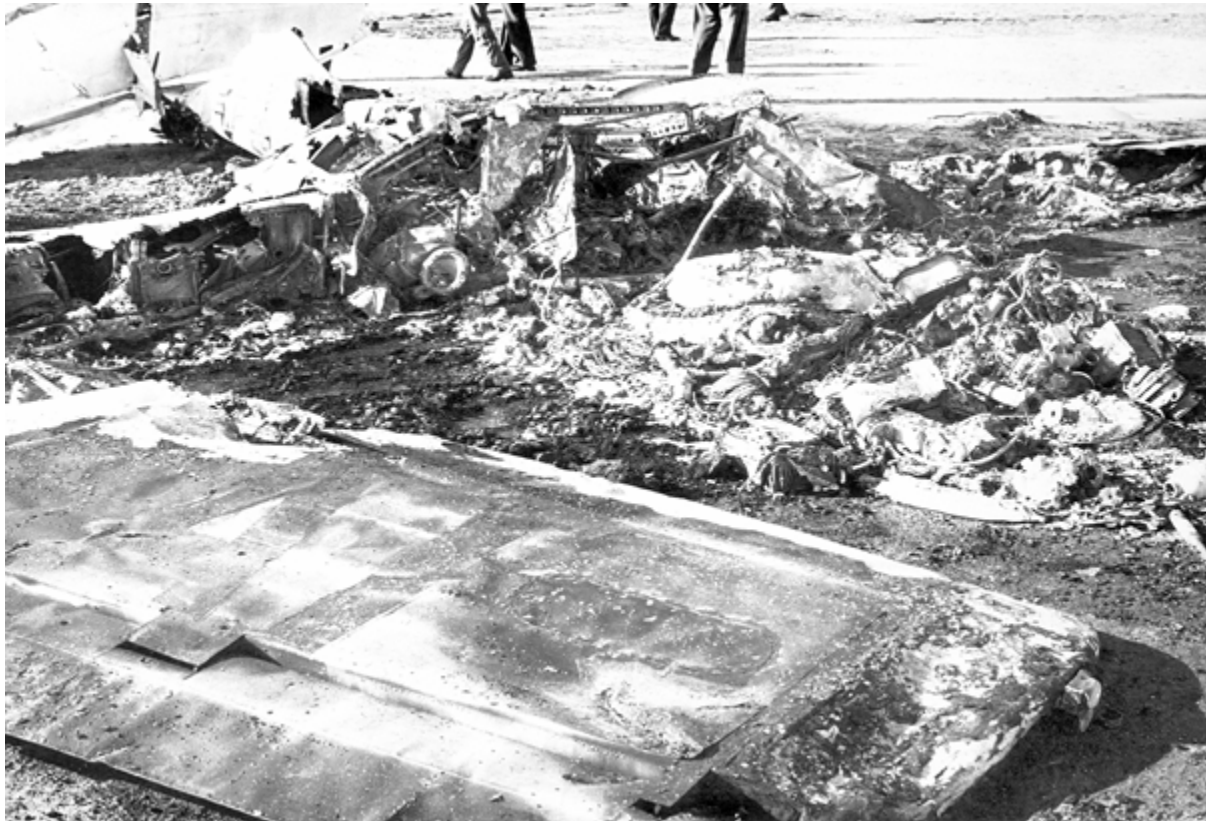
Figure 114. Stall – Traffic Pattern Reentry.

107.1. **Mishap. Figure 114.** This mission was scheduled and flown as a solo pattern-only sortie. The student pilot took off, proceeded to the auxiliary airfield and accomplished two patterns with only minor deviations. During his third pattern, the student initiated a breakout due to a falsely perceived traffic conflict. The controller became concerned when the student pilot failed to arrive back in the pattern in the normal amount of time needed to accomplish a breakout and re-entry. After questioning the student about his position, the RSU controller stepped outside the RSU in order to visually or aurally acquire the aircraft. The aircraft was spotted at approximately 500 feet below traffic pattern altitude and descending, headed perpendicular to the approach end of the runway. At approximately the same time as the RSU controller spotted the aircraft, the student pilot initiated an abrupt left turn using excessive back pressure. This resulted in an accelerated stall, followed rapidly by a transition to a spin. The mishap pilot did not initiate the ejection sequence and was fatally injured. The aircraft was destroyed by ground impact and post-impact fire.

107.2.1. **Operator Factor.** The mishap student pilot over controlled the aircraft by abruptly entering a left turn, resulting in an accelerated stall followed by a spin.

107.3.2. Human reaction to problems is magnified by stress. Everyone suffers from self-imposed stress, particularly the fear of failure. The mishap student perceived danger and a sense of failure because he was not on the appropriate ground track. Individual stress may have led him to over control the aircraft. To minimize the effects of stress, pilots should have a basic plan. Preparation helps them remain calm and aids in analyzing the situation. Above all, regardless of the situation, they must maintain aircraft control.

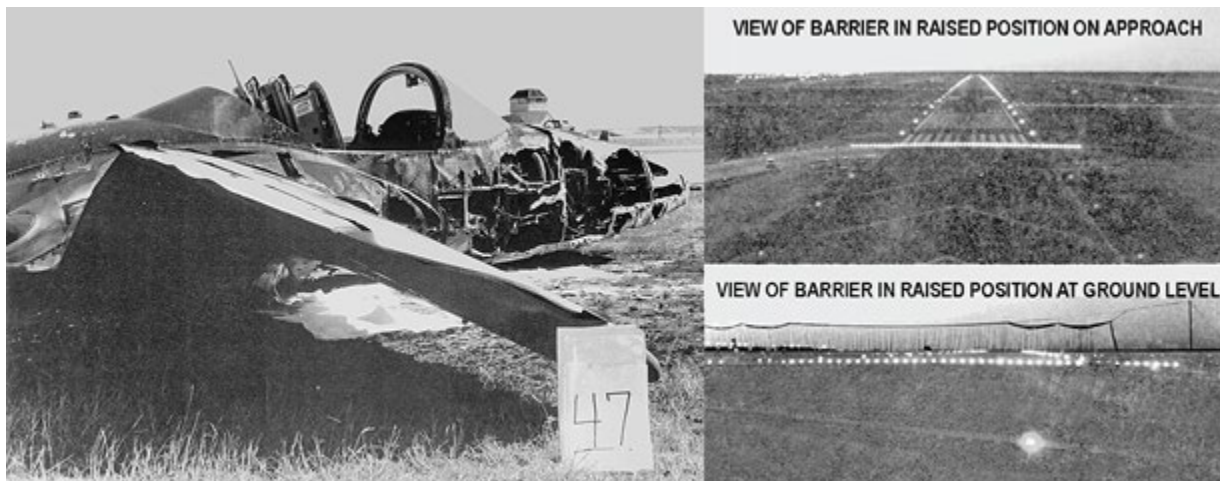
Figure 115. Unintentional Barrier Engagement.

108.1. **Mishap. Figure 115.** The mishap sortie was a local airfield lighting flight check with the primary objective of evaluating threshold lighting in response to a hazardous air traffic report. The mishap crew consisted of two instructor pilots who took off shortly after sunset. After two overhead patterns were flown and lighting was reported satisfactory, clearance was given to fly an overhead approach to a different runway in an attempt to compare lighting intensities. On a normal four-degree final approach, at 100 knots, with full flaps and speed brake, the mishap aircraft struck the raised BAK-15 barrier. The aircraft impacted the overrun approximately 25 feet short of the threshold, main gear first. The impact resulted in the aft wing spars failing, rupturing the fuel cells, and causing a fire. The aircraft settled on the runway on its belly, and as it departed the runway, the aircrew shutdown the engines. The aircraft came to rest one thousand feet down the runway and off to one side. One IP received a back injury and the other was treated and released with only minor injuries. The aircraft sustained major fire damage and was destroyed.

108.2.1. **Supervisory Factor.** Group acquisition allowed a BAK-15 barrier to be installed on a runway without obstruction lights as required by AFI. Complacency in the squadron resulted in the aircrew conducting a night sortie, opposite direction traffic, without adequate planning or proper coordination.

108.2.3. **Operations Factor.** Inadequate risk assessment resulted in a Numbered Air Force policy requiring the barrier to remain in the raised position where training operations were conducted. This policy created an unnecessary risk without any potential gain for

other aircraft training operations. An inadequate risk assessment existed. Local MAJCOM guidance existed as required by directive, but no discussion of barriers was included (focus was on deconfliction and interagency coordination).

108.4.2. Guidance in AFI 13-204 Volume 3, Airfield Operations Procedures and Programs, was revised to require consideration of airfield conditions and flight profiles (tactical procedures) that may affect opposite direction operations.

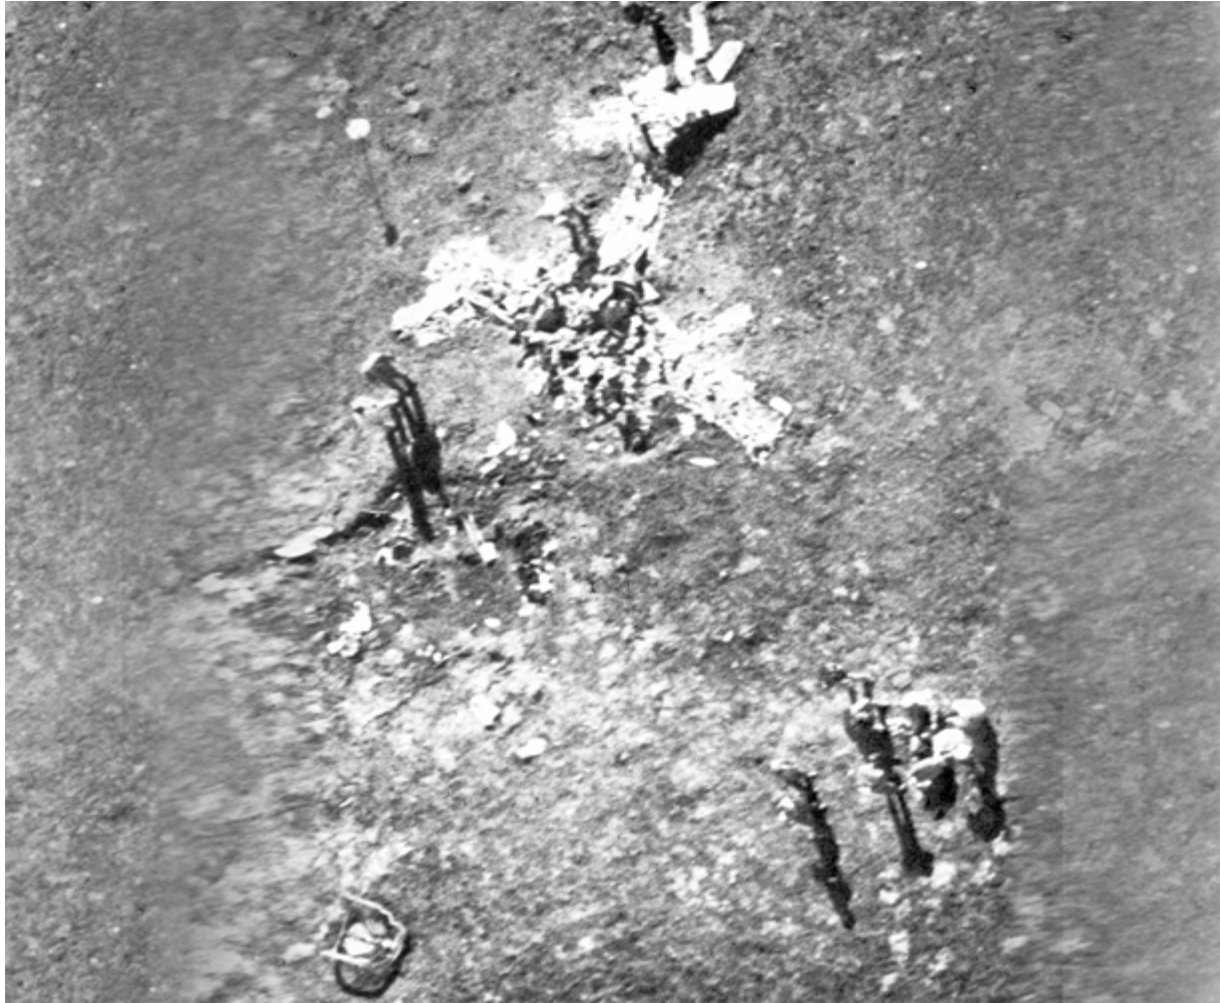
Figure 116. Stall/Final Turn Breakout.

109.1. **Mishap. Figure 116.** The mission was a solo contact training mission. The student pilot proceeded to an auxiliary airfield and entered the pattern for practice approaches. The aircraft impacted the ground 9,000 feet from the runway and was destroyed. The student was fatally injured.

109.2.1. **Operator Factor** . In violation of established directives, the student began an overhead pattern after another pilot reported at 5 NM on a straight-in approach. The RSU perceived no conflict and allowed both aircraft to continue on the approaches. This mishap student configured his aircraft for landing and started the final turn. In response to a query by the RSU, the straight-in pilot reported, “3 miles” followed 10 seconds later by, “2 miles, gear down”. Perceiving a conflict between the two aircraft, the RSU did not clear the straight-in aircraft for landing. The instructor pilot in the straight-in aircraft did not initiate a go-around when he was not cleared to land at 2 miles. The mishap student heard the straight-in call, “2 miles,” perceived a conflict, and initiated an improper breakout from the final turn. The student failed to add military power, and instead of going around, reversed his turn on the base leg. He inadvertently applied right trim as he rolled the aircraft. The student failed to maintain control of the aircraft and entered a right banked dive from which recovery was impossible. Channelized attention contributed to this error. The student ejected outside the safe ejection envelope and was fatally injured.

109.2.2. **Supervisory Factor** . The RSU failed to resolve the conflict by ensuring the straight-in crew went around. The RSU failed to provide adequate guidance to the mishap student when noting the improper breakout.

109.3.1. There were numerous pilot and supervisory errors that caused this mishap. The rules require the straight-in aircraft to discontinue the approach when clearance is not received. Failure to follow procedures resulted in a conflict. The conflict led to the student's decision to break out, which was not in accordance with directives, and lessened his attention to aircraft control. The sequence of events resulted in unnecessary complications for the student. The human factor of channelized attention may have contributed to the student's failure to control his aircraft. The student may have been confused by the gear-warning horn and light activation when he raised the gear with the throttles retarded. Or, he may have been watching the straight-in aircraft as he passed it with minimal separation. In either case, he was not paying adequate attention to what should have been his top priority-maintaining aircraft control. RSU controllers must not be content to merely issue guidance to pilots in the traffic pattern. They must ensure directives are followed to maximum extent of their capabilities.
